**SUBJECT:** **Customer Satisfaction Program 20N11 - Supplement #3**  
Certain 2016 - 2019 Model Year Explorer Vehicles equipped with *Satin or Chrome Plated* Roof Rack Covers  
Roof Rack Cover Inspection/Repair

**Customer Satisfaction Program 20N11 - Supplement #3**

Certain 2016 - 2019 Model Year Explorer Vehicles equipped with *Satin or Chrome Plated* Roof Rack Covers  
Roof Rack Cover Inspection/Repair

## CERTAIN 2016-2019 MODEL YEAR EXPLORER VEHICLES EQUIPPED WITH SATIN OR CHROME PLATED ROOF RACK COVERS— ROOF RACK COVER INSPECTION/ REPAIR

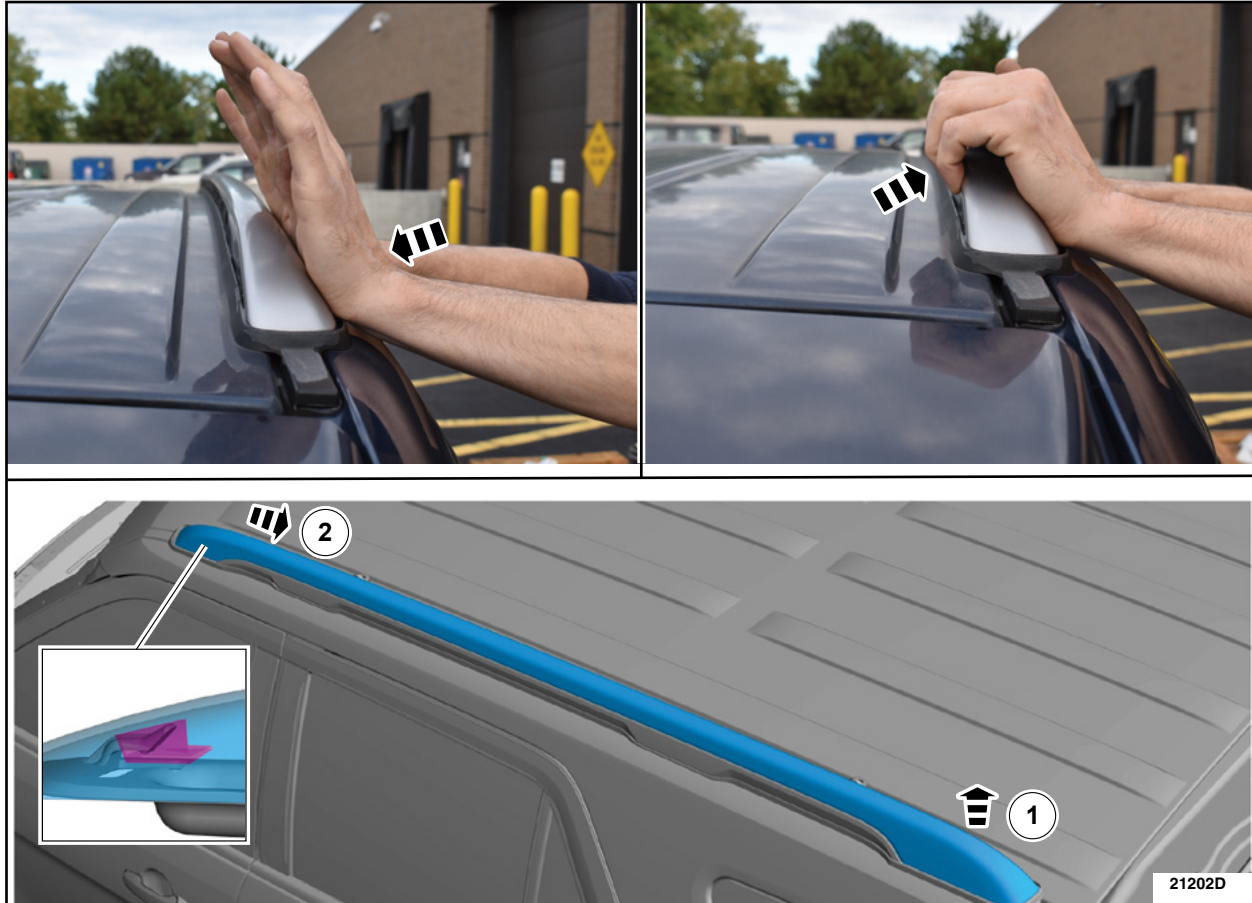
FIGURE 5

a. Remove the affected roof rack cover(s). See Figure 5.

2. Reinstall the roof rack cover by reversing the removal procedure. See Figure 5 on Page 5.

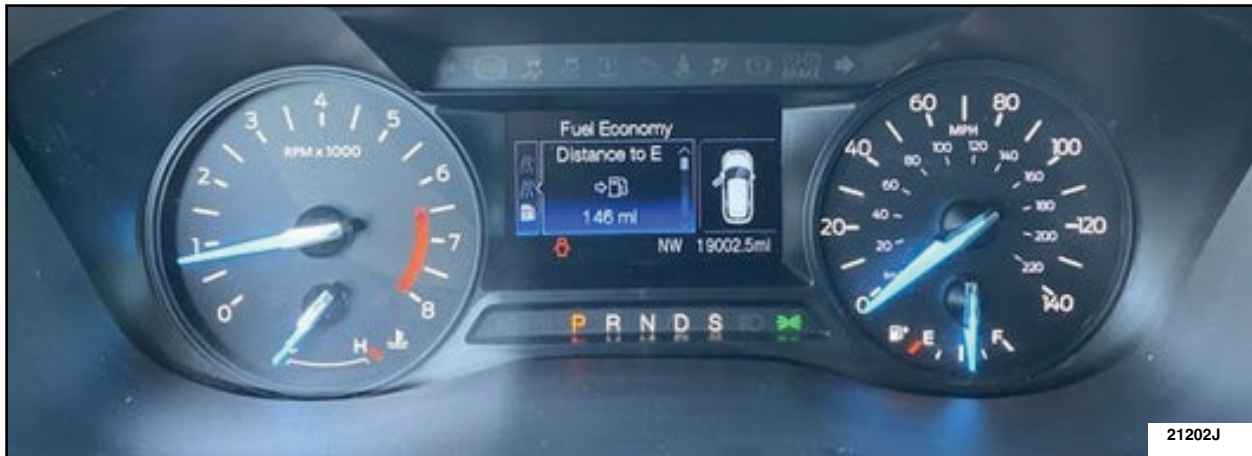
**FIGURE 10**

ii. Take photo showing vehicle mileage. See Figure 10.

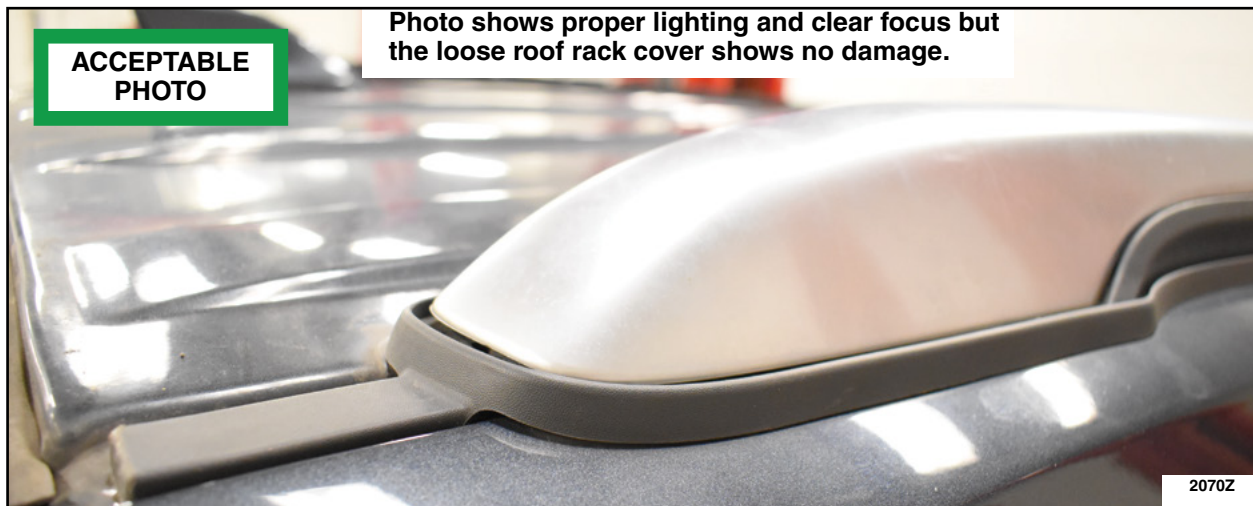
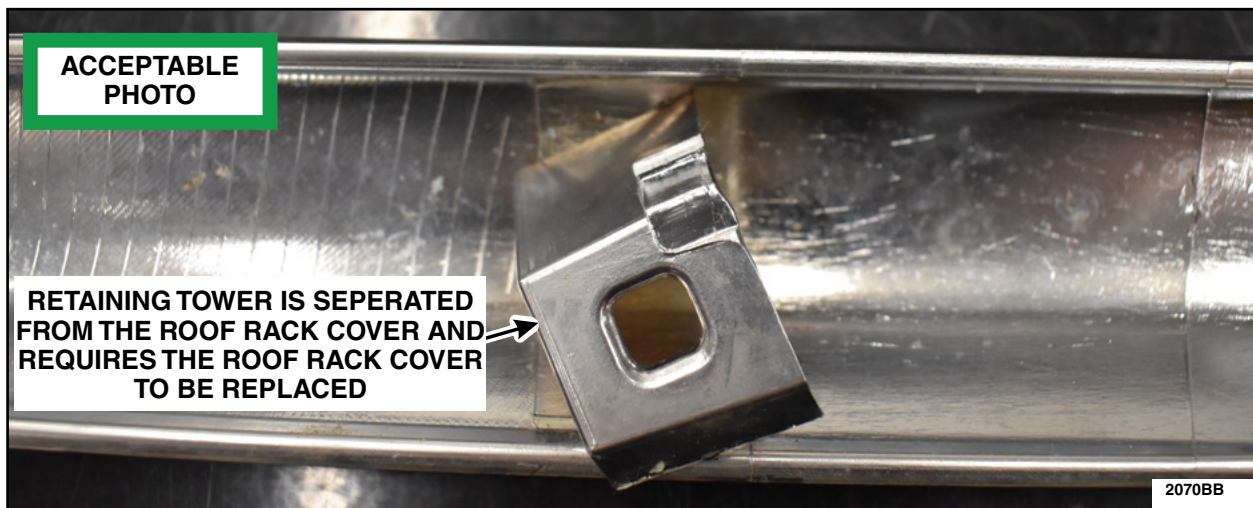
1. Digital images are now required to be attached to each roof rack cover part order. Before submitting VIN-specific part order to SSSC, review new digital image submission requirements on page 2 of Attachment II in the Dealer Bulletin. See Figures 22 through 25 for examples.
