# Technical Service Bulletin

Subject:			
RUST OR PAINT PEELING AT INSIDE EDGE OF FRONT DOOR(S)	Bulletin No.: 09-016/21		
	Last Issued : 07/12/2021

2017-2020 CX-5 vehicles with VINs lower than JM3KF\*\*\*\*\*869654 (produced before Aug. 24, 2020) 2021 CX-5

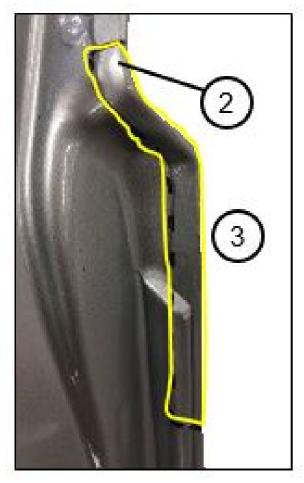
- Pressing the protector tape and bleeding any air, gradually peel it off the release paper.
- Start the application at the top of the area and continue while lightly pulling the tape downward.
- Align the upper end (2) of the protector tape to the end of the curve.
- Align the edge of the protector tape to the inner edge of the door hem (3) so that it is not visible from the outside.
