Technical Service Bulletin

Subject: REAR CONSOLE / CUP HOLDER WARMING	Bulletin No.: 09-023/21
	Last Issued : 07/19/2021

2016-2021 CX-9

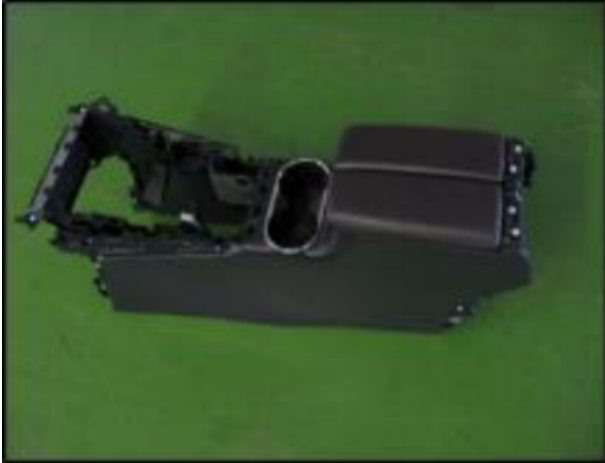
Rear Console Removed

1. Remove the rear console according to MGSS online (REAR CONSOLE REMOVAL/INSTALLATION).

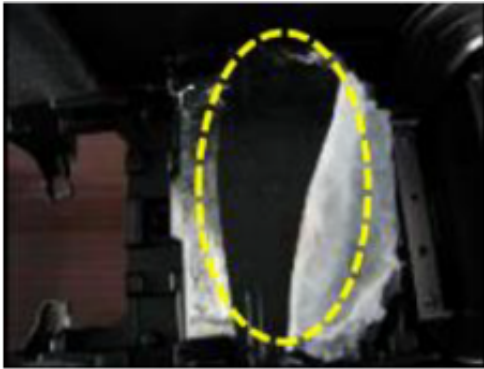
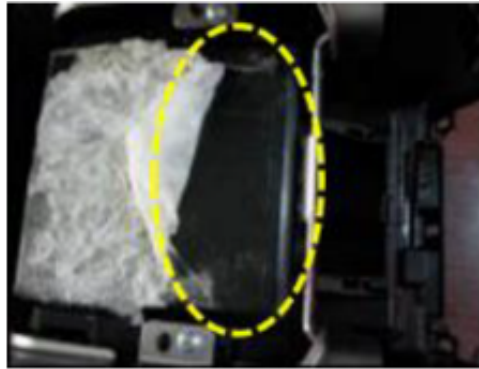
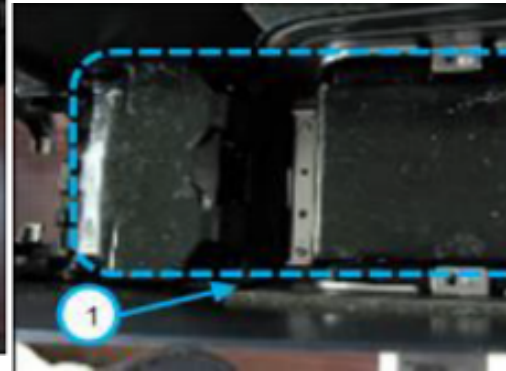
(1) After Insulator Removal

2. Thoroughly remove all the white insulator (1) from the bottom of the rear console.

NOTE: Make sure there are no leftover pieces of insulator. Use parts cleaner to remove any stuck insulator remains.

3. Place the first 100 mm x 270 mm SEAL A (1) in the marked location (as shown below (left)), then adjust the center of the seal according to the dotted line (as shown below (right)).
