Service Bulletin

20-058

July 26, 2021 Version 7

2021 Passport/Pilot: Popping or Crackling from the Speakers; No Sound from the Audio System; *Network Loss* Message and/or Display Issues Supersedes 20-058, dated June 17, 2021. See REVISION SUMMARY.

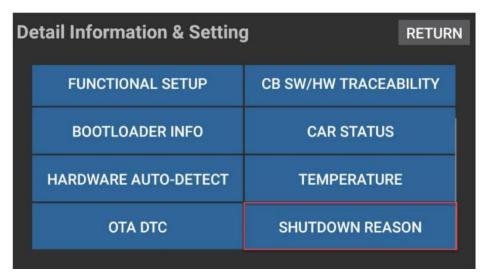
4. Scroll down the menu, and select **SHUTDOWN REASON**.

In this example, the cause of the failure can be identified as Meter:SUDDEN_SIGNAL_OFF.

Write down any failures; they will be collected on the warranty claim. Then, clear the data.
