Tips&Tricks – All models

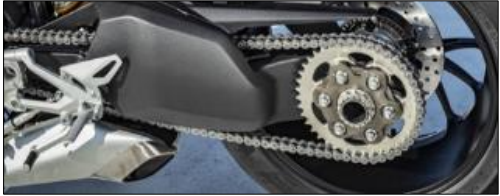
<p>We have received reports of some complaints about rough shifting with DQS, particularly at low rpm. In other words, rough shifting with uncomfortable torque cuts.</p> <p>We have checked that very often the cause is related to an incorrect chain tensioning, especially after the first settling of the chain which takes place at around 200/300 Km (new bike or chain). We therefore invite you to always check the correct tensioning of the final drive chain before making further analysis.</p>

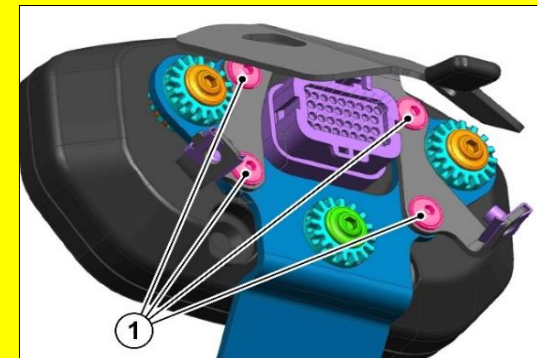
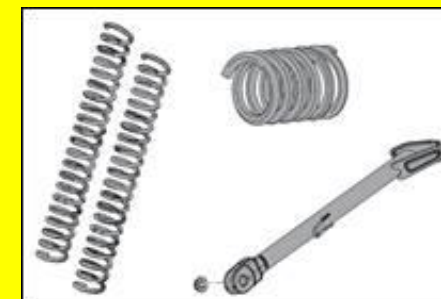
<p>We have received a few reports stating that 4 M5x8 screws (1) part no.77240243C required to fix the headlight fairing support bracket to the instrument panel support bracket are missing from the kit supplied with the motorbike.</p> <p>We would like to inform you that the kits available in stock have all been sorted out.</p> <p>For the headlight fairing assembly procedure and all Pre-delivery operations, please refer to the model introduction bulletin SRV-SRB-21-022.</p>
NEW 2	<p><u>ONLY</u> Monster MY21 (937cc)</p> <p>Standard motorbike lowering and conversion kits now available</p>	Standard motorbike lowering and conversion kits	-	<p>We hereby inform you that the following kits are now available:</p> <ul style="list-style-type: none">- Motorbike lowering kit part no.96280801AA- Motorbike lifting kit part no.96280821AA <p>The kits include the following dedicated components:</p> <ul style="list-style-type: none">• a pair of front fork springs• rear shock absorber spring• side stand• side stand retaining nut <p>Please follow the procedure outlined in the kit or accessories catalogue and the detailed information in the workshop manual.</p>

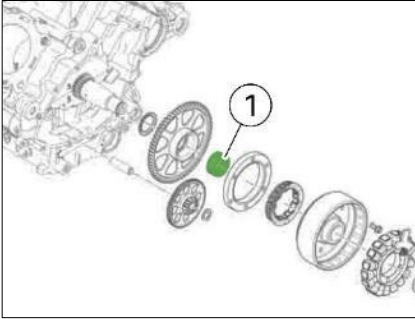
no.	Symptom	Subject	Photo	Notes and Indications - Corrective action
4	<p><u>ONLY</u> Panigale V4</p> <p>Starting system update</p>	Starting system	-	<p>In order to ensure a better starting operation of the engine, we inform you that from engine serial number:</p> <ul style="list-style-type: none"> - ZDM1100W4#007612# for EUR version, - AGNK007652 for CAL version, <p>the roller bearing (1) has been introduced instead of the bushing.</p> <p>Please, note that the spare part catalogue has been updated.</p>

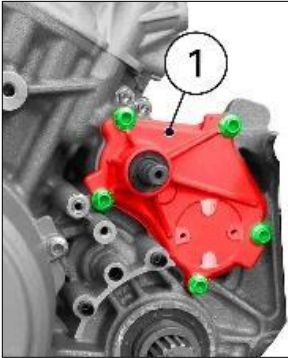
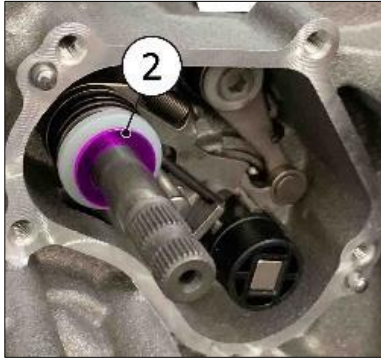
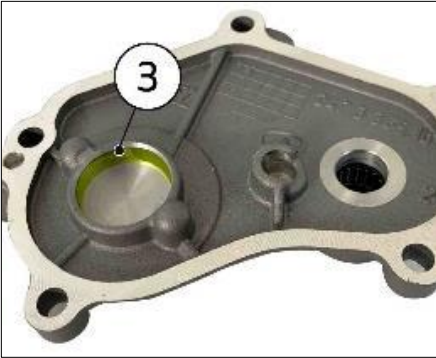
no.	Symptom	Subject	Photo	Notes and Indications - Corrective action									
12	<p><u>ONLY</u> 959 Panigale (all versions)</p> <p>Possible hardening of gear shift control with difficulty in shifting gears when hot</p>	Gear selector	-	<p>We have received some isolated reports about a possible hardening of the gear shift control with difficulty in shifting gears when hot. Based on the analyses carried out, this phenomenon could be due to a hardening between the gearbox sensor magnet plastic support and the relevant seat inside the cover.</p> <p>You are kindly asked to carry out the following operations:</p> <ol style="list-style-type: none"> 1) Remove the gear shift cover (1), on the left side of the motorcycle; 2) Make sure that shim (2) is in place; 3) Using sandpaper, 4) polish the internal surface (3) of the cover shown in the figure. <div style="display: flex; justify-content: space-around;">

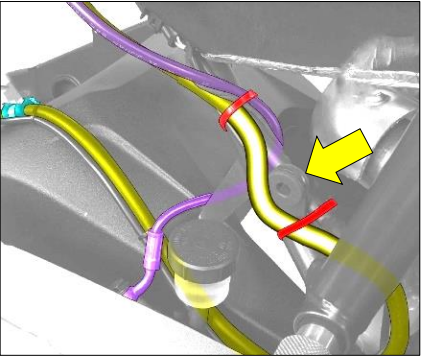
no.	Symptom	Subject	Photo	Notes and Indications - Corrective action				
1	<p><u>ONLY Scrambler 800 (all model versions and MY, excluding Desert Sled model version)</u></p> <p>Precautions when routing the rear brake calliper hose</p>	Rear brake hose	-	<p>We have found that sometimes, during maintenance operations, the rear brake calliper hose is not correctly positioned along the frame.</p> <p>Make sure that the rear brake calliper hose (yellow), passes outside the left side cover mounting bracket with respect to the bike centreline and is fixed with the two self-locking ties (red) as shown in the figure.</p> <p>The operation of inspection and possible repositioning is very simple and involves the disassembly of the left side cover only.</p>

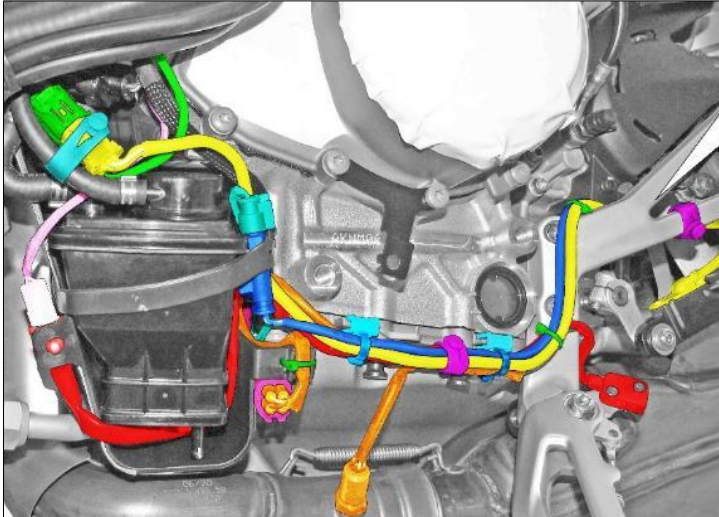
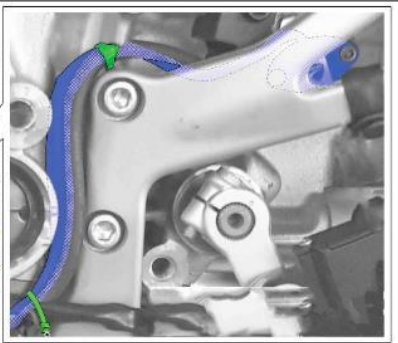
no.	Symptom	Subject	Photo	Notes and Indications - Corrective action
1	Updated layout of motorcycle wiring	Wiring	-	<p>We would like to inform you that the layout of the side stand cable - gear sensor cable - Ducati Quick Shift cable - lambda sensor cable and of the gear sensor connector and cable at the lower crankcase, on the left side of the bike (as shown in the figure) has been updated starting from frame number ZDMFA00AALB003932.</p>

<p>We ask you to respect the new layout of the cables and the gear sensor connector in case of servicing of the mentioned parts.</p>

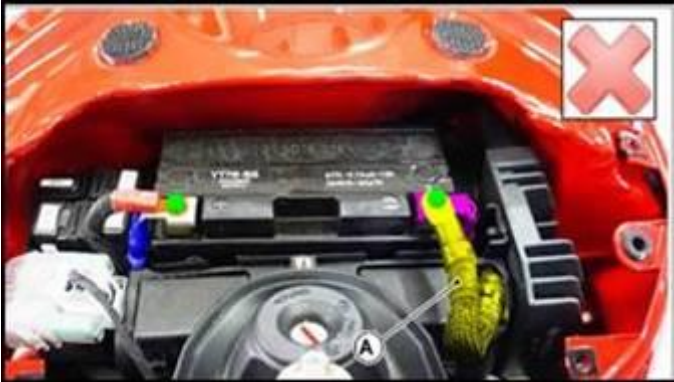
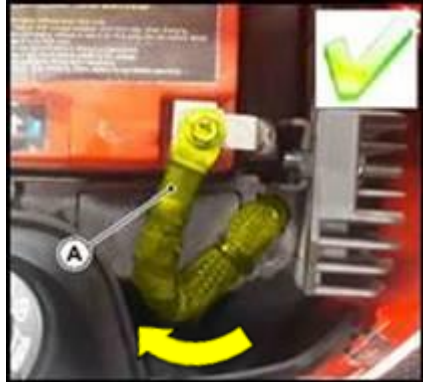
<p>We have received isolated reports of possible interference between the battery negative cable and the battery cover (in particular, the pin fixing the mesh to the cover). We inform you that in order to avoid the contact described above, we have updated the battery fitting procedure and in particular that of the ABS negative cable; it is necessary to connect the ABS negative cable (A) orienting it towards the ignition switch as shown in the figure:</p> <div style="display: flex; justify-content: space-around;">

</div> <p>We ask you to follow the new battery fitting procedure during pre-delivery operations and in any case to always check that the battery is fitted correctly the first time the motorcycle is brought to the workshop. <u>This new battery mounting procedure cancels and replaces the information contained in the model introduction bulletin SRV-SRB-20-002.</u></p>
