SERVICE BULLETIN

Communication #: L-21-01

SUBJECT: FAST CHARGER WIRE HARNESS

2016-2021 GEM E2, E4, E6, EL XD BUILT WITH FAST CHARGER (3 KW OR 6 KW)	
Bulletin #	L-21-01
Claim Type	SB (Service Bulletin)
Labor Allowance	0.8 hours (48 minutes)
Part Number / Description	2416229 (QTY 1) HARNESS-CHARGER,FAST,MAIN,FSD 7080492 (QTY 7) CABLE TIE, 11 IN
Parts Availability	Available to order
University of Polaris Video Training Required	NO

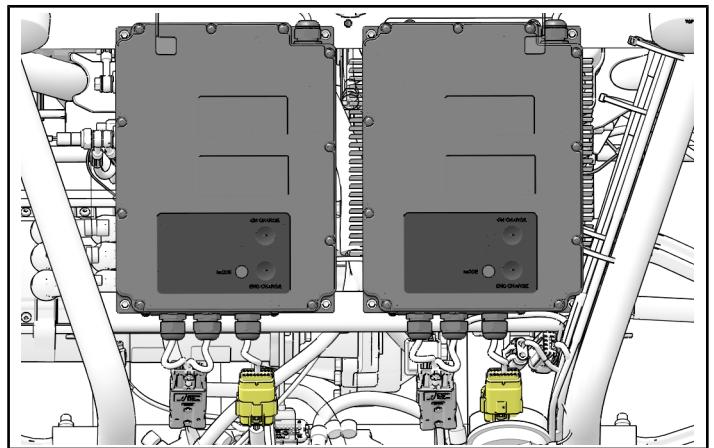
Vehicle shown is equipped with a 6 kW fast charger setup.

6. Disconnect the 16-pin connector from the charger connections.
