HYUNDAI Technical Service Bulletin	GROUP AUTOMATIC TRANSMISSION	NUMBER 21-AT-009H
	DATE JULY, 2021	MODEL PALISADE (LX2) SANTA FE (TMA) SANTA FE HYBRID (TM HEV) SONATA (DN8/DN8A) SONATA HYBRID (DN8 HEV) TUCSON (NX4/NX4A) TUCSON HYBRID (NX4 HEV)
SUBJECT: AUTOMATIC TRANSAXLE PUSH-BUTTON SHIFTER DIAGNOSIS

DESCRIPTION: This TSB provides a procedure to diagnose the push button shifter operation.

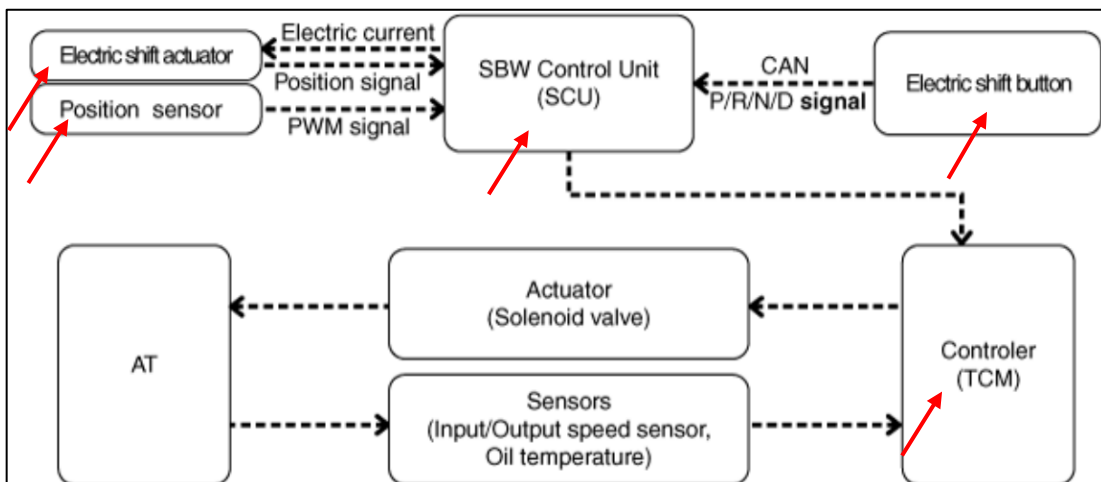
4 components are required to shift to P, R, N and D.

In addition, the PCM or TCU are required to select the correct transmission solenoids.
