Technical Service Bulletin

GROUP Fuel System	NUMBER 21-FL-003HG
DATE July, 2021	MODEL(S) G80 (DH)

SUBJECT: DTC U0109/U010900 FUEL PUMP CONTROL MODULE

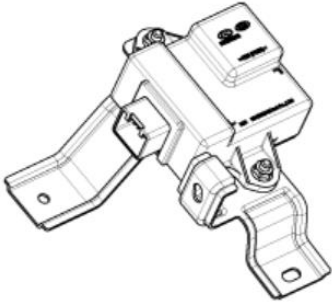
Parts Name	Part Number	Description	Note
Controller-Fuel Pump	33041-XXXXX

Refer to Electronic Parts Catalog for the applicable P/N based on VIN
