Service Bulletin

Bulletin No.: 21-NA-129

Subject: Rear Seat (60 Percent) and/or (40 Percent) Chucking Movement, and Noise is Present at Rear Latch to Striker

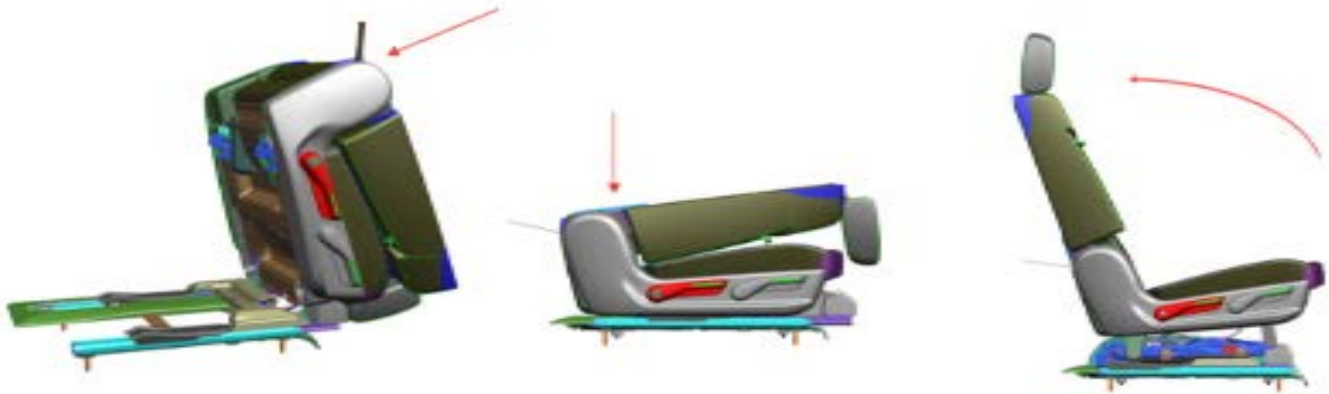
4. For any latch location (inboard, outboard or both) which displays the chocking movement between the floor latch and striker, complete the repair steps below:

Caution: Material removal at the latch plates should be by hand tool operation only; NO power tools. If too much material is removed, the chocking movement could become permanent, and the entire seat structure would need to be replaced.

Note: Material removal should be accomplished in several repeated steps, not all at one time. And use care to ensure NO material is removed from the latch hook.

- 4.6. Insert a 4 inch, FLAT fine grade file, or equivalent, and evenly remove a minimal amount of material from both sides of the latch plates; **only until the wax pencil marking has been removed.** Use short strokes keeping the file perpendicular to the latch plates, so an even amount of material is removed from each plate.
