Subject: Engine Wire Harness Chafing

Brand:	Model:	Model Year:		VIN:		Engine:	Transmission:
		from	to	from	to		
Chevrolet	Silverado 1500 (New Model)	2019	2019			Equipped with L82, L84, L87, LV3, L3B, or LM2	
	Silverado 1500	2020	2021				
GMC	Sierra 1500 (New Model)	2019	2019				
	Sierra 1500	2020	2021

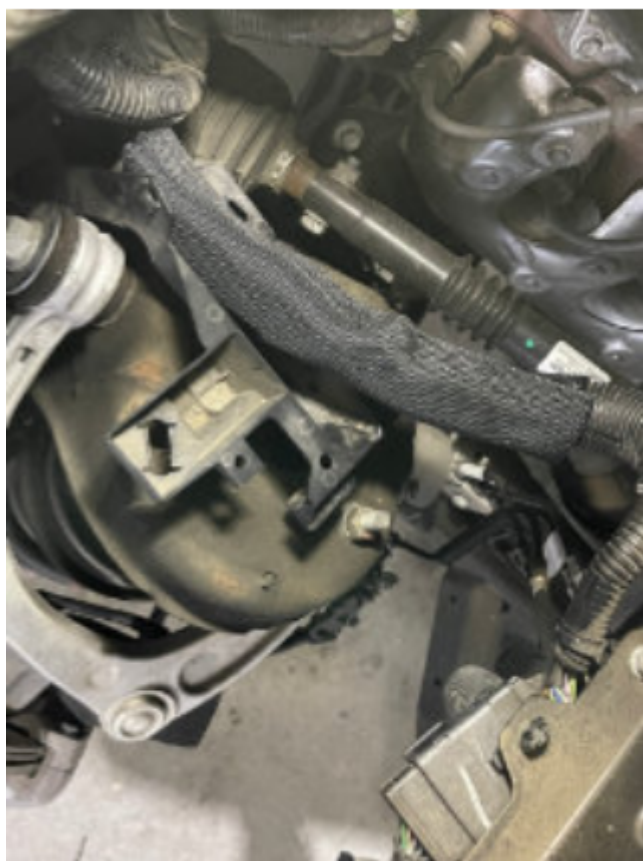
5868358

6. At the shock tower point there is a wire harness canal (1).

7. Verify the wire harness is wrapped and secured at all three points, the ECM/TCM Bracket (1), Upper Control Arm (2), and the Shock Tower (3). Then reassemble the vehicle.
8. Reinstall the front wheelhouse liner and tire and wheel. Refer to *Front Wheelhouse Liner Replacement* and *Tire and Wheel Removal and Installation* in SI.
9. Remove the support and lower the vehicle.
