GLOBAL SAFETY FIELD INVESTIGATIONS
DCS5874
URGENT - DISTRIBUTE IMMEDIATELY

Subject: N212339040 - Customer Satisfaction Program
Radio Calibration Incorrect for Steering Wheel Switches

Models: 2021 Chevrolet Tahoe
Equipped with Special Service Sales Package (RPO 5W4) and Radio
Infotainment System (RPO IOR)

N212339040 Radio Calibration Incorrect for Steering Wheel Switches

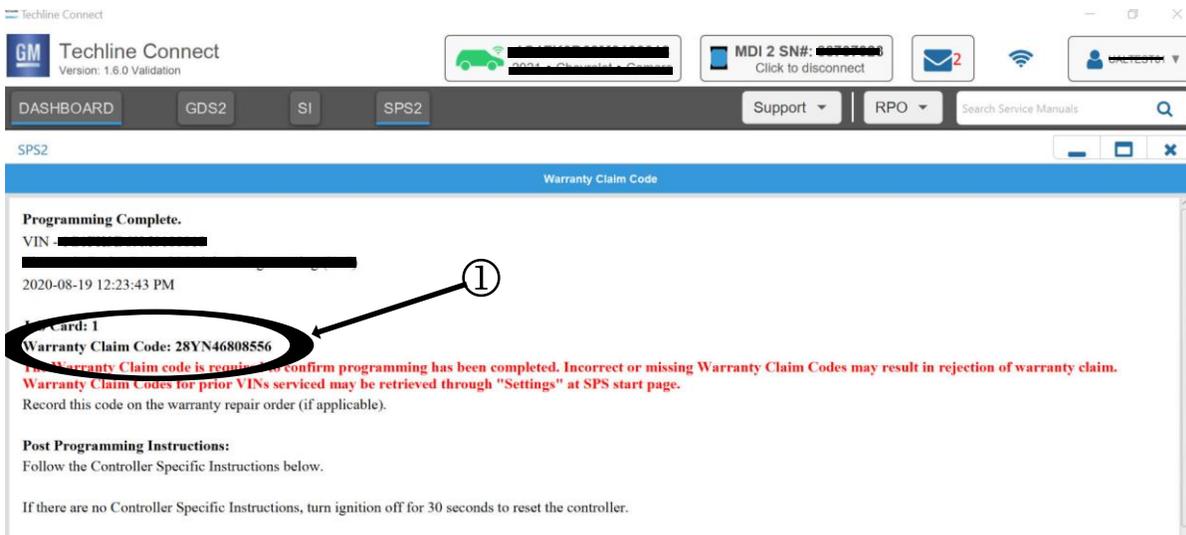
5644478

Condition	On certain 2021 model year Chevrolet Tahoe vehicles with a special service sales package and radio infotainment system (RPOs 5W4 and IOR), the left hand buttons on the backside of the steering wheel currently enable favorites instead of being repurposed for the use of emergency equipment such as police lights or sirens and push-to-talk microphone.
Correction	Dealers are to reprogram the radio.

1. Reprogram the radio. Refer to *A11 Radio: Programming and Setup* in SI. USB reprogramming is not required.
