SIB 01 21 18

## N63: OIL CONSUMPTION CLASS ACTION SETTLEMENT DIAGNOSIS/REPAIRS (VERSION 13.0)

### MODELS

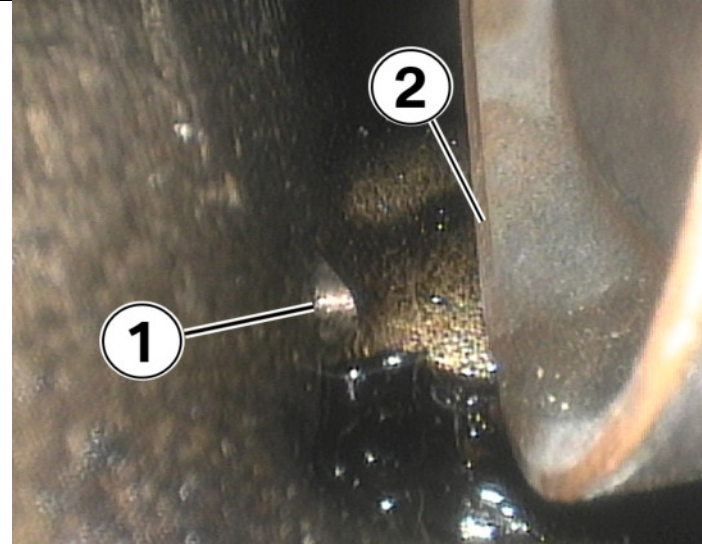
<p>Inspect the surrounding area of the engine valley drain hole (1).</p> <p>Engine valley drain hole (1)</p> <p>Metal vacuum reservoir (2) shown.</p> <p>This is a clean picture. No oil can be seen in the oil drain hole (1).</p> <p>The dark material at the bottom of the photo is dust and dirt. This material appears to be reflective but it is dry</p>

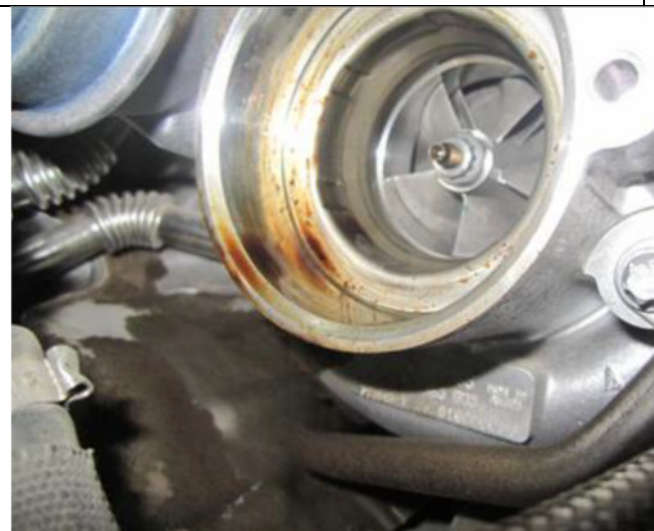
The turbocharger is OK.  
No engine oil can be seen around the turbocharger impeller.

If the turbocharger inspection is "NOT OK", then replace the turbochargers in conjunction with the recommendations in step 11. Go to step 11.

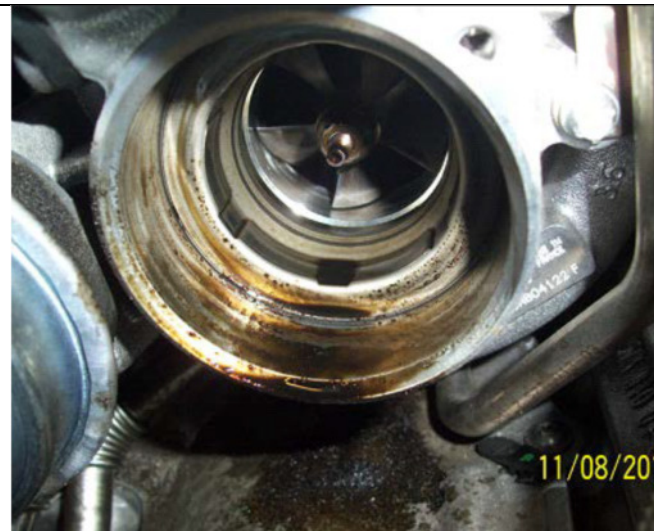
The turbocharger is OK.  
No engine oil can be seen around the turbocharger impeller.

If the turbocharger inspection is "NOT OK", then replace the turbochargers in conjunction with the recommendations in step 14. Go to step 14.

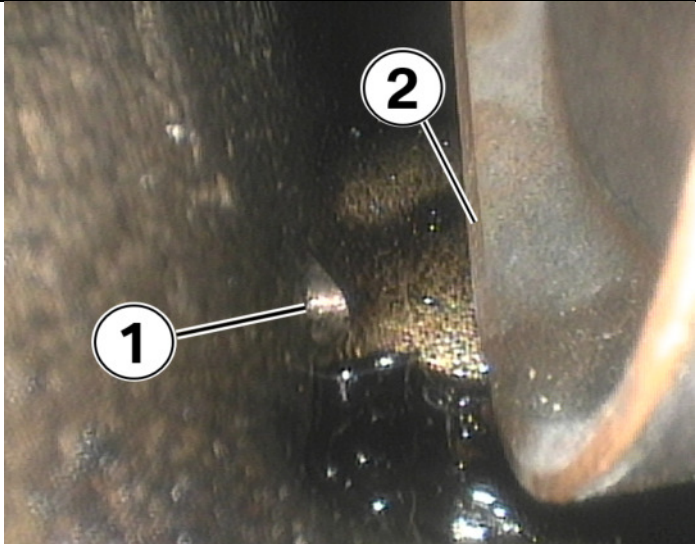
<p>A close-up bore scope view of the engine valley drain hole (1) and the metal vacuum reservoir (2). The drain hole is a small circular hole in the metal surface, and the reservoir is a larger metal component with a circular opening at the top.</p>	<p>Inspect the surrounding area of the engine valley drain hole (1).</p> <p>Engine valley drain hole (1)</p> <p>Metal vacuum reservoir (2) shown.</p> <p>This is a clean picture. No oil can be seen in the oil drain hole (1).</p> <p>The dark material at the bottom of the photo is dust and dirt. This material appears to be reflective but it is dry</p>

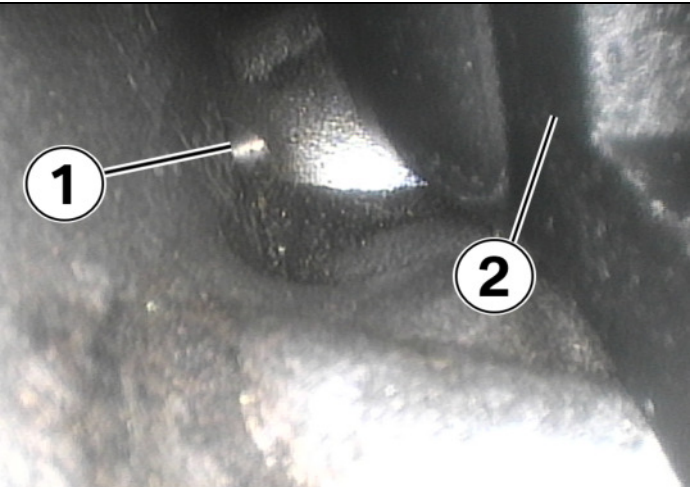
<p>Once the borescope has gone under the plastic reservoir tab then the engine valley drain hole (1) and surrounding area can be clearly inspected.</p> <p>The dark material at the bottom of the photo is dust and dirt. This material appears to be reflective but it is dry.</p> <p>Engine valley drain hole (1)</p> <p>Plastic vacuum reservoir (2)</p>
<p><b>If engine oil is found in the valley area, then the root cause of the engine oil leak resides in the components on top of the engine i.e. turbocharger oil line cover, turbo charger, etc. Further basic diagnosis will be needed to find the root cause this engine oil leak. Do not remove the transmission from the vehicle. Go to Step 7.</b></p> <p><b>If <u>NO</u> engine oil residue is found at the engine valley drain hole, but an original visual inspection indicated leak in the bell housing area, the root cause of the engine leak resides in the rear main seal and rear engine cover. Do not remove transmission from the vehicle. Go to step 7.</b></p> <p><b>If <u>NO</u> engine oil residue is found at the engine valley drain hole, then the root cause of the engine oil leak will be related to the original visual inspection of front cover, or oil pan. Go to step 12.</b></p> <p><b>Using the borescope, provide a picture of the engine valley drain hole regardless if oil is present or not.</b></p>

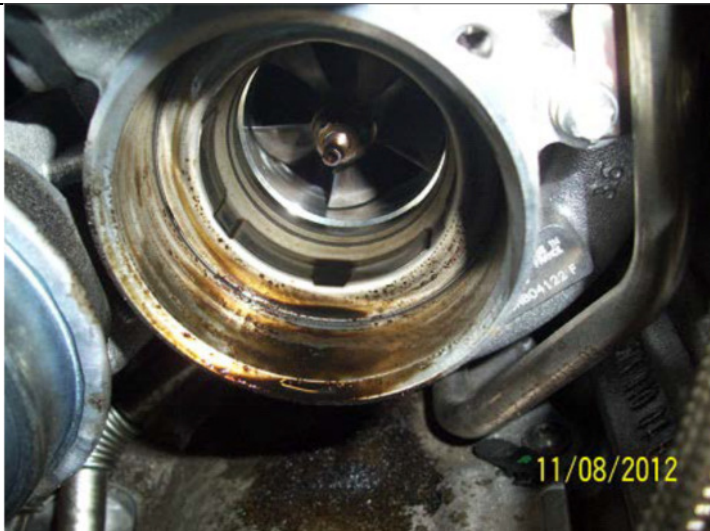
The turbocharger is OK.  
No engine oil can be seen around the turbocharger impeller.

If the turbocharger inspection is "NOT OK", then replace the turbochargers in conjunction with the recommendations in step 10. Go to step 10.
