SIB 52 09 20

2021-06-08

HEAD RESTRAINT AND/OR BACKREST OF 3RD ROW SEATS CANNOT BE FOLDED DOWN

E-Series	Model Description
G07	X7 Sports Activity Vehicle

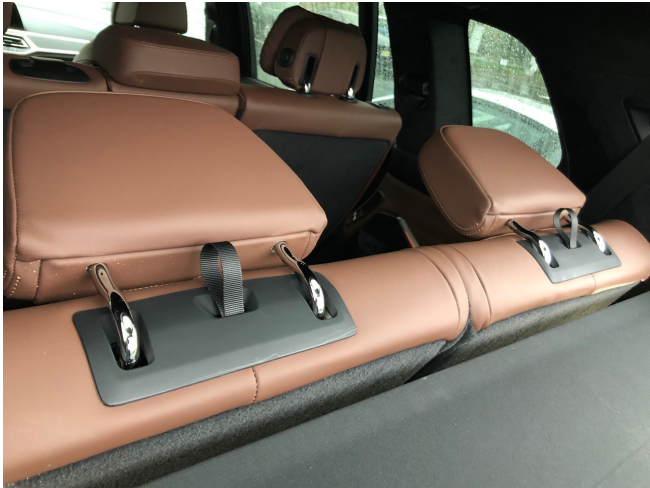
1. Head restraint cannot be folded down:

Can the head restraint be manually unlocked using the release loop beneath the headrest (see picture) and thus folded down?

YES = Head restraint mechanism is faulty.
Replace the folding module of the head restraint (#2 in picture).

See REP 52 30 118 Remove and install/replace folding module of left or right head restraint

NOTE: The head restraint cannot be removed without destroying the covering material. **A new cover (leather) will be required to perform this repair.**

If the Bowden cable is mounted and correctly routed, replace the Bowden cable for the headrest (shown in yellow in picture).

See REP 52 30 253 Replace Bowden cable for left or right head restraint
