## SIB 11 08 21 FAILURE OF REAR OXYGEN SENSOR

E-Series	Model Description
K63	S 1000 R
K66	M 1000 RR
K67	S 1000 RR
K69	S 1000 XR

# Service Information Bulletin

11 08 21

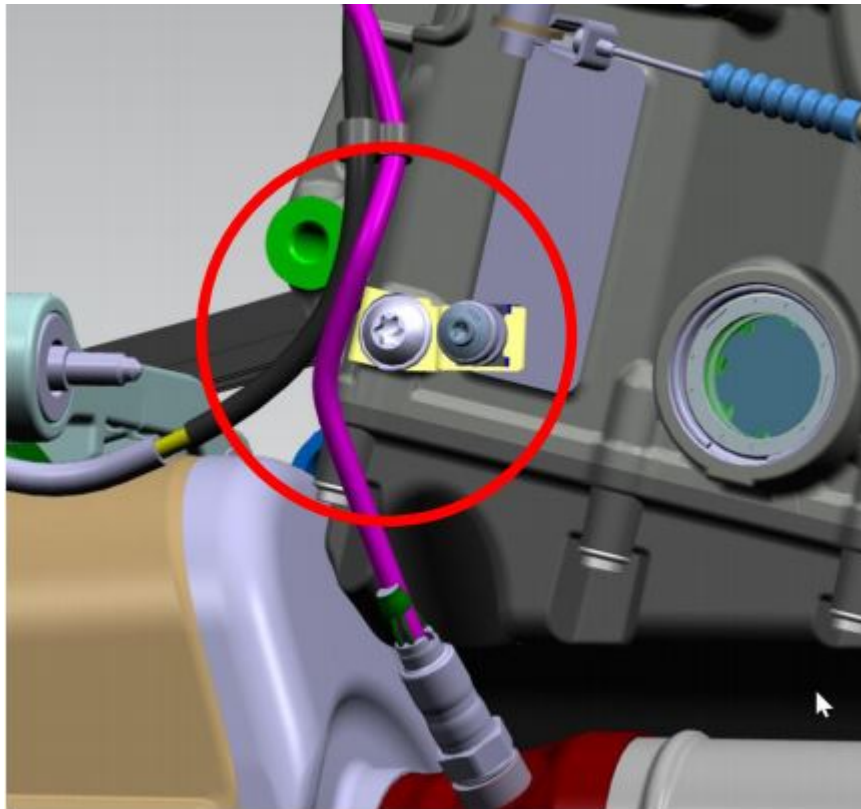
The failure usually occurs shortly after the vehicle handover or the running-in check. Analysis of the defective parts received showed that the oxygen sensor cable is crushed when the engine spoiler is installed.

[insert\\_drive\\_file K69 Oxygen sensor - damage of the lines, wiring harness.jpg](#)

It is possible to repair the damaged area by insulating the single damaged wire with about 3 cm of black heat-shrink tubing with internal adhesive. The black outer insulation tube must also be appropriately covered to repair the damaged area. If a proper repair is not possible, the oxygen sensor must be replaced.

Please ensure that the oxygen sensor cables are not crushed when installing the engine spoilers.

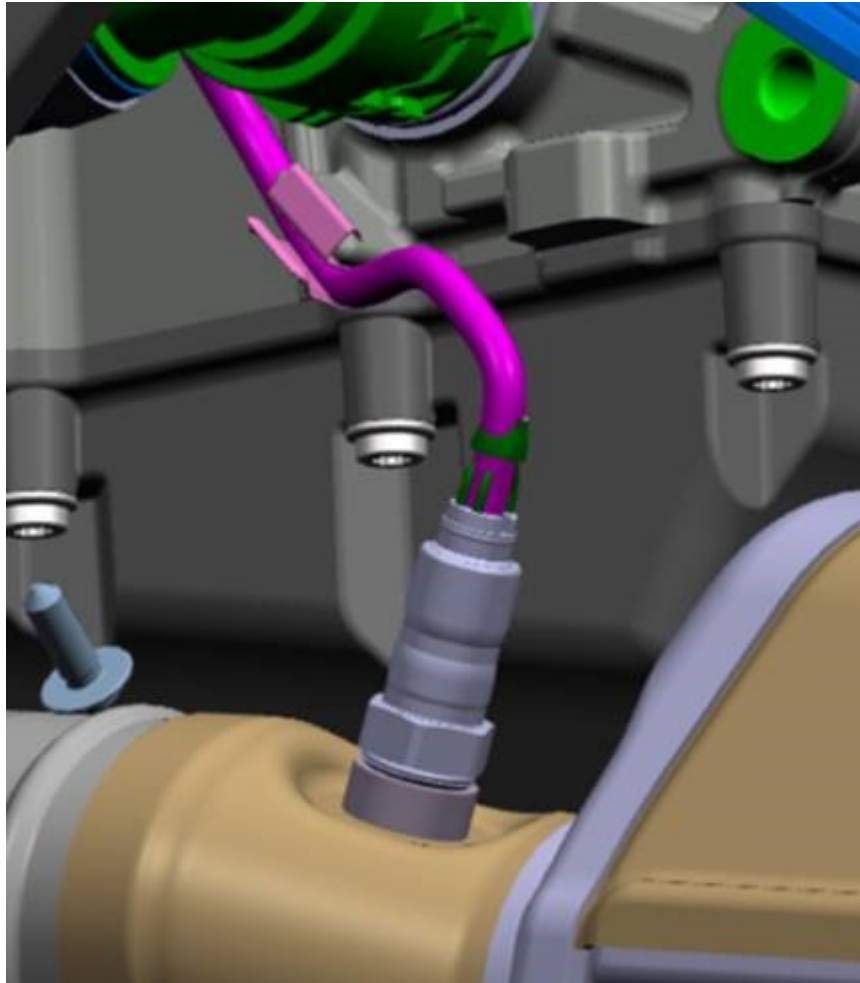
Cylinder bank 1: At the sheet metal clamp that affixes the oxygen sensor cable, see Figure 1:  
*Figure 1: K69 Oxygen sensor bank 1 - damage of the lines, wiring harness at the clamp*

It is possible to repair the damaged area by insulating the single damaged wire with about 3 cm of black heat-shrink tubing with internal adhesive. The black outer insulation tube must also be

appropriately covered to repair the damaged area. If a proper repair is not possible, the oxygen sensor must be replaced.

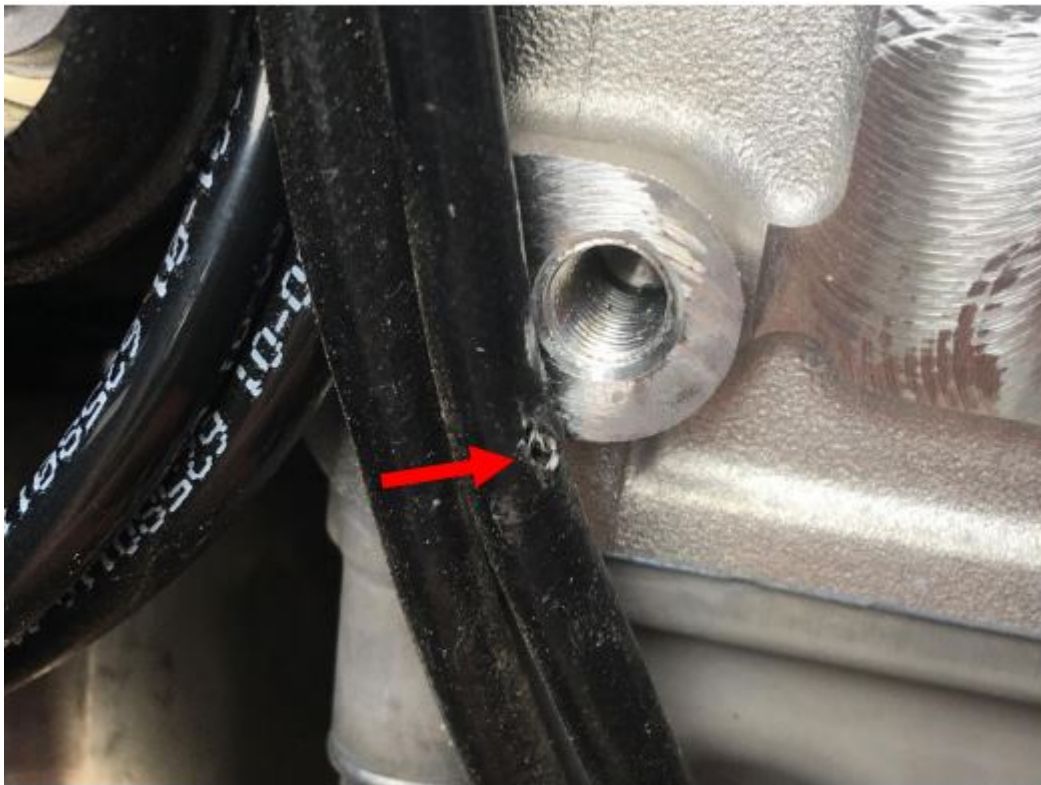
Cylinder bank 2: Incorrectly routed oxygen sensor wiring pinched between the engine and the engine spoiler, see Figure 2:

Figure 2: K69 Oxygen sensor bank 2 - damage of the lines, wiring harness at the bracket for engine spoiler
