GROUP	MODEL
BOD	2022MY Stinger (CK)
NUMBER	DATE
302	August 2021

## TECHNICAL SERVICE BULLETIN

### SERVICE ACTION: FRONT DOOR TRIM GRIP HANDLE INSPECTION AND REPAIR (SA483)

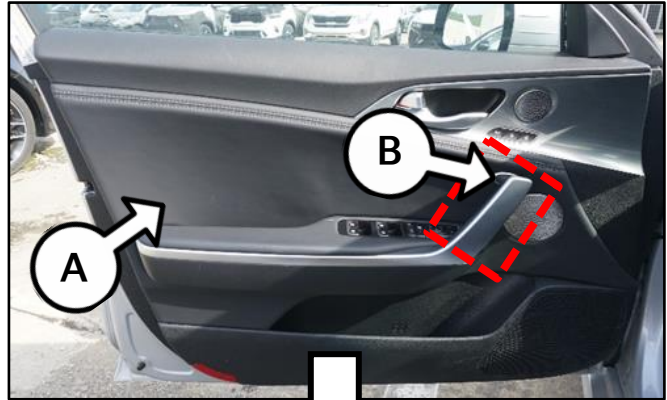
1. Open the driver (LHS) door and check the inside door trim (A) grip handle (B) for the following conditions:

- A. If the grip handle (B) is detached from the door trim panel (as shown to the right), then replace the front door trim panel assembly by referring to the "Body (Interior and Exterior) → Front Door → Front Door Trim → Repair procedures" in the applicable Shop Manual on KGIS.

- B. If the grip handle is not detached, replace the front door inside handle bracket screws by following the 'Replacement Procedure' outlined on page 3.
