## Notice of Defect

This notice is sent to you in accordance with the requirements of the Motor Vehicle Safety Act. This is to inform you that your vehicle may contain a defect that could affect the safety of a person. The VIN numbers of your affected Polar trailers are listed above. We are referring to this action as the "Dexter Recall" and it has been assigned file number 2021-320 by the Department of Transport.

**Subject: SMART-STEER 2.0 Bolt-On Steer Arm Reinforcement Welds**

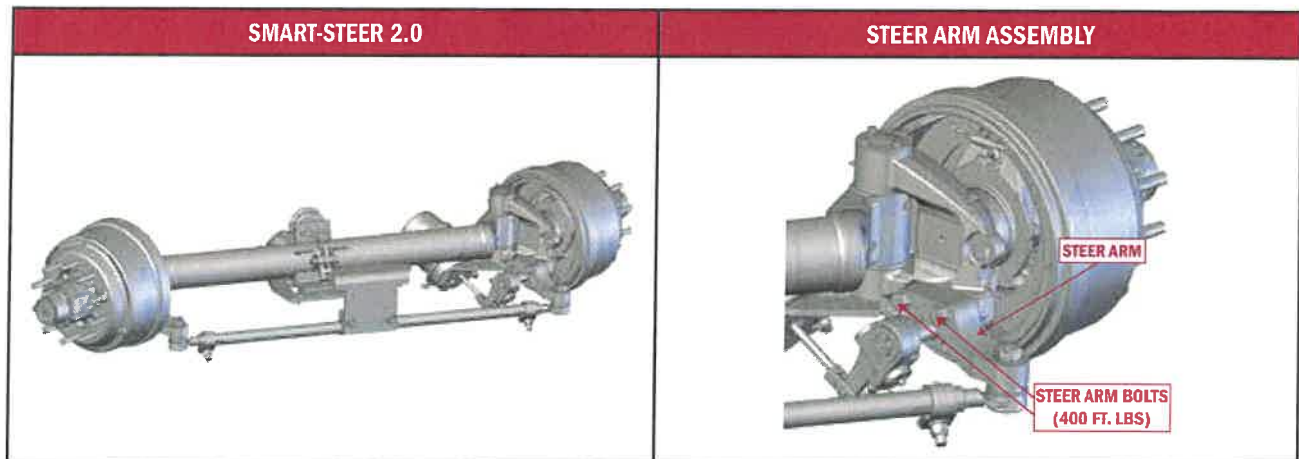
Based on feedback from our customers, Dexter Heavy Duty has become aware that under certain loading conditions, the 8-7/8" steer arm setup on the SMART-STEER 2.0 axle is prone to shearing the attaching steer arm bolts. This will lead to a failure in the steer arm assembly.

Dexter recommends that you perform a steer arm inspection of your axle(s) as soon as possible; but no later than four weeks after receiving this service bulletin. Please follow the steps listed below:

1. Visually inspect steer arm bolts and washers for mechanical tightness and replace if necessary.
2. Ensure the steer arm bolts are torqued to 400 Ft. Lbs.
3. Place welds as shown on page three of this bulletin. If you would like a copy of engineering drawing 750049, please contact one of the service technicians listed below.
