Document ID: IK1600131

Title: Cab Water Leak Troubleshooting Tips

Applies To: LT, RH, ProStar, HX Steel Cab, and Lonestar sleeper cabs. However some aspects may also apply to all cabs in the High Performance Vehicle family - MV, HV, LT, RH, ProStar, LoneStar, TransStar, WorkStar(HV), DuraStar(MV), and TerraStar. 9000i, PayStar(HX) Aluminum Cab, CityStar, CV, or LoadStar are not covered in this document.

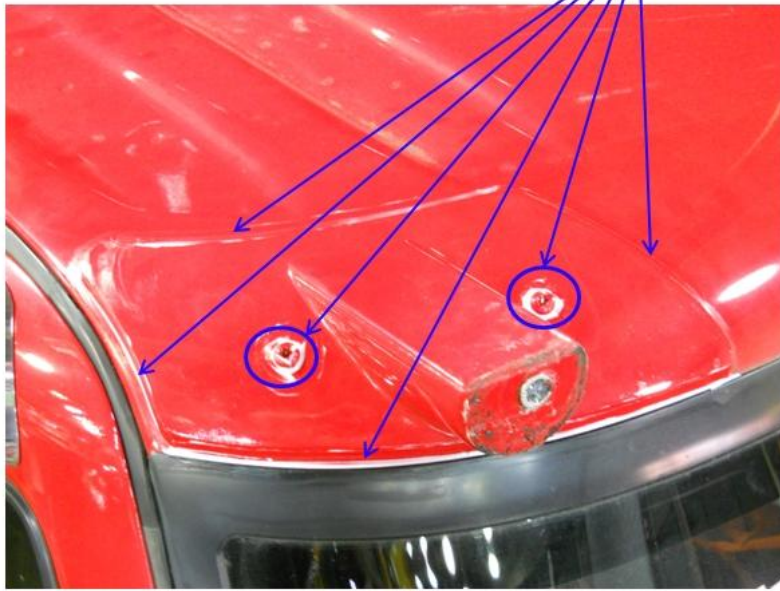
Sunshade Mounting Leaks

- Water leaks from the sunshade mounting can originate where the bracket mounts to the cab or where the sunshade mounts to the mounting bracket. One or both areas may not be properly sealed.
3. Roof marker lights
- Each marker light is held in place with two #8 SS sheet metal screws. One goes directly into the cab roof and the other goes into a U-nut clip. Sometimes the U-nut tears the foam gasket. Sometimes the screw that goes directly into the cab roof strips the hole and causes the gasket not to compress and seal. Add a new U-nut to the stripped hole location.
 - Remove each marker light to inspect and verify seal integrity. (See attached photos for example of defective seal.)
 - Check all five marker lights as more than one could be leaking.

1. Remove the marker lights to access the sunshade attachment bolts.
2. Disconnect the wire harness.
3. Remove the sunshade from the vehicle at the three mounting attachments and dispose of the fasteners (if the replacement fasteners, 3820148C1, are not available then keep the original fasteners for reassembly).
4. Remove and dispose of the foam gaskets on the mounts.
5. Thoroughly clean the fasteners that attach through the sunshade mounting brackets as well as the perimeter surface of each mounting bracket with IPA (isopropyl alcohol).

6. Allow the surfaces to dry.
7. Apply Dow® BETASEAL™ (2611723C1) to the same areas cleaned in Step 5.
8. Immediately wipe off the surfaces (prolonged exposure to the Dow® primer could damage the paint). These surfaces are now prepped for good adhesion to the sealer.
