Service Alert

Mazda North American Operations
Irvine, CA 92618-2922

Subject: CONNECTED VEHICLE REMOTE FUNCTIONS INOPERATIVE, NO OTP AND/OR ENGINE NO START DUE TO LOW BATTERY VOLTAGE	Service Alert No.: SA-045/21
	Last Issued : 08/02/2021

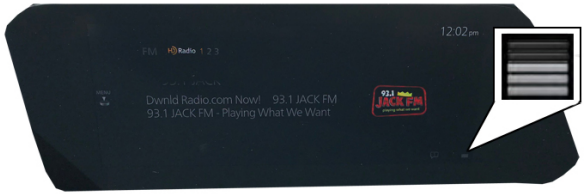
<p>Mazda3 CX-30</p>

<p>Connected Vehicle reception strength icon</p>	<p>CX-5 CX-9</p>

21. Verify repair.	Customer is enrolled into connected vehicle services. (CX-5 and CX-9 only)	At vehicle pickup, use the customer's phone and the MyMazda App to confirm connected vehicle remote functions operate normally. <ul style="list-style-type: none"> • Engine Start / Stop • Door Lock / Unlock • Lights ON / OFF
	Customer is not enrolled into connected vehicle	Confirm connected vehicle reception strength icon shows good strength.
