<b>HYUNDAI</b> <b>Technical Service Bulletin</b>	<b>GROUP</b> <b>AUTOMATIC TRANSMISSION</b>	<b>NUMBER</b> <b>21-AT-013H</b>
	<b>DATE</b> <b>August, 2020</b>	<b>MODEL(S)</b> <b>ELANTRA SPORT (AD) 1.6T</b> <b>VELOSTER (FS) 1.6T</b> <b>ELANTRA (ADa) 1.4T</b>
<b>SUBJECT:</b> DUAL CLUTCH TRANSMISSION CLUTCH REPLACEMENT AND TCU SOFTWARE UPDATE

This TSB supersedes 20-AT-021H to update model information, removing Tucson and Sonata.

**Description:** Certain vehicles (listed below) equipped with 7-speed Dual Clutch Transmission (DCT) may exhibit abnormal vibration at low speeds. This bulletin outlines the procedures for diagnosing and replacing the Double Clutch, including a Transmission Control Unit (TCU) software update.

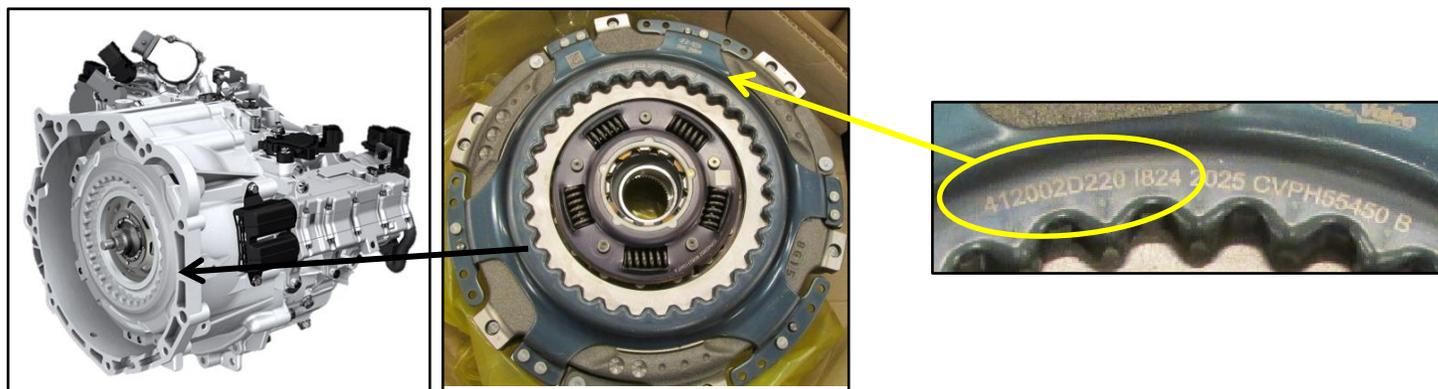
**Updated F850 clutch material identification:**

MODEL	PREVIOUS CLUTCH PART NUMBER (F833DS)	NEW CLUTCH PART NUMBER (F850)
2017~2018 Elantra Sport (AD) 1.6T 2016-2017 Veloster (FS) 1.6T	41200-2D101	41200-2D220
2016-2018 Elantra (ADa) 1.4T	41200-2C101	41200-2C220
