Particulate Matter (PM) Sensor Troubleshooting **Guide - US14+OBD16 And Newer Emissions**

25074-9 FSB 258-039, SCR Fittings, One Box, Replacement

FSB 284-069, Exhaust Particulate Sensor, Repair (2017 Vehicles)

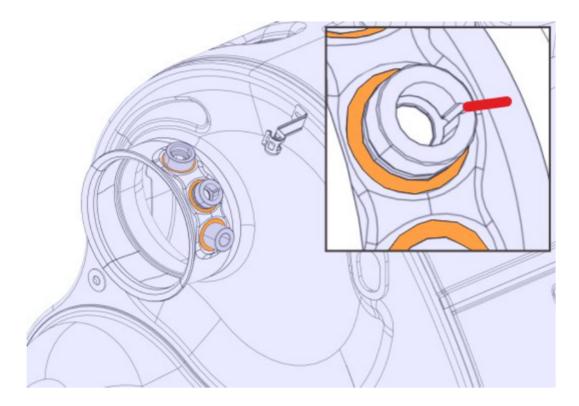
Note: If the PM sensor boss is damaged as shown in the illustration mark the position of sensor boss notch before removing the boss welding. The notch of PM sensor boss is always set in the 3'o clock position.

1. Remove the damaged boss welding.

2. Remove the damaged boss/bosses (Temperature/NOx/PM sensors).

6. Tack weld the sensor boss, complete the weld around the boss.
