Title: QLS Emergency Calibration

Applies To: EPA 2017 and Newer X15 / L9 / B6.7 Engines

This document is intended for information purposes only to inform the user about an emergency calibration release that has been approved by the EPA and CARB to help provide relief from the global supply shortage of electrical components.

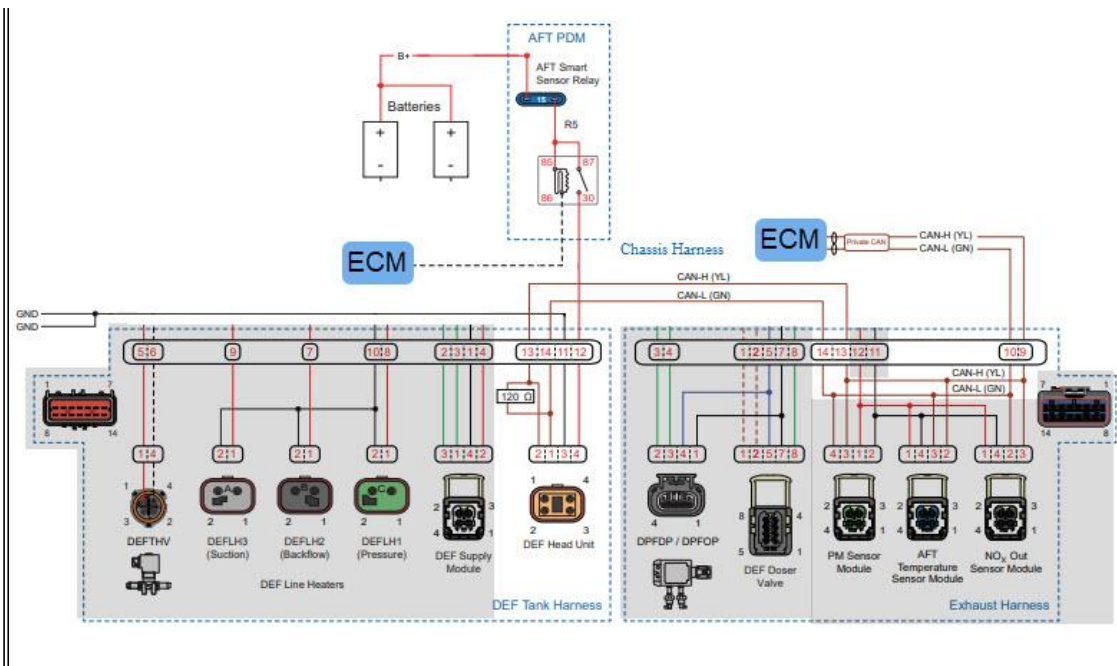
Figure 4: General QLS Wiring Diagram

Note: Refer to chassis circuit diagrams for detailed information

In some failure conditions the QLS sensor can produce faults intermittently, it is recommended that the sensor be removed electrically from the chassis harness to prevent this as it can lead to additional warnings and de-rate events. This can be performed simultaneously with the programming event. The intent of this procedure is to disconnect the sensor electrically and seal the harness to prevent moisture and corrosion in the chassis harness connector for when the QLS is replaced under future activity. The QLS must remain in the tank and connected to the DEF and coolant lines as they are still required for vehicle operation.
