**SERVICE INFORMATION BULLETIN**

**APPLICABILITY:** 2020-2021MY Outback  
 2019-2021MY Forester  
 2019-2021MY Ascent

**NUMBER:** 07-199-21R

**SUBJECT:** Measurement of Dark Current  
 (Standby Current Draw)

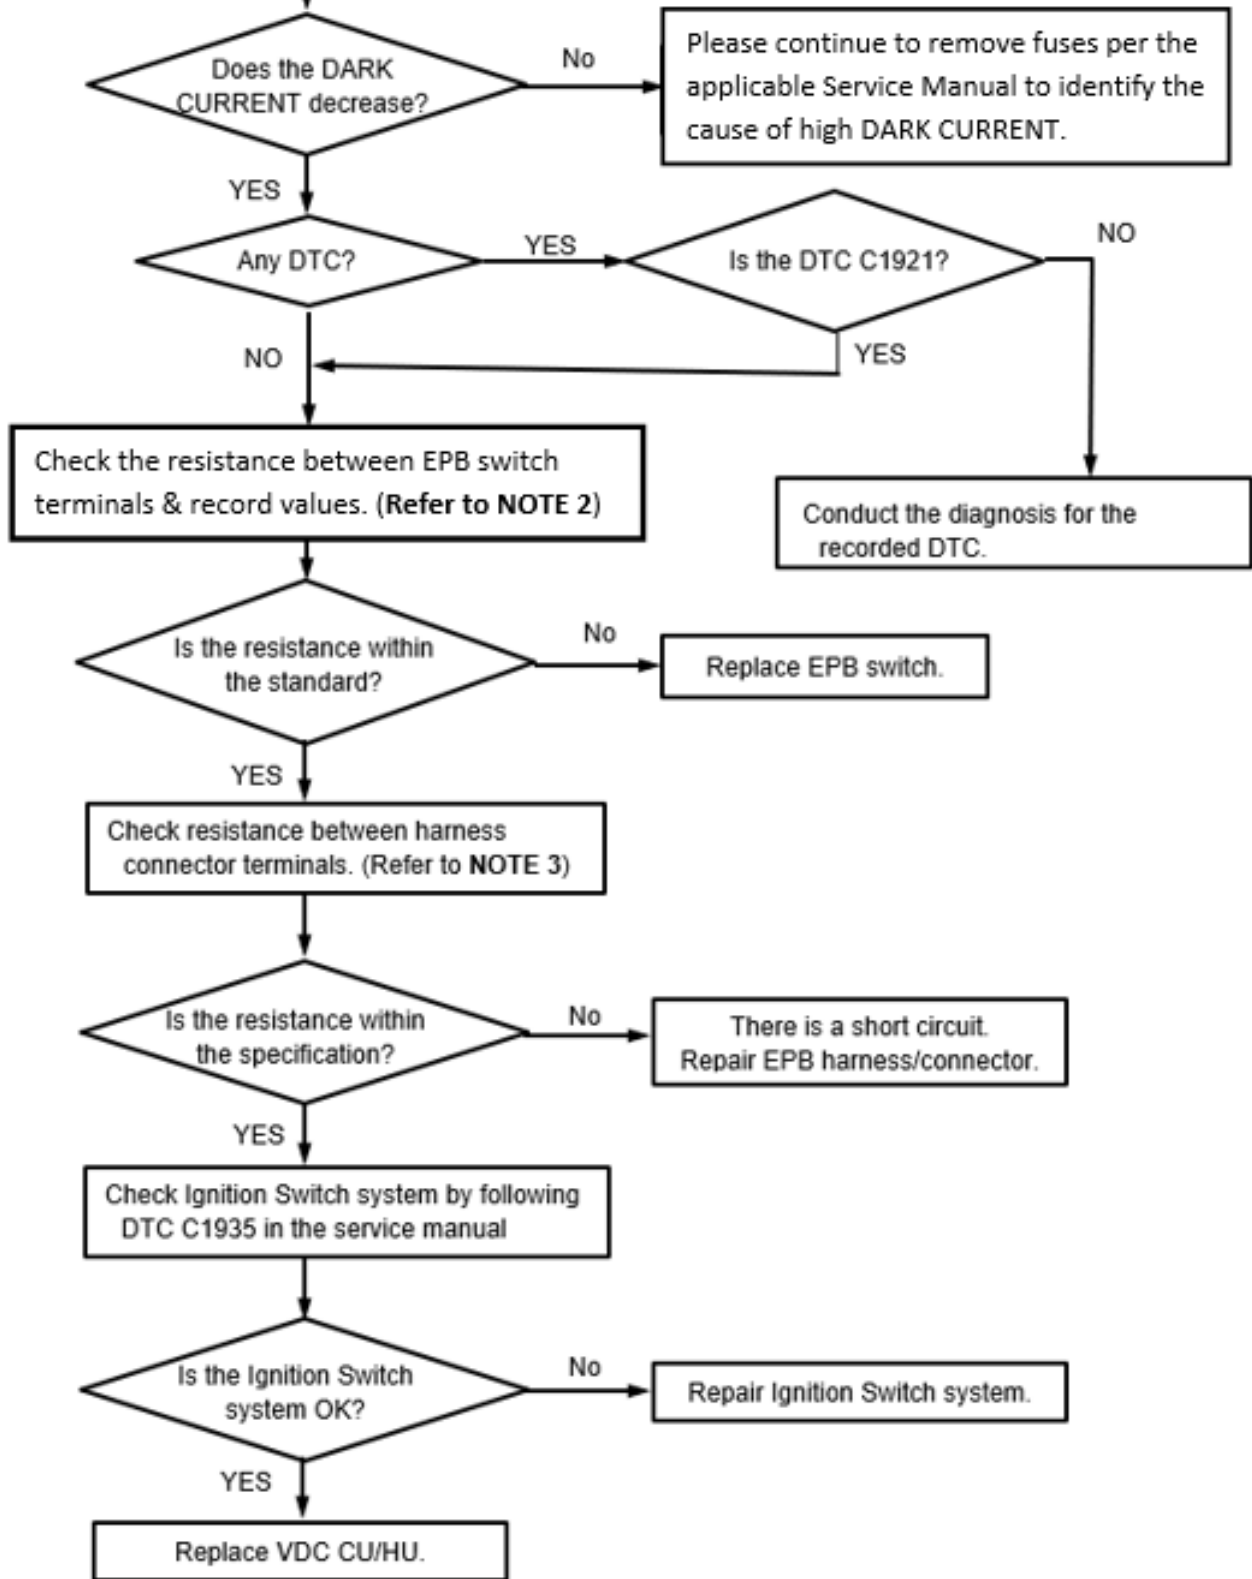
**NOTE 1)** Troubleshooting Tree for Dark Current (Standby Current) draw from VDC system.

Remove the following fuse in the Step (17) of the applicable Service Manual: Engine > STARTING/CHARING SYSTEM > Battery > INSPECTION.
