SERVICE BULLETIN

APPLICABILITY: 2017-21MY WRX

NUMBER: 07-200-21

SUBJECT: Metallic Rattle Sound While Operating Horn

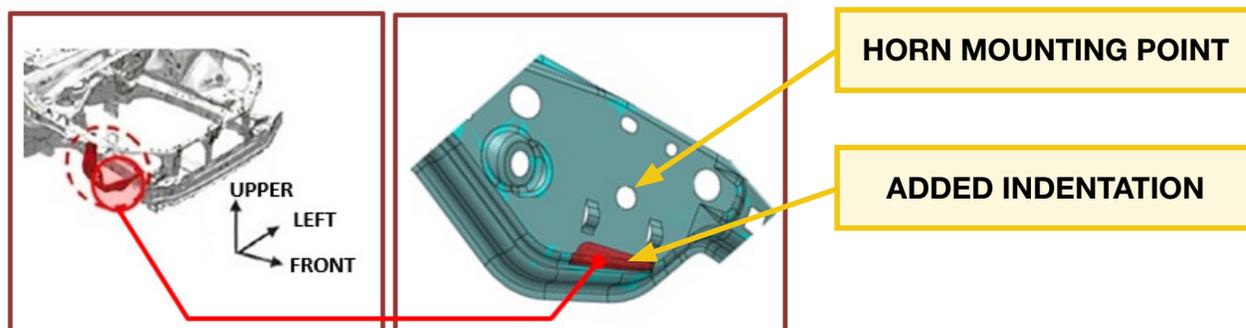
PART INFORMATION:

This bulletin announces the design changes to the right front wheel apron. A customer may experience a “metallic rattle” sound when operating the horn. This can be the passenger side horn mount making contact with the wheel apron creating a vibration/sound. The new apron has an added indentation to providing needed clearance for the horn. There has also been a horn stopper removed from the apron to allow additional clearance as well.

- Vehicles produced as of January 2020 will have the added indentation.
- Vehicles produced as of August 2021 will have the added indentation and the deleted horn stopper.
