SERVICE BULLETIN

APPLICABILITY: 2019-**22**MY Impreza
 2019-**22**MY Crosstrek (Including Hybrid Model)
 2019-**22**MY Forester
 2019MY Legacy/ Outback
 2019-**22**MY WRX
2019-22MY WRX STI
 2019-**22**MY BRZ- Navigation -equipped ONLY
 2019-**22**MY Ascent

NUMBER: 15-236-18R

SUBJECT: Reprogramming File Availability for Optimization of Harman Gen 3.1 and Gen 3.1α Audio and Navigation Head Units

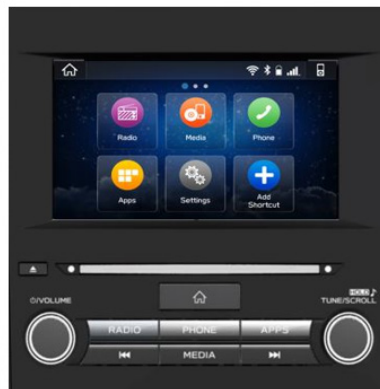
**BASE +
Uses MID
update file**

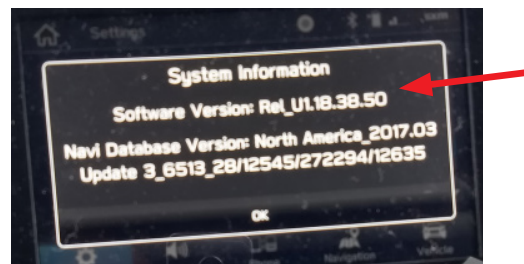
- The currently installed software version will be displayed. If the Software Version is **Rel_UA.19.36.70** or **Rel_UF.20.28.70**, (or before), proceed to **Step 2**. This version number is the same for all 4 levels of head unit.

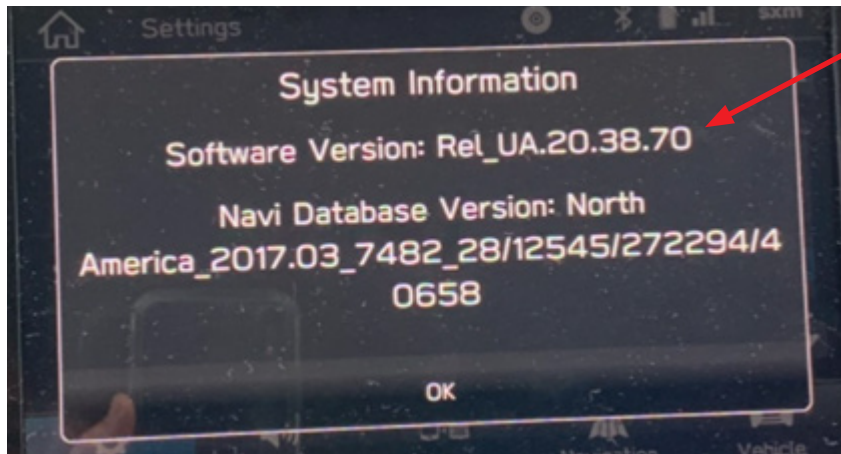
- Confirm Software Version is now “Rel_UA.20.38.70,”.
