SERVICE BULLETIN

APPLICABILITY: 2018-2021MY Crosstrek 2.0L DI & PHEV
2017-2021MY Impreza 2.0L DI

NUMBER: 09-81-21

SUBJECT: Fuel Injector- Design Change
Misfire DTC P030* / Engine Knocking / DTC P219C-D-E-F

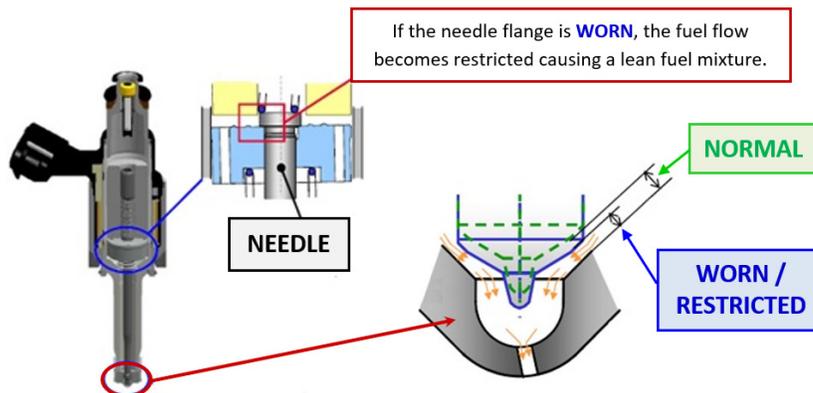
PART INFORMATION:

Injector Assembly Part Number	Flow Rate Number
16611AA971	"4"
16611AA981	"5"
16611AA991	"6"

- Using the illustration below for identification reference, always replace an injector assembly with the same flow rate number as originally equipped.
