Tips & Tricks – All Models

no.	Symptom	Subject	Photo	Notes and Indications - Corrective action
1	<p><u>ONLY</u> <u>Monster 821</u> <u>Monster 1200</u> <u>SuperSport</u></p> <p>Possible engine popping sound during deceleration and/or irregular idling</p>	Airbox

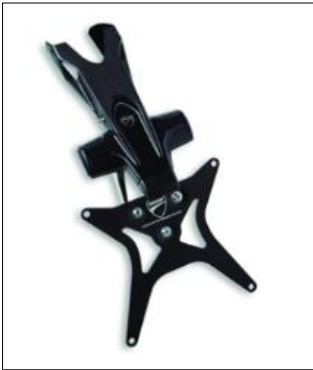
3	<p><u>ONLY</u> <u>Panigale V4</u> <u>(all versions)</u> <u>Panigale V2</u></p> <p>Assembly precautions for Carbon number plate holder kit part no. 97380921A</p>	Carbon number plate holder kit part no. 97380921A

<p>We kindly inform you that <u>ONLY</u> when installing the carbon number plate holder kit part no. 97380921A to a Panigale V2 model, it is necessary to purchase wiring part no. 5101H931A to connect the number plate holder connector to motorcycle rear wiring harness connector.</p> <p>We also inform you that the new carbon number plate holder kit part no. 97381161AA is now available. It is specific for Panigale V2 and Streetfighter V4 and will include the above-mentioned wiring.</p>

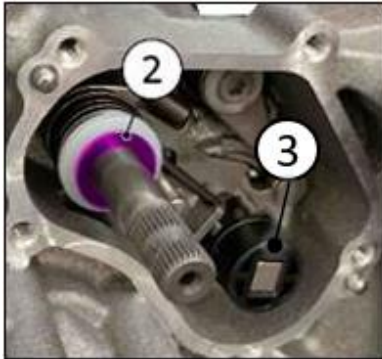
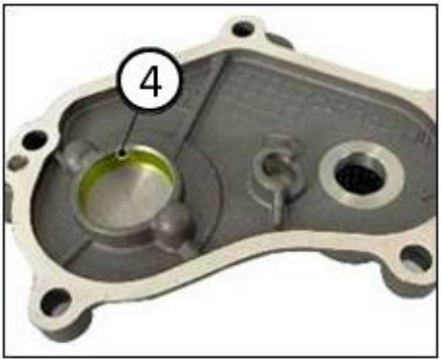
no.	Symptom	Subject	Photo	Notes and Indications - Corrective action
11	<p style="text-align: center;"><u>ONLY</u> 959 Panigale (all versions)</p> <p>Possible hardening of gear shift control with difficulty in shifting gears when hot</p>	Gear selector	-	<p>We have received some isolated reports about a possible hardening of the gear shift when hot with consequent difficult selection of gear ratios. Based on the analyses carried out, this phenomenon could be due to a hardening between the gearbox sensor magnet plastic support and the relevant seat inside the cover.</p> <p>You are kindly asked to carry out the following operations:</p> <ol style="list-style-type: none"> 1) Remove the gear shift cover (1) on motorcycle LH side; 2) Check for the presence of shim (2); 3) Mill the end face of the plastic cage for the selector magnet (3) shorter by 0.1 mm maximum and the outer curved edge where it enters the bore of the cover by 0.1 mm maximum, <u>or</u> mill the internal surface (4) of the cover highlighted in the figure and remove 0.1 mm maximum of material from the end and bore of the recess. Ensure the orientation of the magnet is not changed on the shift selector or the gear position will not be able to be determined by the sensor. <div style="display: flex; justify-content: space-around; margin-top: 10px;">

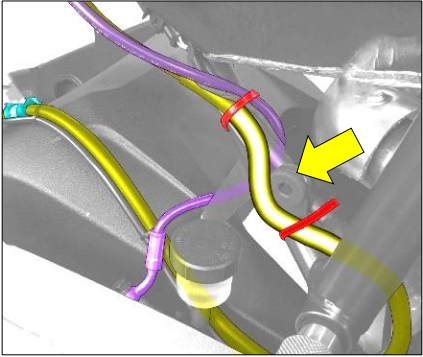
no.	Symptom	Subject	Photo	Notes and Indications - Corrective action				
1	<p><u>ONLY Scrambler 800 (all model versions and MY, excluding Desert Sled model version)</u></p> <p>Precautions when routing the rear brake caliper hose</p>	Rear brake hose	-	<p>We have found that sometimes, during maintenance operations, the rear brake caliper hose is not correctly positioned along the frame due to incorrect installation by the technician during service.</p> <p>Make sure that the rear brake caliper hose (yellow), passes outside the left side cover mounting bracket with respect to the motorcycle centerline and is fixed with the two self-locking ties (red) as shown in the figure.</p> <p>The operation of inspection and possible repositioning is very simple and involves the disassembly of the left side cover only.</p>

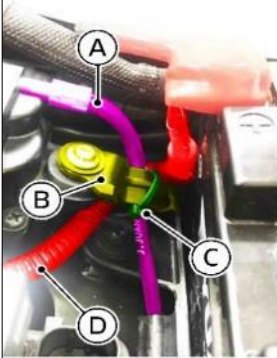
4	<p><u>ONLY</u> <u>Scrambler 1100</u> <u>Model Year 2020</u> <u>(all model versions)</u></p> <p>Precautions during PDI: installation of the battery on the vehicle</p>	Battery assembly	-	<p>During the installation of the battery on the vehicle and, in any case, when the motorcycle first comes to the workshop for a service, we ask you to always check the correct positioning of the exhaust butterfly valve cable (A) under the retainer (B) and the presence of the self-locking tie (C).</p> <p>Make sure the motorcycle positive cable (D) is positioned under the exhaust butterfly valve cable (A).</p>

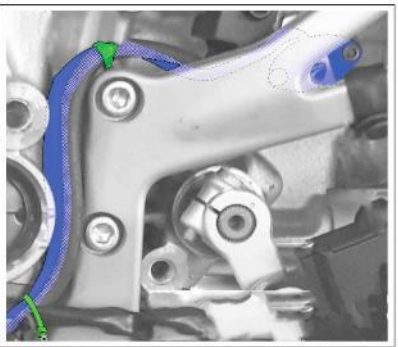
no.	Symptom	Subject	Photo	Notes and Indications - Corrective action
1	Updated layout of motorcycle wiring	Wiring	-	<p>We would like to inform you that the layout of the side stand cable - gear sensor cable - Ducati Quick Shift cable - lambda sensor cable and of the gear sensor connector and cable at the lower crankcase, on the left side of the motorcycle (as shown in the figure) has been updated starting from frame number ZDMFA00AALB003932.</p>

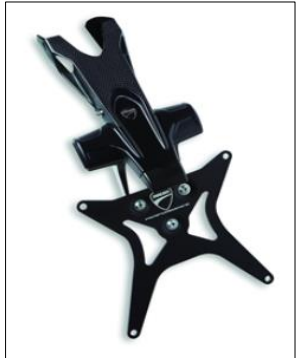
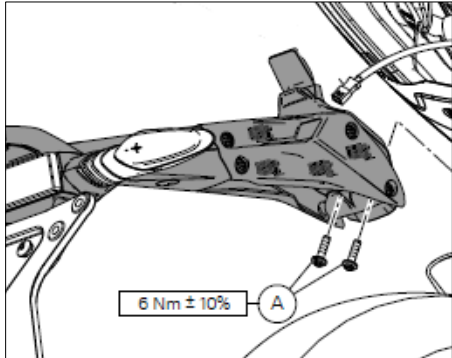
8	Precautions for the assembly of Ducati Performance carbon number plate holder kit part no. 97381161CA	Ducati Performance carbon number plate holder kit part no. 97381161CA

<p>When assembling the Ducati Performance carbon number plate holder unit part no. 97381161CA, we remind you to always apply LOCTITE 243 on the threads of the 2 screws (A) for fixing the unit to the rear subframe and tighten them to the specified torque of 6 Nm ± 10% as indicated in the relevant instructions.</p>
