CR221 – Check and Possible Re-Route of Instrument Panel Wiring

Monster (937cc) MY 21-22 (all versions)
Technical Service Bulletin SRV-TSB-21-009

Date: September 16, 2021
To: Dealer Principal, General Manager, Service Manager, North American Dealer Network
From: Richard Kenton, Technical Director
Eric Bradley, Technical Training and Publications Manager

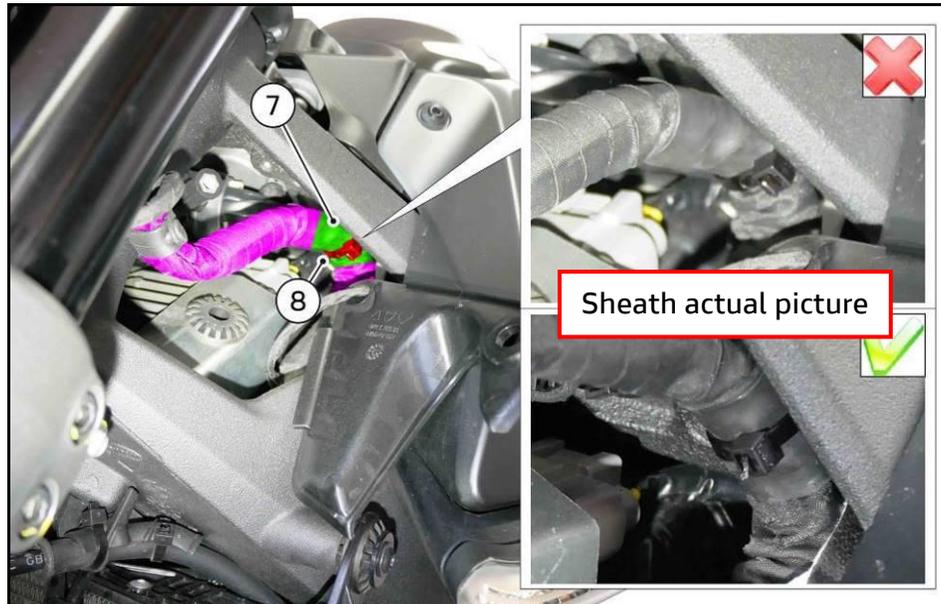
2 A. Should the tie be already correctly positioned at the center of the sheath, mark the check with a felt pen (see figure below), then proceed to step 8
