# Technical product information

| Topic | Convertible hood cannot close - Header trim flap eyelet broken |
| Brand | Bentley |
| Transaction No. | 2060120/5 |

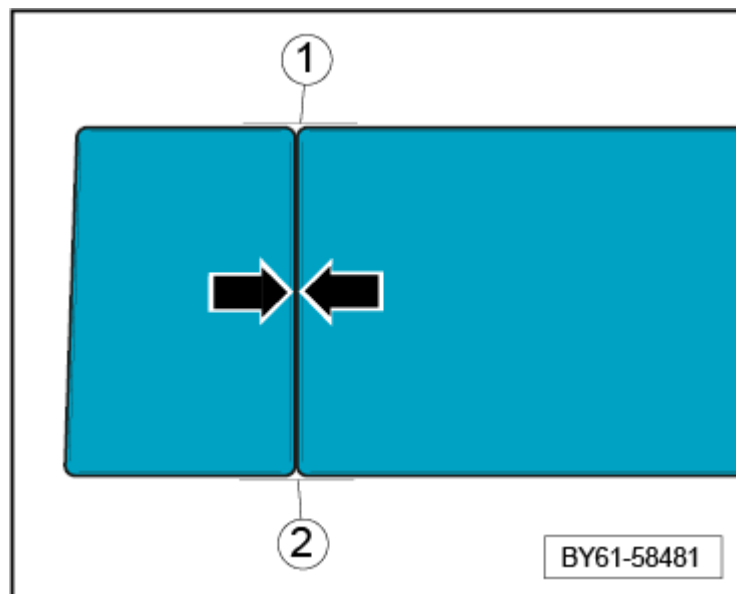
*Misalignment of the panels can cause damage to both the header trim panel and the header trim panel flap assembly.*

- Align the flap assembly to the header trim panel, ensuring that the edges **-1-** of the two panels align, and that the gap **-arrowed-** between the two panels is 2.5mm (+0.5/-1.5) and consistent along the whole length .
