**Location:** Body Exterior & Electrical

**Topic:** Electrochromatic (EC) Roof Glass diagnosis

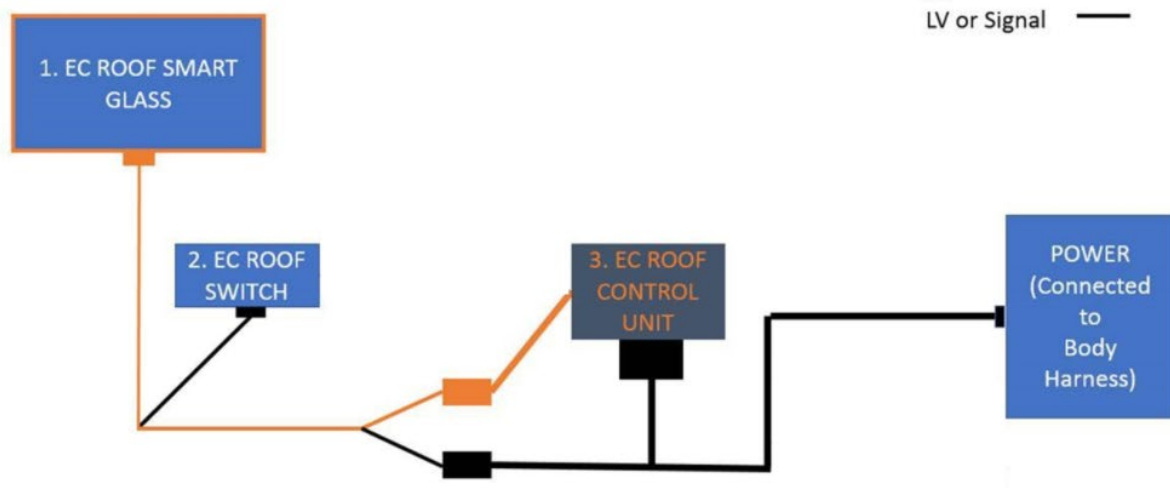
Figure 1.1 - EC glass basic system

Please refer to image 1.1 for a brief system overview of the main components and how they interact with the system. The 3 main components to consider when carrying out diagnoses on the system are:

- EC Glass Controller
- EC Glass Switch Panel
- EC Roof Smart Glass

For diagnosing issues related to this system, please first follow the steps below:

- Check fuses for cigarette lighter and EC roof glass fuse (EC roof fuse is located above the fuse box on a separate bracket above electric city)
- Check all connectors are fully engaged in the correct orientation. Take extra care as connectors and be forcefully connected in reverse. See image 1.2.
