## Popping/Crackling from the Speakers; Display Blank

Supersedes 21-032, dated October 01,2021, to revise the information highlighted in **yellow**.

Year	Model	Trim	VIN Range
2021	TLX	ALL	ALL

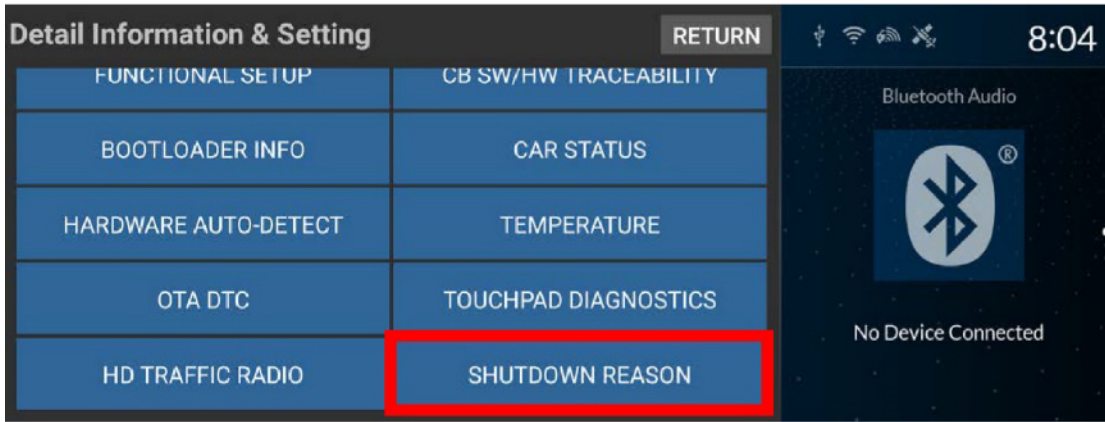
3. Scroll down the menu, and select **SHUTDOWN REASON**.

In this example, the cause of the failure can be identified as **Meter:SUDDEN\_SIGNAL\_OFF**

4. Write down any failures as they will be collected on the warranty claim. Then, clear the data.
