To: All U.S. and Canadian Volvo Retailers
Subject: Service Action – S10101

<h1>Quality Bulletin</h1>				
TITLE: Service Action S10101: AC Hose Grommet, XC40 Recharge Model Year 2021				
GROUP: 8741	CAT/NO: S10101	ISSUING DEPARTMENT: Product, Safety and Compliance	CAR MARKET: United States and Canada	
REVISIONS:			ISSUE DATE: 2021-06-10	STATUS DATE: 2021-06-10
Page 1 of 3

Title	Connector Block to Air Conditioning Compressor (AC) Line	Page	1 (4)
Action	Adjustment	Operation number:	97768-2

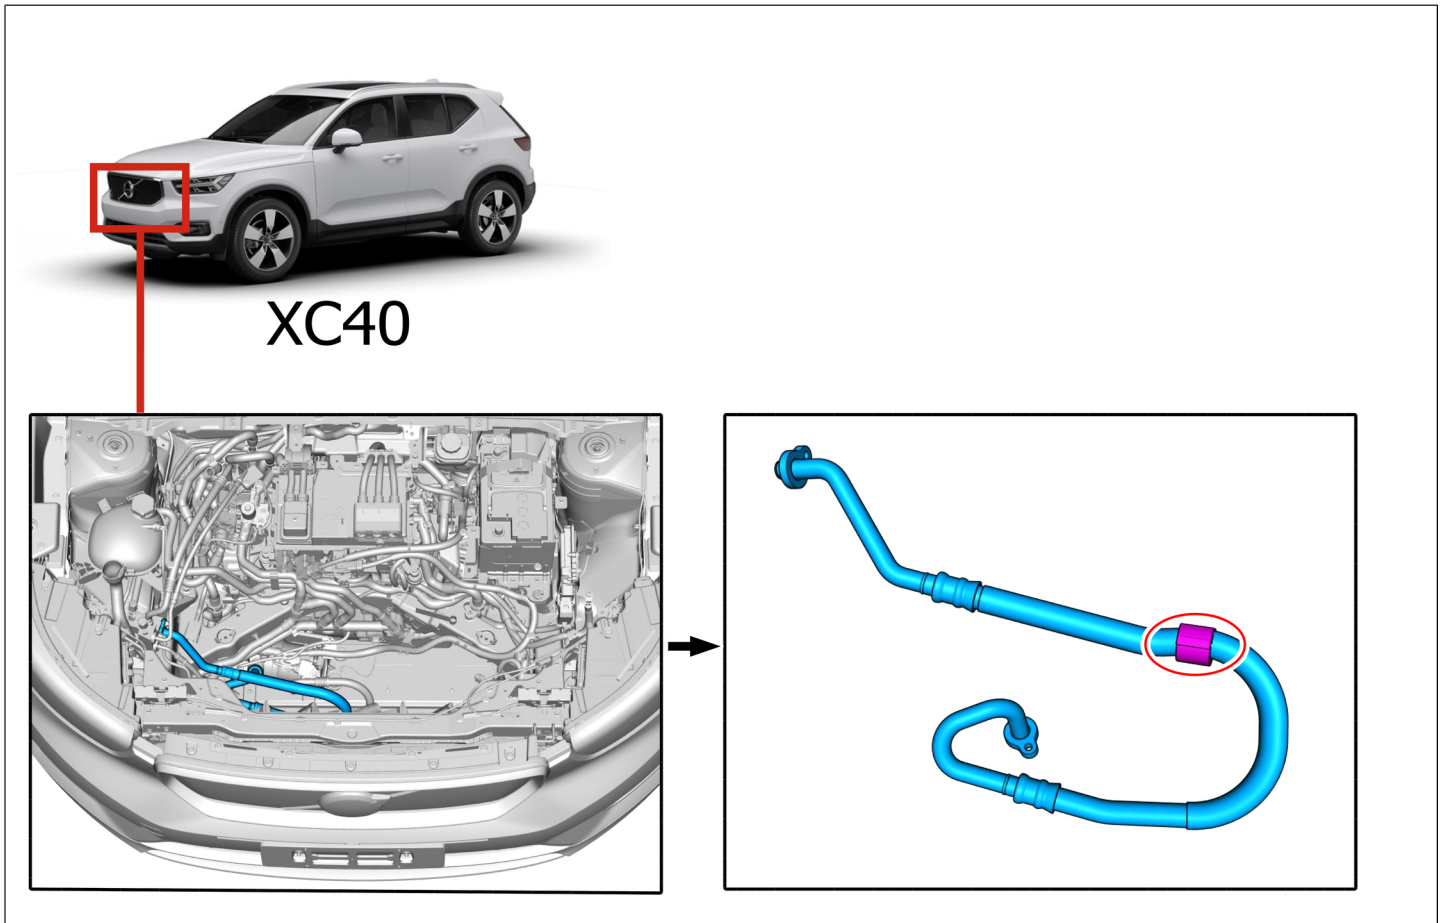
Orientation view

Volvo has identified that the Air Condition hose grommet (chafing protection) is incorrectly positioned.

The corrective action is to reposition the A/C hose grommet (chafing protection)
