# Service Alert

<b>Subject:</b>  <b>CONNECTED VEHICLE SYMPTOM TROUBLESHOOTING</b>	<b>Service Alert No.: SA-013/21</b>
	<b>Last Issued : 10/13/2021</b>

2019-2021 Mazda3  
2020-2021 CX-30  
2021 CX-5  
2021 CX-9

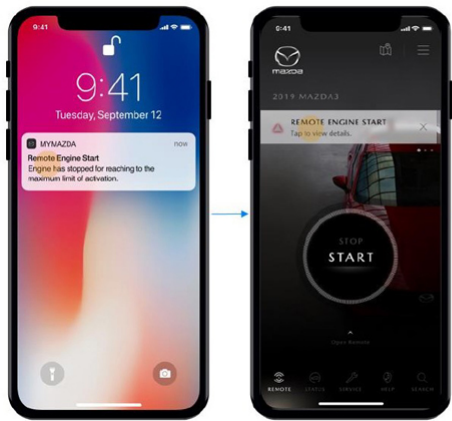
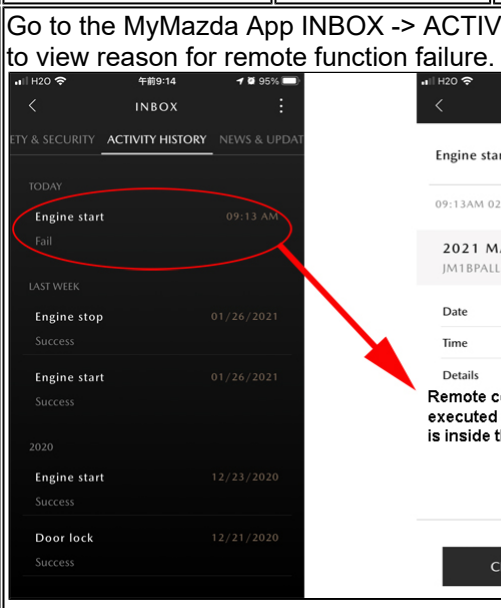
Connected Vehicle Troubleshooting			
	Symptom	Cause	Action
1	Remote function(s) inoperative. <ul style="list-style-type: none"> <li>• Engine Start / Stop</li> <li>• Door Lock / Unlock</li> <li>• Lights ON / OFF</li> </ul>	Go to the MyMazda App to view the reason for remote function failure.	<b>Push Notification</b>

<p><b>OS Lock Screen</b> Tap the push notification</p>	<p><b>Home</b> Tap the alert card</p>
	<p><b>Activity History</b></p>	<p>Go to the MyMazda App INBOX -&gt; ACTIVITY to view reason for remote function failure.</p>

<p><b>Troubleshooting needed</b></p>	<p>1. Use MDARS to ID the vehicle and check for DTC's stored?  <ul style="list-style-type: none"> <li>• Yes - Go to MGSS and perform normal DTC diagnosis</li> <li>• No - Go to next step.</li> </ul>                 2. If applicable, confirm SSPC7 or DRW41 is closed. Go to Vehicle Inquiry.                  3. Confirm TCU software version is at the following using <a href="#">Version Check</a> <ul style="list-style-type: none"> <li>• CX-5 and CX-9 - 10020 or later</li> <li>• CX-30 and Mazda3 - 10004 or later</li> </ul>                 4. Perform KAM reset.  <b>NOTE:</b> Test drive vehicle after a KAM reset to allow clock to synchronize before retrying Authorization                  5. <b>Perform one of the following:</b> <ul style="list-style-type: none"> <li>• <b>Customer:</b> Un-enroll Connected Services, then re-enroll Connected Services as a new primary user.</li> <li>• <b>Dealer:</b> Perform customer take-over enrollment confirmation, then at customer pick-up, inform customer to enroll into Connected Services as a new primary user.</li> </ul>                 6. Contact Hotline for additional technical support if needed.</p>

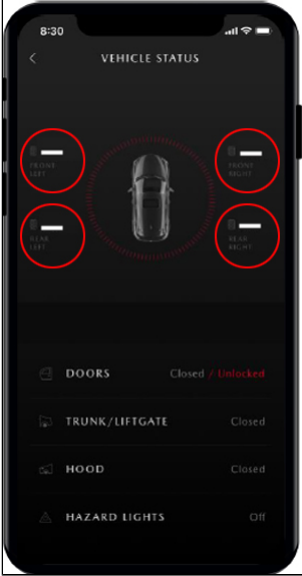
4	<p>Except CX-5 and CX-9</p> <p>MAZDA CONNECT and/or MyMazda App displays incorrect tire pressures after battery disconnect and/or infotainment CMU software update.</p>	<p>Incorrect calendar entry (month/day/year) after a battery disconnect or infotainment system software update.</p>	<p>Go to <a href="#">SA-002/21</a></p>

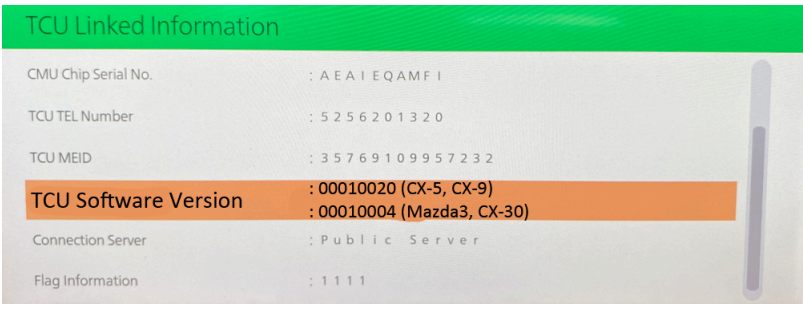
<p>4. Scroll down to TCU Software Version and confirm the software version is at:</p> <ul style="list-style-type: none"> <li>• 10020 or later for CX-5 and CX-9</li> <li>• 100004 or later for CX-30 and Mazda3</li> </ul> <p><b>Is the TCU software version correct?</b></p> <ul style="list-style-type: none"> <li>• <b>Yes:</b> TCU Software Version Check is complete.</li> <li>• <b>No:</b> Go to <a href="#">SSPC7</a> (Repair Procedure) to update the TCU software version.</li> </ul>
