SERVICE BULLETIN

APPLICABILITY: 2010-19MY Legacy and Outback
 2014-19MY Forester
 2012-19MY Impreza
 2013-19MY Crosstrek (Exc. 19MY PHEV)
 2015-19MY WRX
 2019-20MY Ascent

NUMBER: 16-103-16R

SUBJECT: Transmission Fluid Seepage

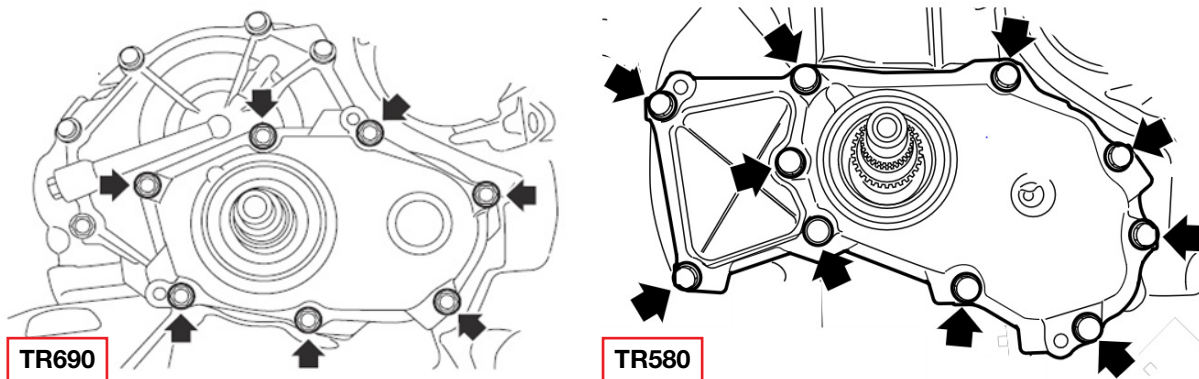
- Remove the 7- (TR690) or 10- (TR580) 12mm hex bolts securing the oil pump chain cover.

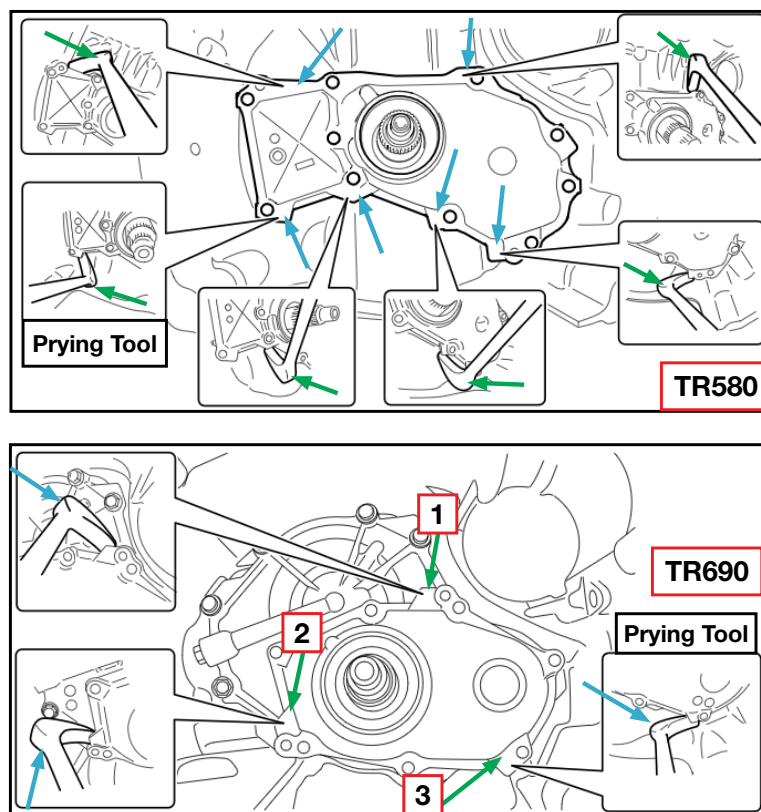
- Using a prying tool, **CAREFULLY** pry (GREEN arrows IN THE ORDER SHOWN for **TR690** model) the cover loose from the housing. Pry **ONLY** on the specific areas or “tabs” of the pump cover indicated by the BLUE arrows. When the cover starts to come loose, continue to pry **ONLY** on the tabs and not the machined sealing surface of the cover.

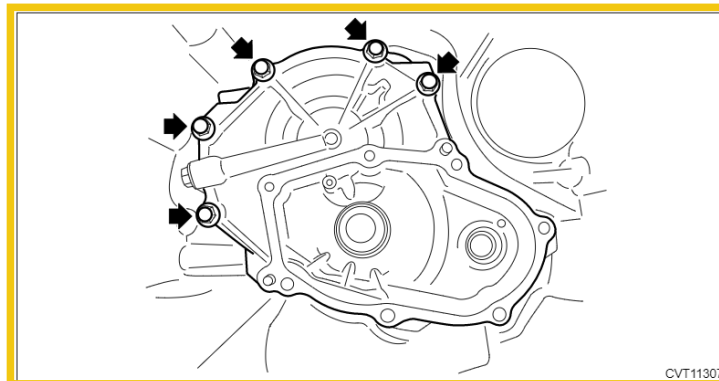
- Remove the 5 – 12mm hex bolts securing the converter case in a crossing pattern.

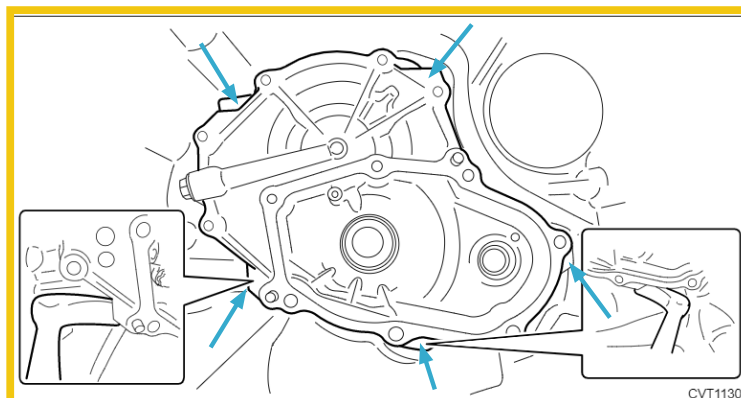
- Using a prying tool, **CAREFULLY** pry the cover loose. Pry **ONLY** on the specific areas or “tabs” of the converter case cover. Once the cover is loose, continue to pry only on the tabs and not the machined sealing surfaces.

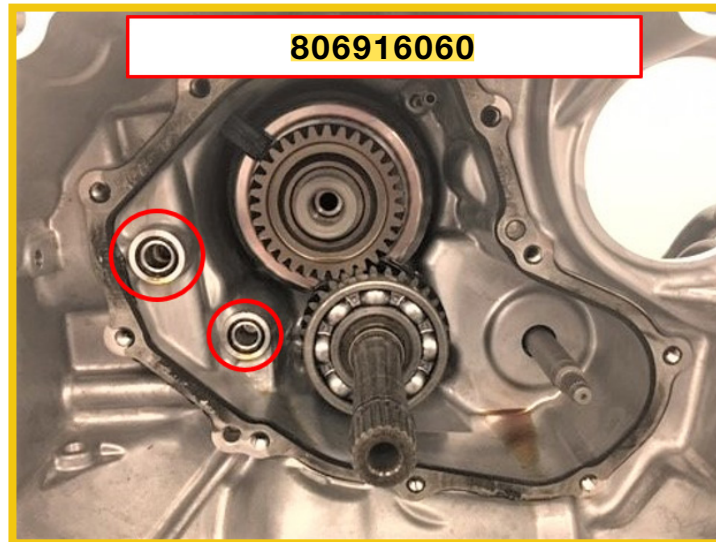
- Remove and replace the two **one-time use** o-rings (806916060).

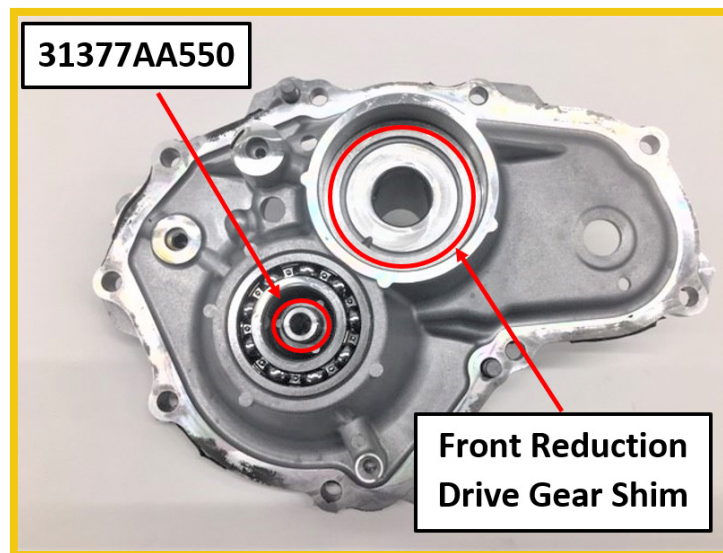
- IMPORTANT:** Always confirm the front reduction drive gear shim stays with the converter case cover when removing and prior to re-installation.

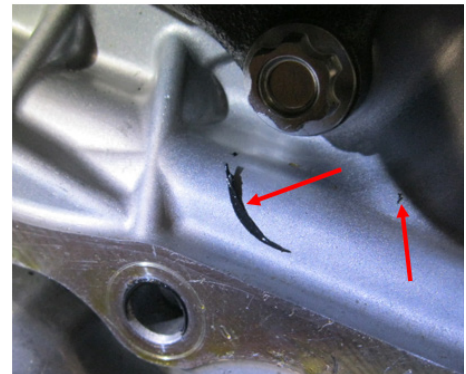
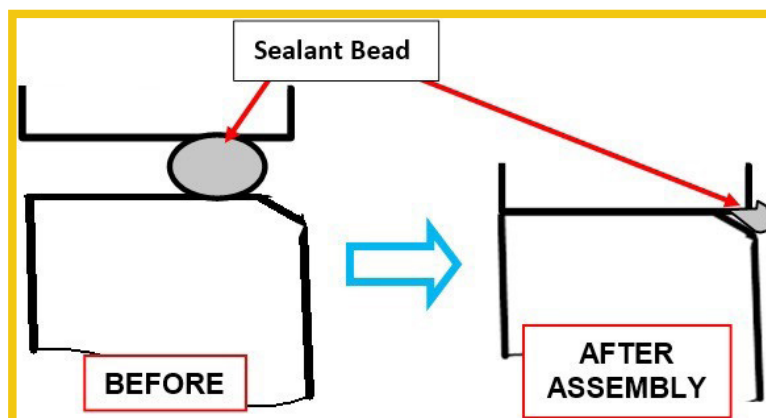
- **CAREFULLY** remove all residual sealant completely from the cover and mating surface of the housing. DO NOT use any abrasive or gasket removal / cleaning discs. Use the adhesive side of a piece of duct tape (or equivalent) to pick up any loose pieces of sealant material which may be found in the cavity around the stator support. DO NOT use compressed air.

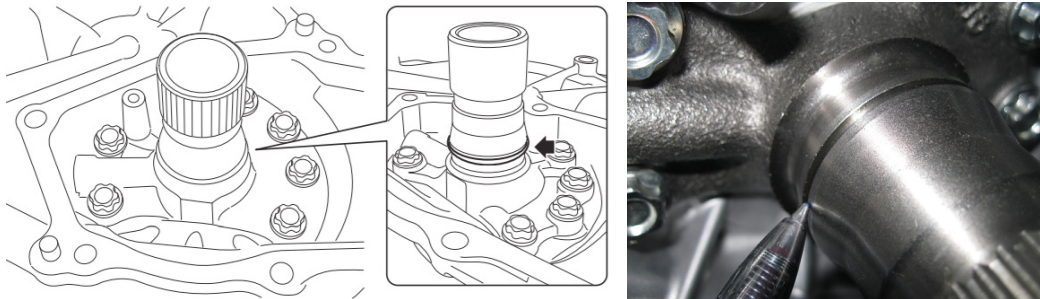
- **IMPORTANT:** Before reassembly, always replace the **ONE TIME USE** plastic sealing ring on the center support and thoroughly lubricate it with CVT fluid.

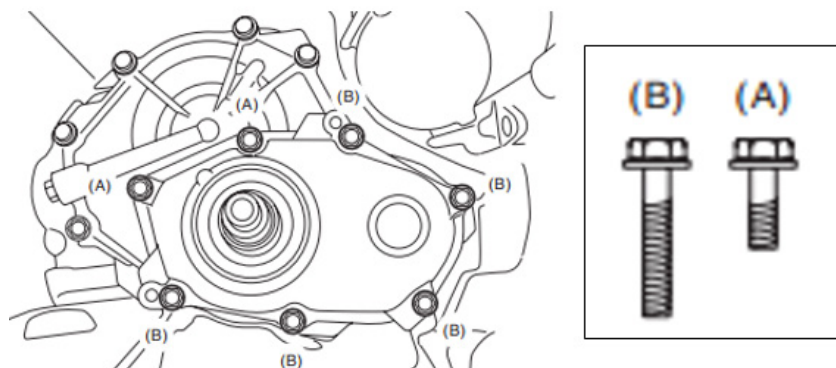
- On the TR690, there are 2 different length bolts for the pump cover. Make sure the proper length bolts (**A** and **B**) are in their respective holes as shown below. Torque to **24 Nm (17.7 ft. lbs)** in a crossing pattern.
