01-18-13 - MIL ON DTC P0401 Exhaust Gas Recirculation Flow Insufficient

Release date: 11/01/2021

Technical Service Bulletin

Transaction No: 2034898/20

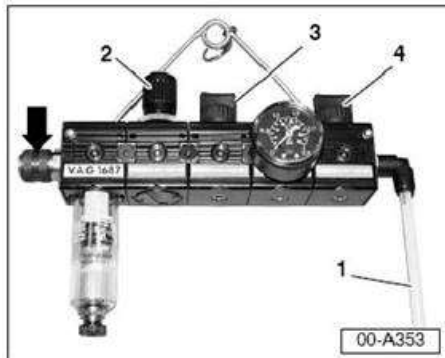
Special tool VAG 1687 Charge air system tester, preliminary set-up

- Back off pressure regulator knob -2- of VAG 1687 fully to protect gauge when shop air supply is applied to the assembly.
- Close valve -3- before gauge.
- Close valve -4- after gauge.
- Shop air supply line will later be attached to inlet of VAG 1687.
- Remove “female” fitting from tester (arrow) and install an appropriate “male” air fitting that will connect to your shop air supply line (See Note below).

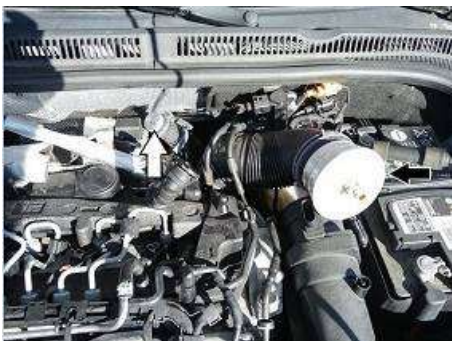
2.0L TDI shown

Special tool VAG 1687/10 pressure adapter, installing

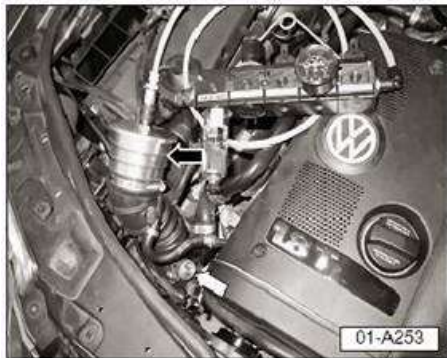
1.8T shown

Special tool KLI9210 (EVAP system leak detector)

- Install optional fitting KLI 9210/50 on hose of special tool KLI9210.
- Connect KLI9210 to VAG 1687/1 adapter (KLI 9210 is shown attached to VAG1687/1 at arrow on 1.8L Turbo).

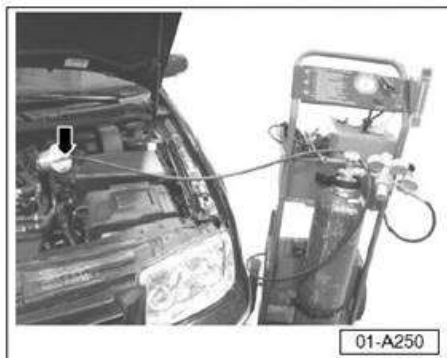
Special tool KLI9210 (EVAP system leak detector)

- Install optional fitting KLI 9210/50 on hose of special tool KLI9210.
- Connect KLI9210 to VAG 1687/1 adapter (KLI 9210 is shown attached to VAG1687/1 at arrow on 1.8L Turbo).

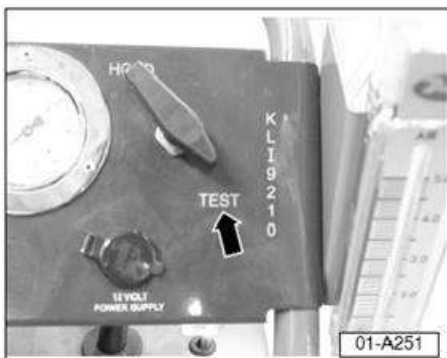
Special tool KLI9210 (EVAP system leakdetector),

preliminary set-up

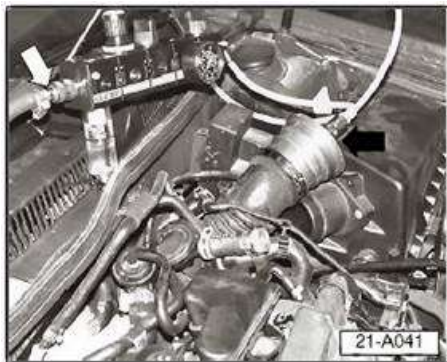
Special tool VAG 1687 connecting to pressure adapter 1687/10

- Connect VAG 1687 quickly to prevent smoke from leaking out.

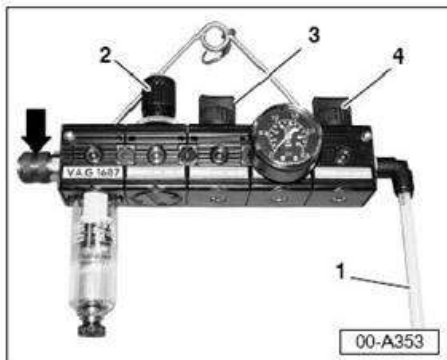
Performing pressure Test:

- With outlet hose -1- of VAG 1687 connected to air pressure adapter.
- Attach shop air supply line to previously installed male fitting.
