## Automated Manual Transmission ( AMT ) - Power Take Off ( PTO ) Active Fault Codes P106E18 (PSID 20 FMI 5) Or P106F18 (PSID 21 FMI 5) PTO Engagement Valve Current Below Threshold

AMT Harness broken PTO wires

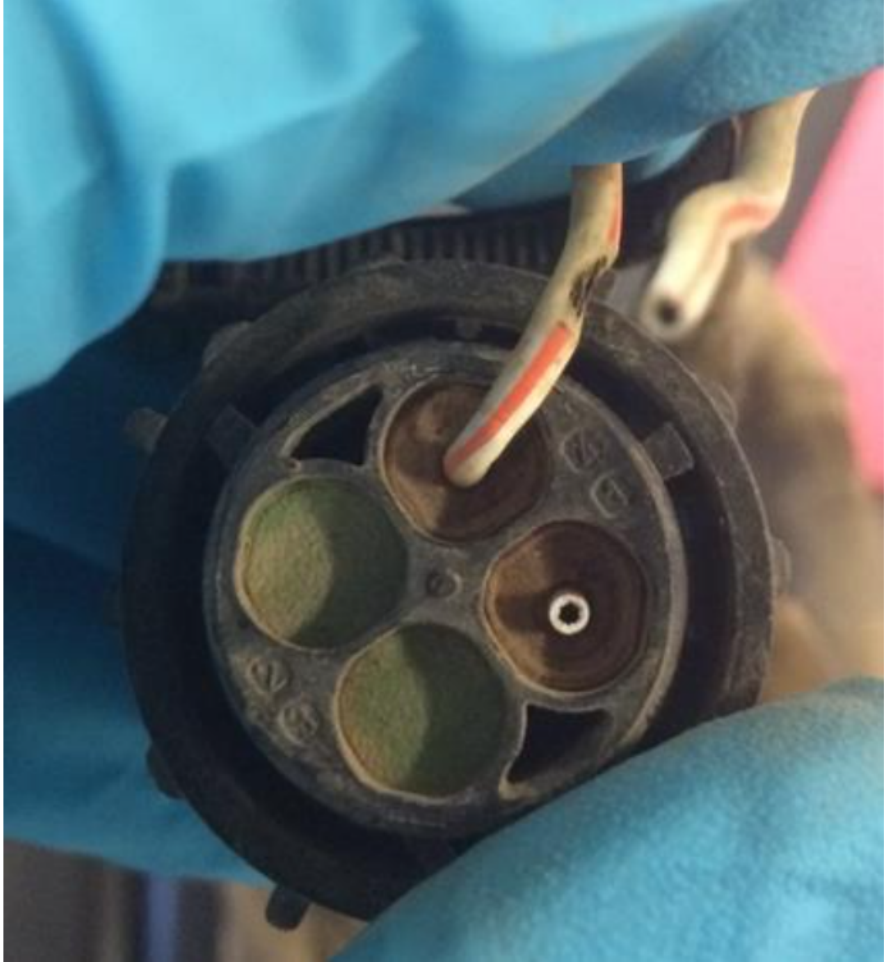
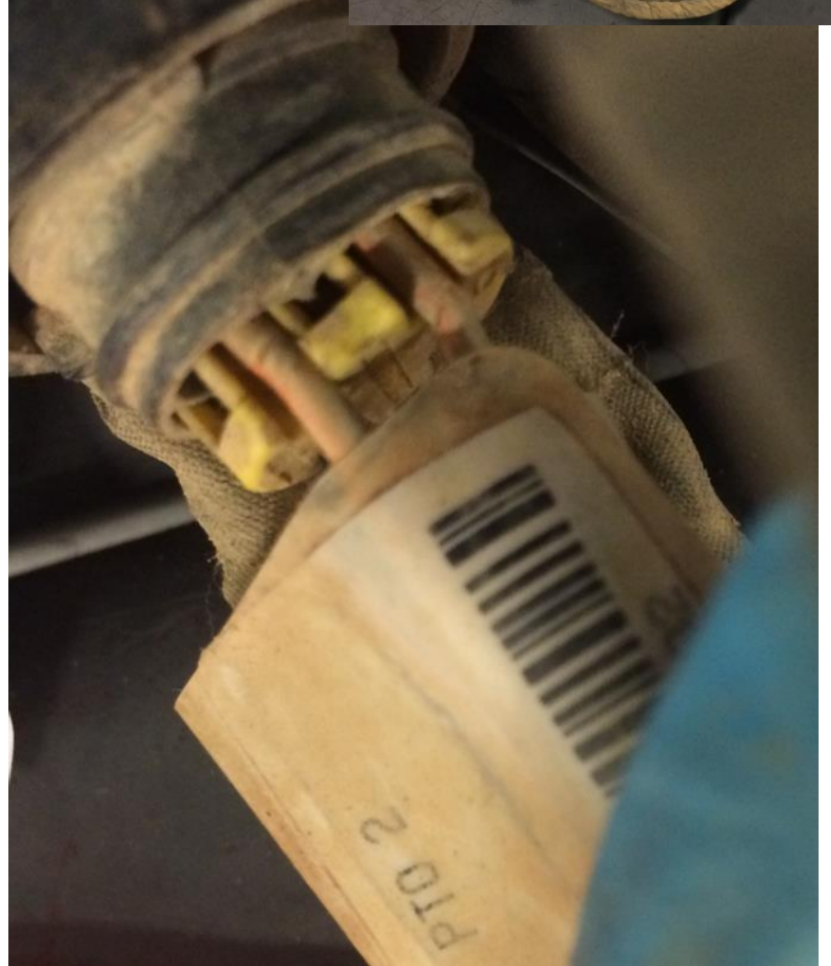
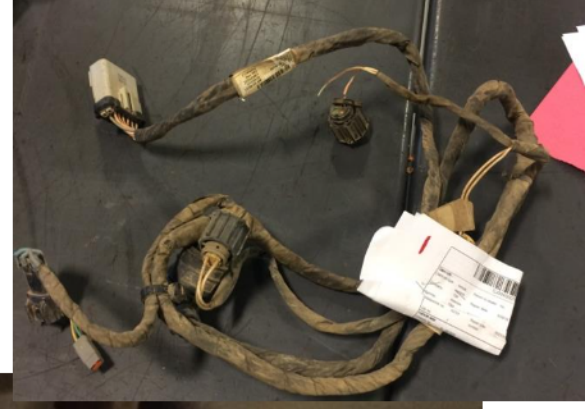
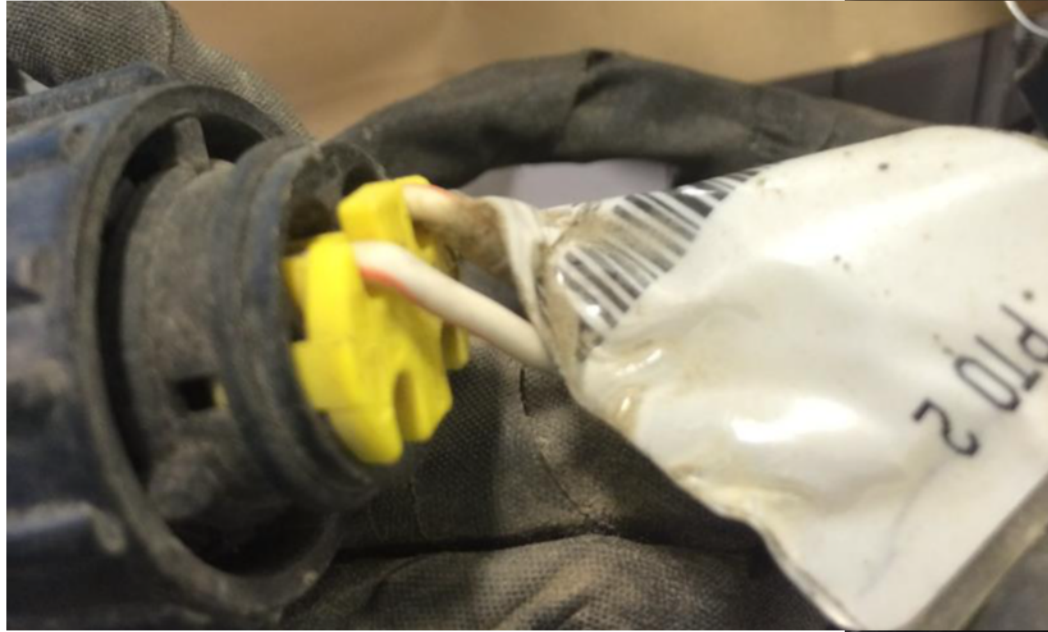
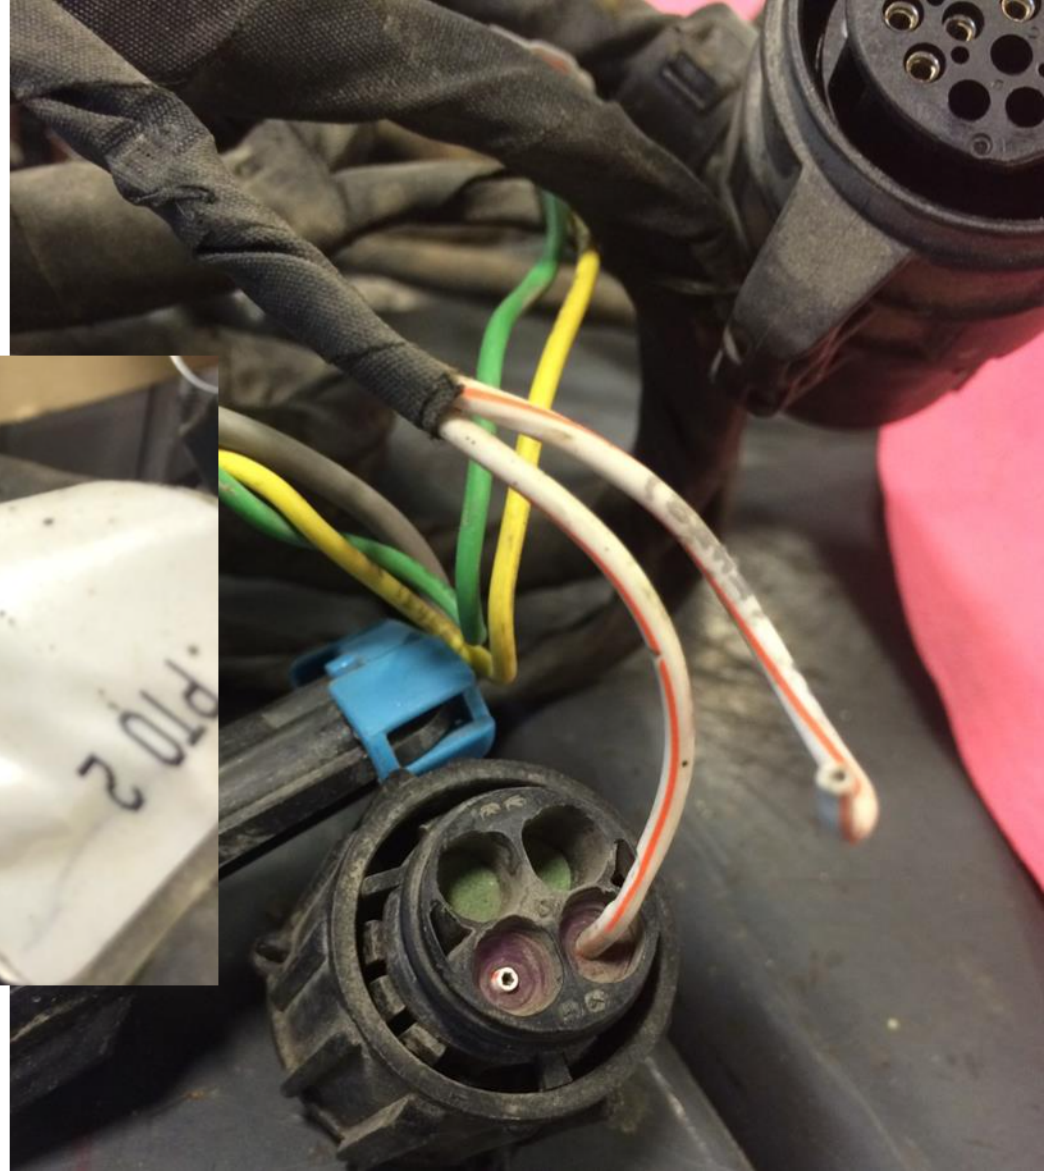
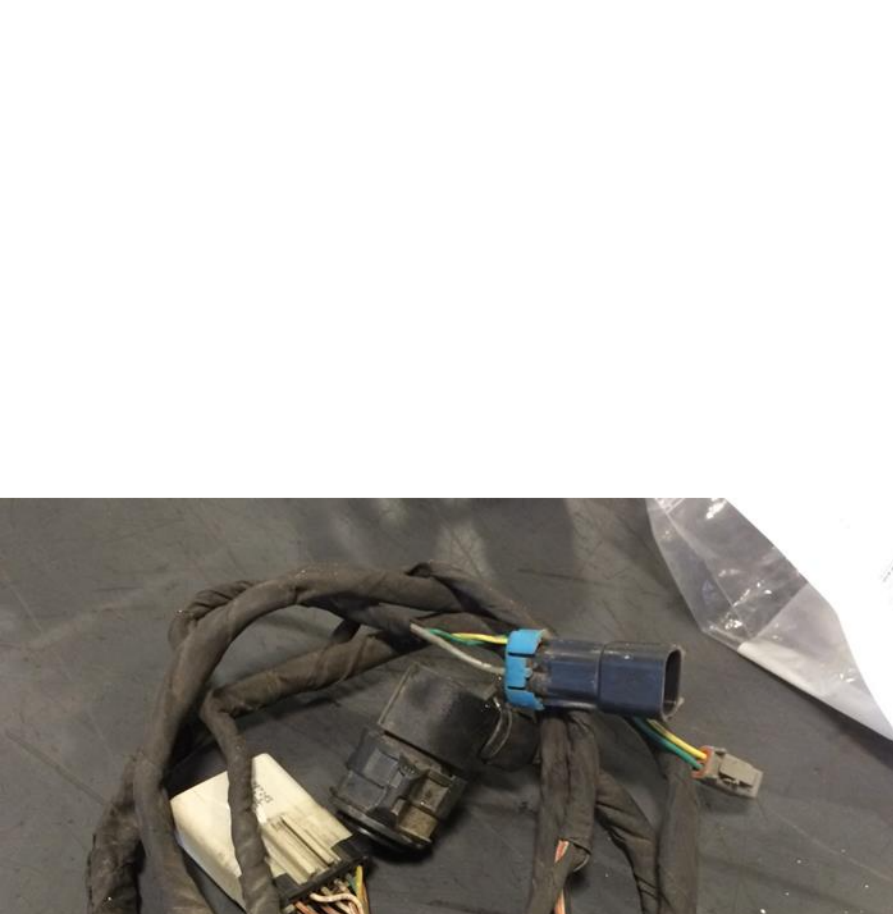
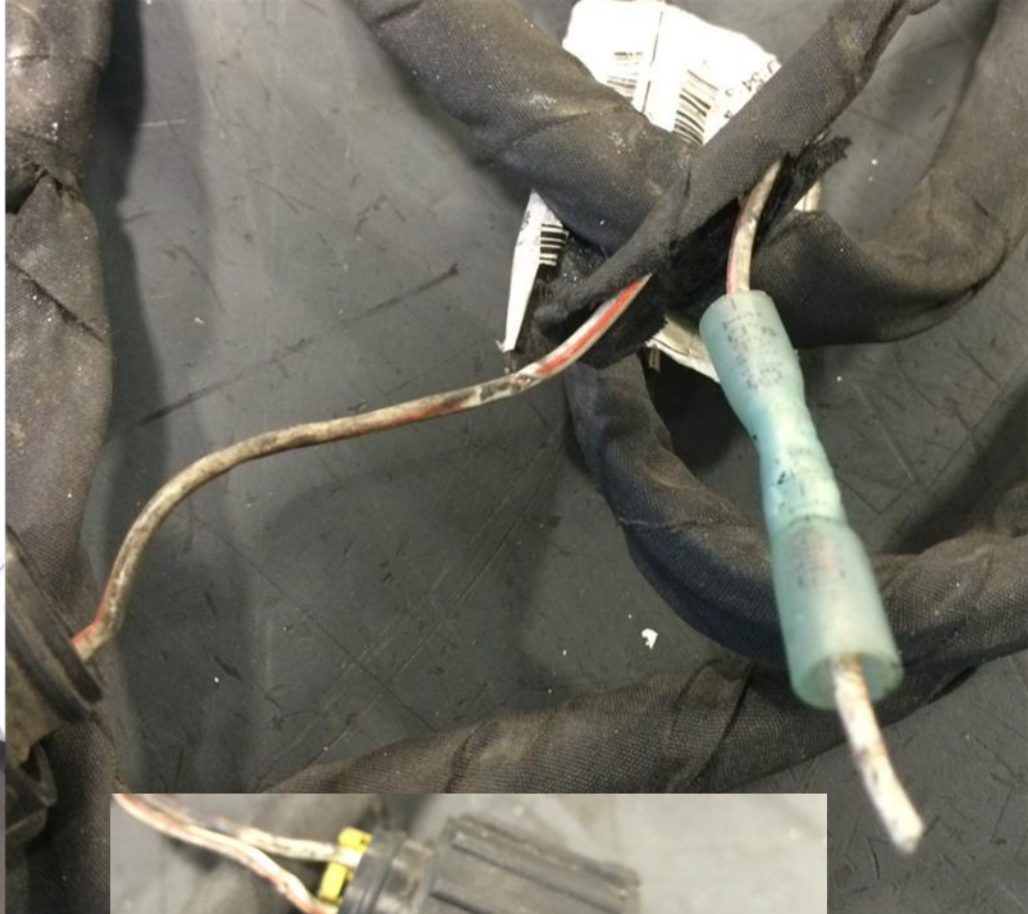
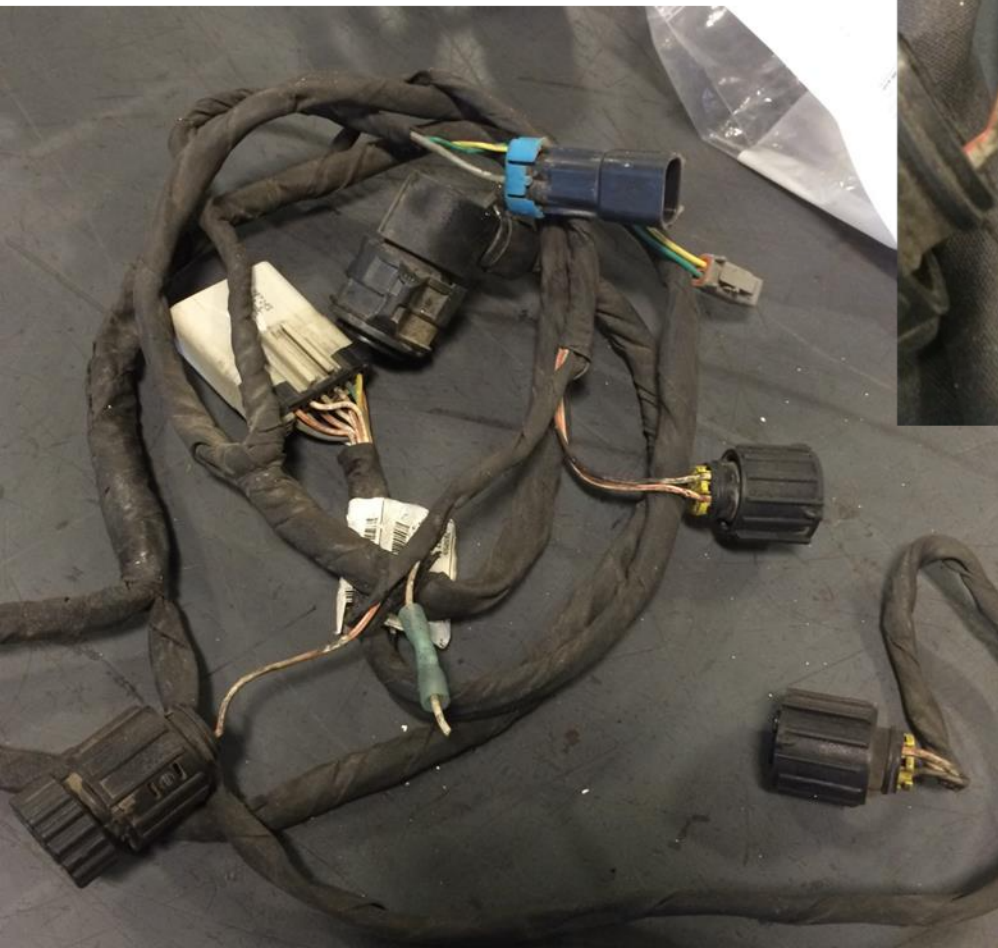
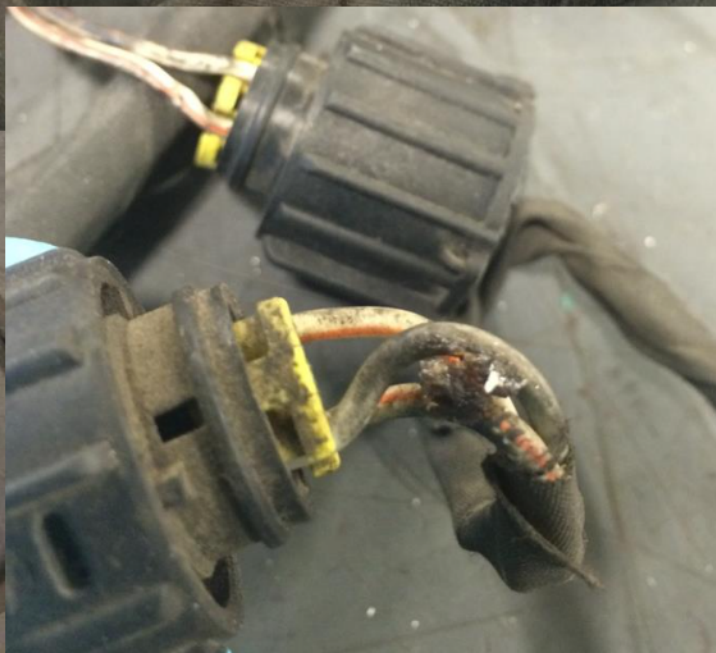
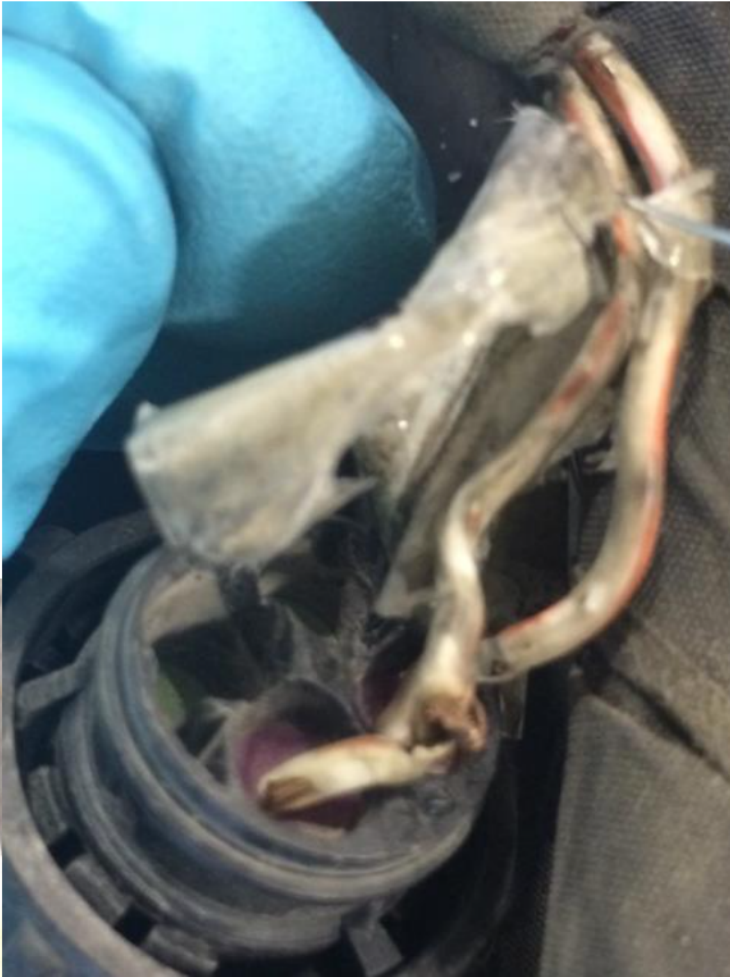
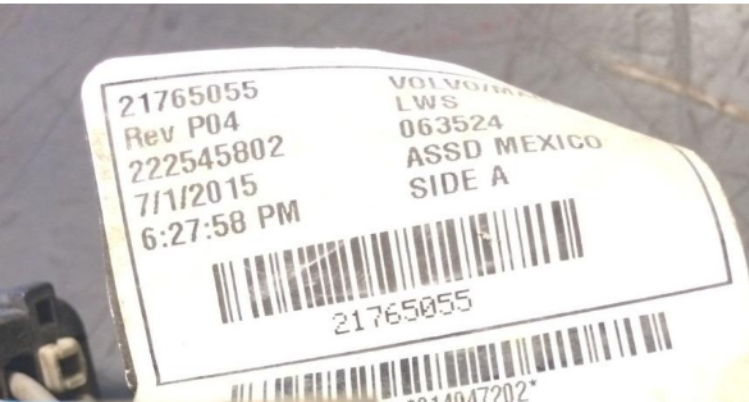
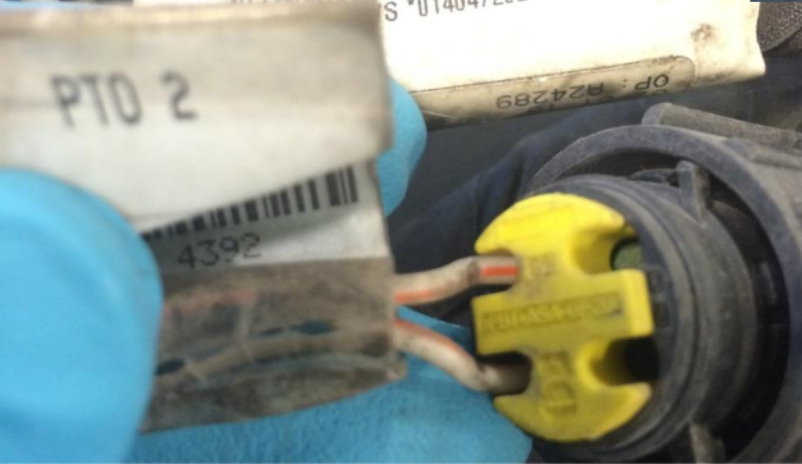
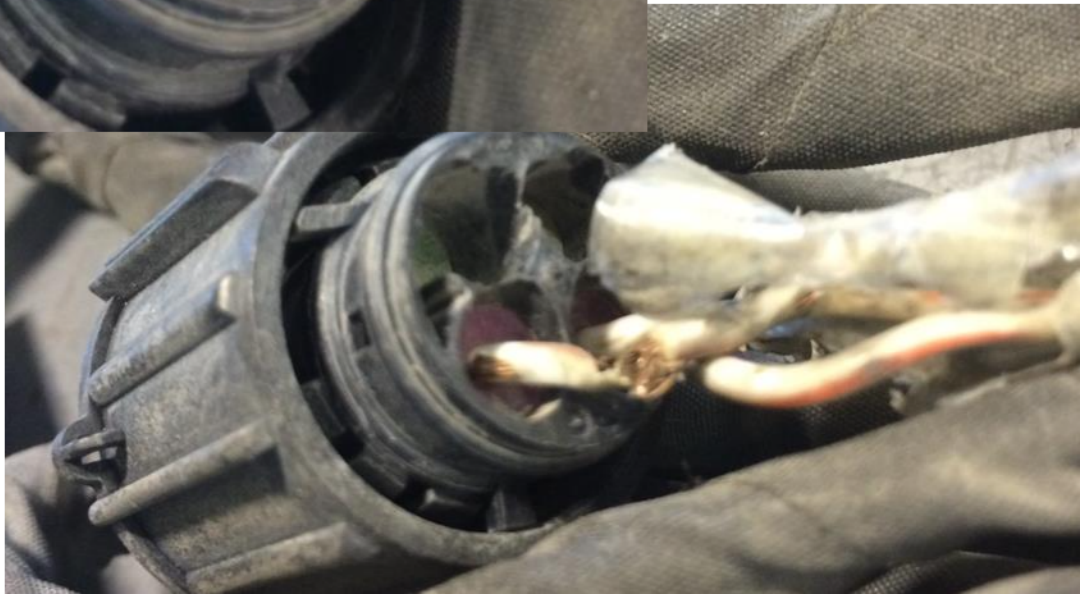
Red numbers on the claim pictures: #11,9,6,&7

The connector/crimping shown in the pictures shows the wires are cut in the same location. Possible vibration in the wiring (design of the connectors??)

One had been repaired by the dealer with a heavier gauge wire and broken in the same location as the production wires

When either of the active faults P106E18 ( PSID 20 FMI 5 ) or P106F18 ( PSID 21 FMI 5 ) are found check the wiring at the PTO solenoids mounted on the back of the transmission. Pull on the wires where they go into the connectors. Replace the harness if a broken wire is found. Repairing the harness with heavier gauge wire does not help.

Due to the intermittent nature of this fault Guided Diagnostics ( GD ) may lead you to replacing the Transmission Electronic Control Unit ( TECU ). Do not replace the TECU without checking this first. It is very unlikely that the TECU is the root cause of this fault.
