## Mack Chassis - Diagnostic Trouble Code ( DTC ) SPN4094, Check List - US10 Emissions

**Bulletin:** SNM 11-09a  
**Date:** Nov 14, 2012  
**Valid to:** Pending  
**Replaces:** N/A  
**Priority:** **HIGH**

**Subject:** EGR Delta P ports

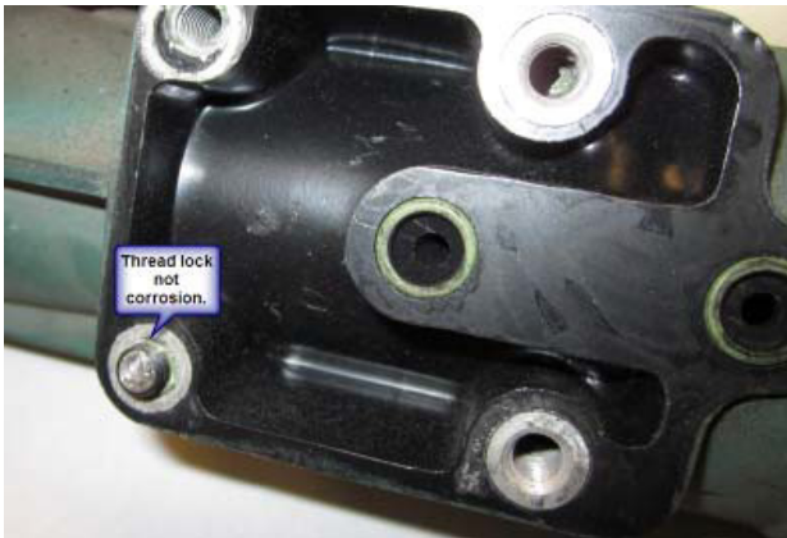
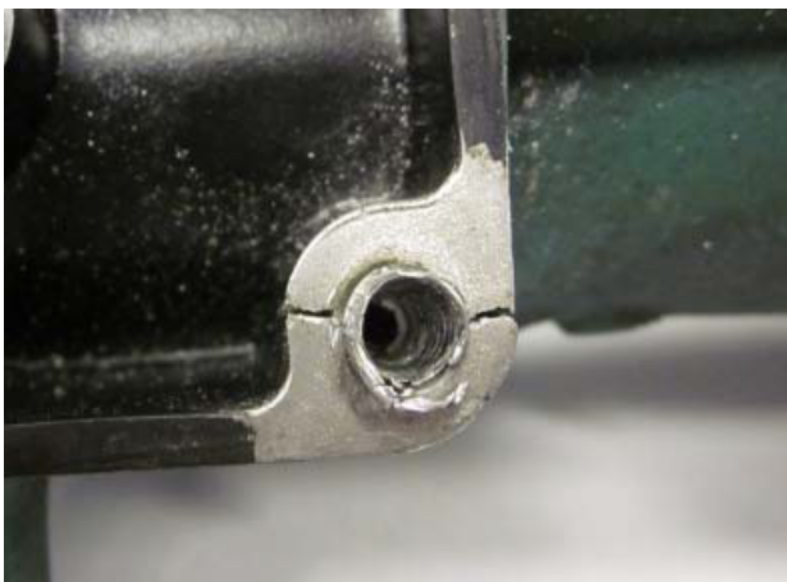
The mounting adaptor in the top picture is not to be reused. The mounting adaptor in the lower picture is borderline. If the coating comes off during proper cleaning then it must be replaced. The corrosive nature of EGR gases will attack the material now and may eventually cause a leak under the seals.

The components are aluminum and are coated to prevent corrosion. Care must be taken not to damage this coating when cleaning the blockage from the ports and tubes.
