Technical product information

Topic	Rotating Display - Fault Diagnosis
Market area	Bentley: worldwide (2WBE),Hongkong-Macau (5HK)
Brand	Bentley
Transaction No.	2055580/9
Level	EH
Status	Approval
Release date

New Continental GT

New Flying Spur

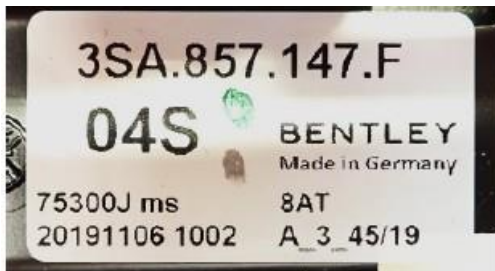
Figure 15

- Take a photo of the BRD prior to packaging (Noting any damage)
- Take a photo of the BRD identification number (Figure 15 as an example)

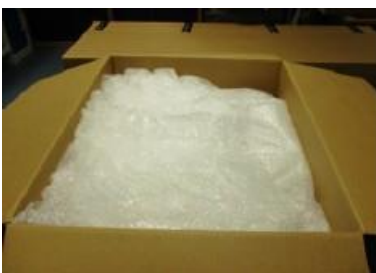
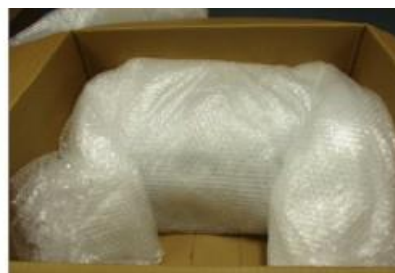
Figure 16

- All returned BRD's must be packaged in the replacements original packaging (Figure 16) to avoid any damage during return transit
