NOVEMBER 2021	APPLICABLE VEHICLES BELOW
DATE	MODEL(S)
CAMPAIGN	21-01-066H
GROUP	NUMBER
	1

THETA GDI ENGINE DTC P1326 - ENGINE INSPECTION / REPLACEMENT (SERVICE CAMPAIGN T3G)

SUBJECT: DTC P1326 – ENGINE INSPECTION / REPLACEMENT (SERVICE CAMPAIGN T3G)

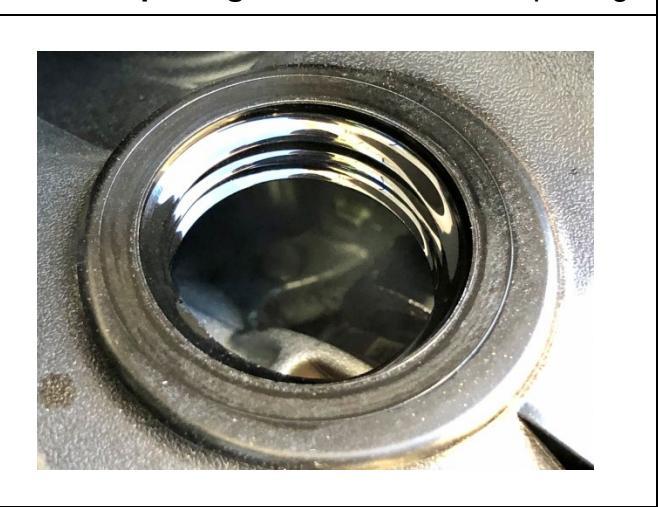
Oil filler cap: Clear view of cap underside

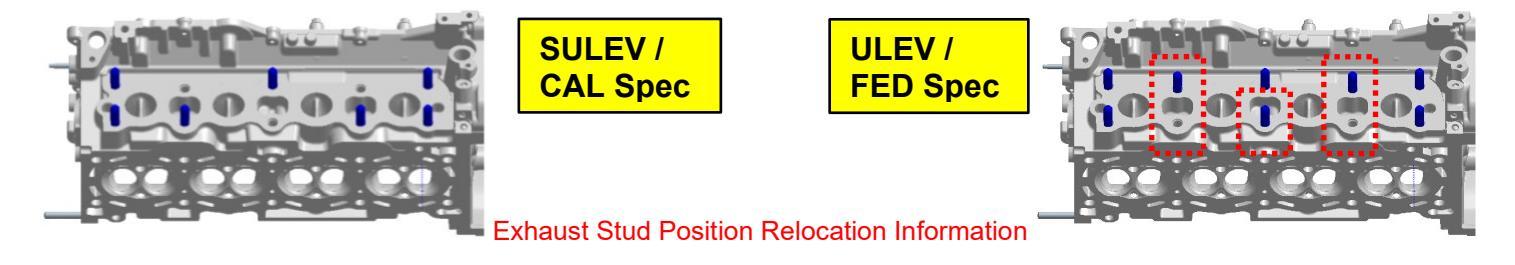
4. (For 2.4L with ULEV / FED emissions only) 2.4L replacement engines are produced with the exhaust manifold studs configured for SULEV / CAL emissions package.

- Two exhaust studs must be relocated on the new engine and 1 exhaust stud must be transferred from the old engine.
 - Use a commercially available stud removal tool or use the double-nut technique to complete this step.

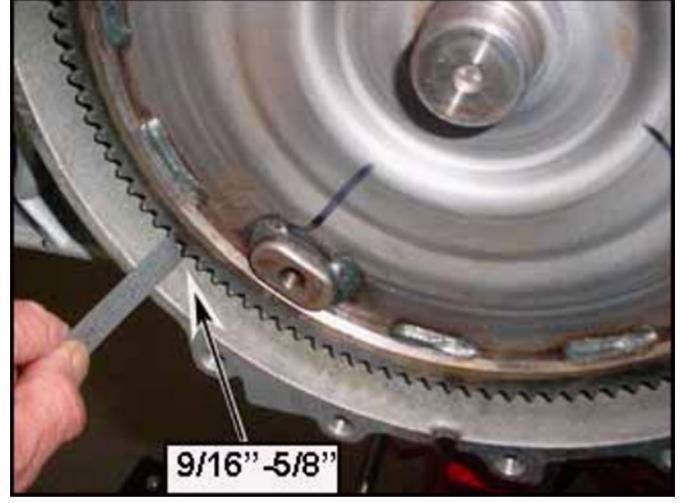
Check the depth of the torque converter to confirm it's fully installed in the transmission otherwise the oil pump may be damaged resulting in transmission failure.

If the torque converter has moved from the fully inserted position, carefully push inward, and rotate the torque converter until the converter is recessed approximately 5/16" -9/16" (8 -14 mm) into the transaxle case when reinstalling the automatic transaxle.
