Case Number: S2108000269

Symptom/Vehicle Issue: Air Bag Lamp On, DTC B2761-11 B Pillar Side Impact Sensor Circuit

STAR ONLINE PUBLICATION

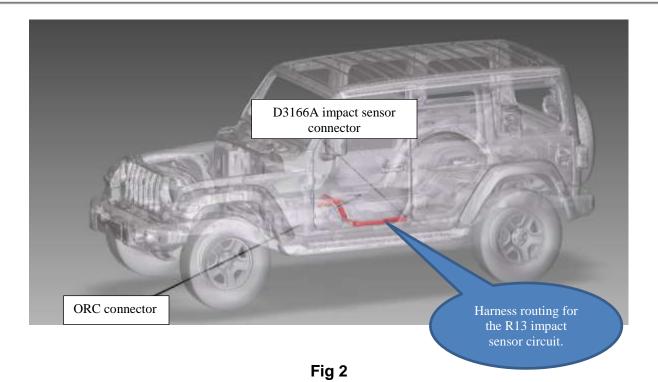
Customer Concern/Technician Observation: Owner complains that the air bag warning lamp is on. Technician observed the ORC sets B2761-11 B Pillar Side Impact Sensor Circuit Short.

Repair Procedure: Remove the driver side door sill trim to inspect the harness for any pinching or harness damage at the sill routing to the ORC. Inspect the B-pillar seat belt retractor bracket location for any signs of chaffing or pinching of the R13 circuit. Follow the diagnostic service procedures for repairs to safety systems Fig 1, 2. See service information 10 - Restraints / Standard Procedure SUPPLEMENTAL RESTRAINT SYSTEM WIRING REPAIRS.
