# **TECHNICAL INSTRUCTIONS**

## **LIMITED SERVICE CAMPAIGN 21TD03**

**CERTAIN 2016 – 2019 Model Year Double Cab Tacoma**

**CENTER HIGH-MOUNTED STOP LAMP – WATER LEAK**

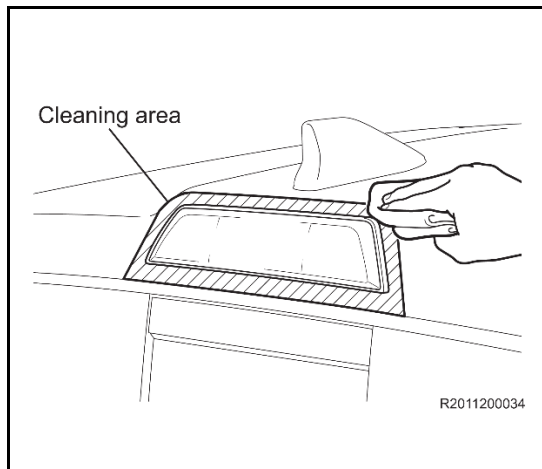
The quality of sealer and trim ring installation needs to be performed when operating temperature is 40°F - 100°F (4°C - 38°C). Confirm the temperature of the vehicles roof meets these requirements using an IR temperature gun.

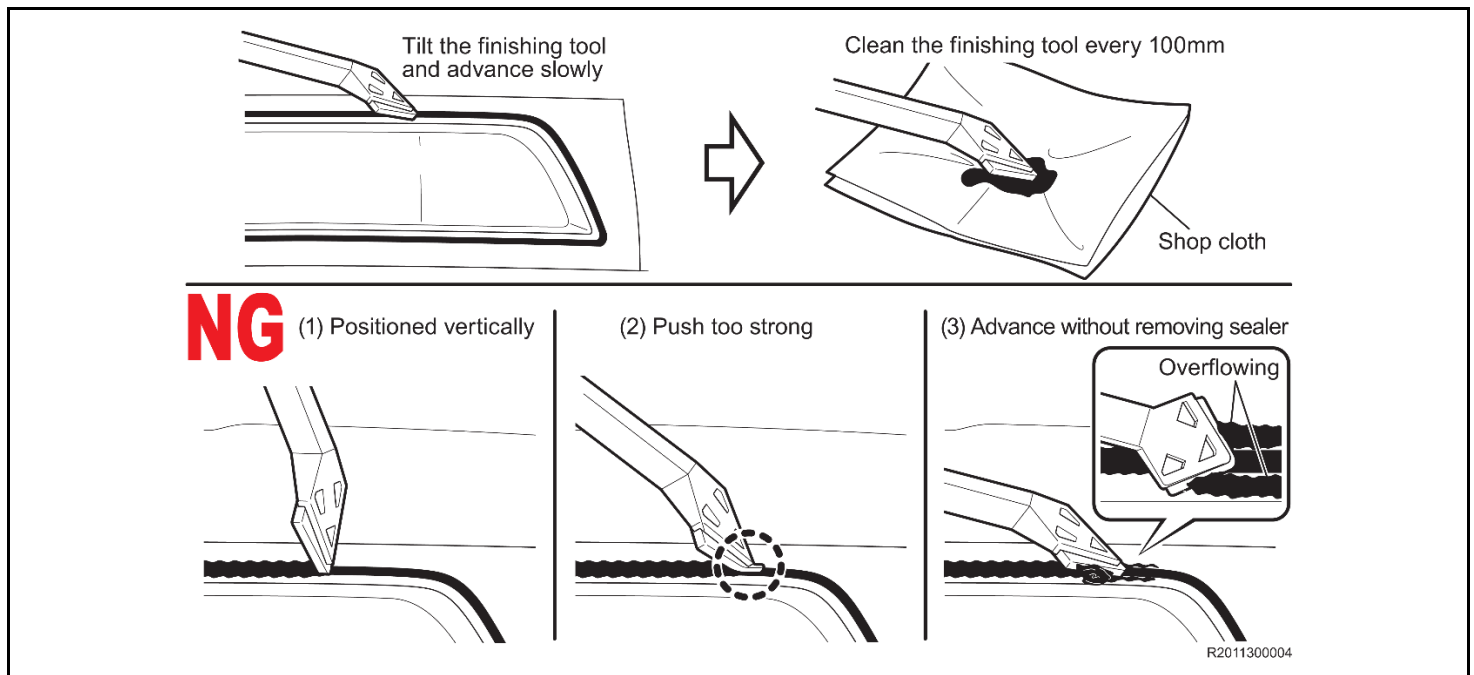
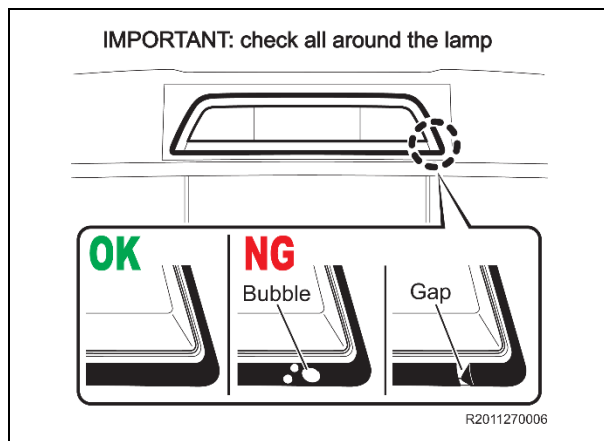
e. Confirm that the sealer is applied well between the center high mount stop lamp and body without any gaps or bubbles.

**Note:** If there are any gaps or bubbles, add enough sealer to the missing points and push in using the finishing tool.

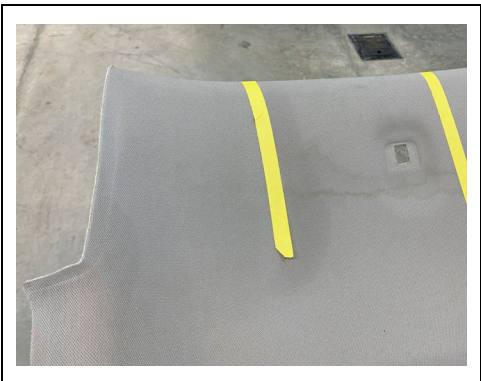
- c. Inspect the condition of the headliner after the 1<sup>st</sup> round of cleaning. The headliner should have no visible staining remaining.
