Highland  
RIDGE RV

## LP Tank Wiring – Fuel Sender and Solenoid

| <b>Bulletin #(s):</b> | 21-025 | <b>Make(s):</b> | Jayco & Entegra |

| <b>Incident:</b> | LP Tank is full but showing empty on Vega Touch panel | | |

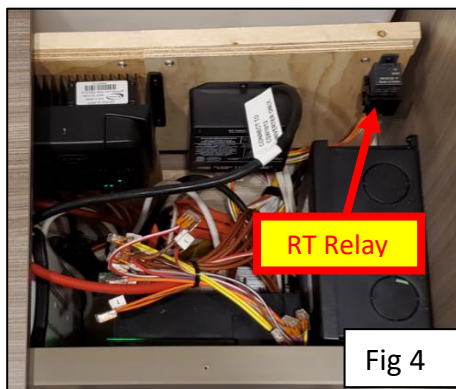
Fig 4

- A. Remove cushions from passenger side bed and set aside for installation later.
- B. Remove bed board from passenger side. Save the 7 fasteners for installation later.
  - i. **Note:** With the bed board fasteners removed, it needs to be moved forward to access wiring behind fuse block. (Figure 3)
- C. Remove the relay to gain access to the wiring
  - i. Relay for RT unit will be located behind the power center at the back of the bed shown in Figure 4.
  - ii. Relay for RA unit will be located behind the power center in the middle of the bed which is shown in Figure 5.
