# Aftersales TSO – Service campaign

**MAS002829**  
(MSC 21-15)

## Service Campaign 430: M15X MY20-21 Sunroof Water Infiltration

MY20 and MY21 Maserati Sedans are involved in a Service Campaign to check for a possible water leak in the sunroof assembly.

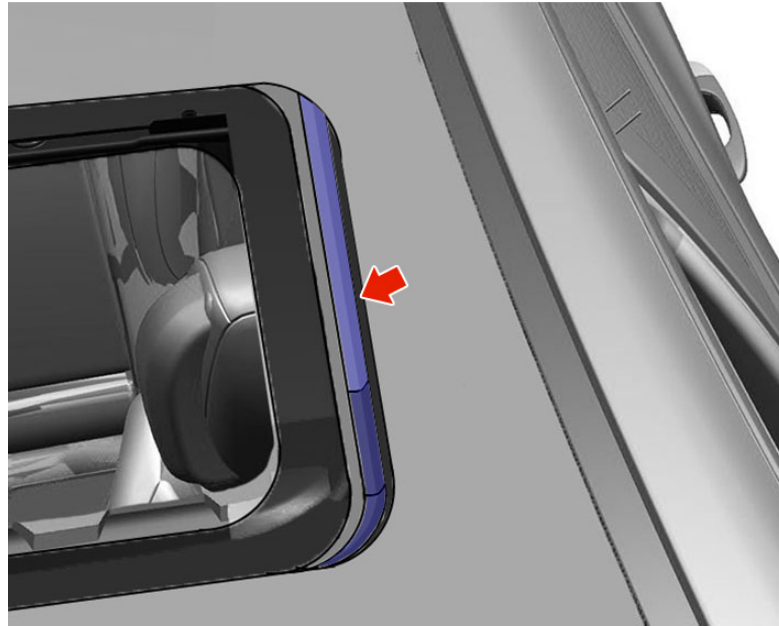
- ❗ The water should flow from top to bottom with no leaks from the lower roof ribs as shown.
- ❗ Attention: Do not let water enter the car.
