SIB 64 06 13

2021-11-01

## A/C COOLING: INTERMITTENT REDUCTION OF AIR FLOW

This Service Information Bulletin (Revision 11) supersedes SI B64 06 13 **dated December 2020**.

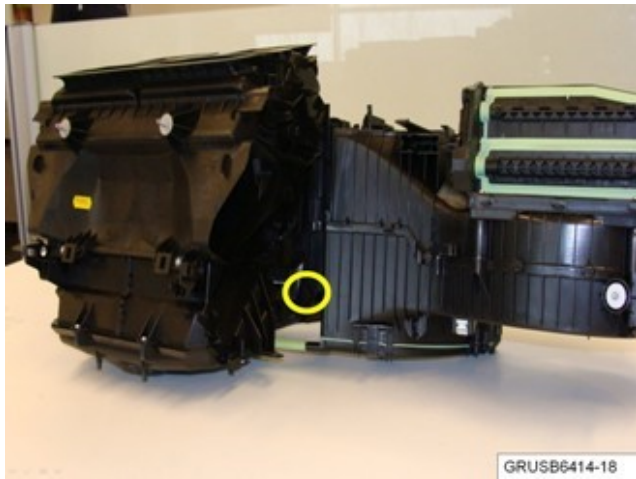
4. The IHKA housing (removed for clarity)

shown is viewed from the passenger's side.

The circle shows the approximate location of the evaporator temperature sensor.

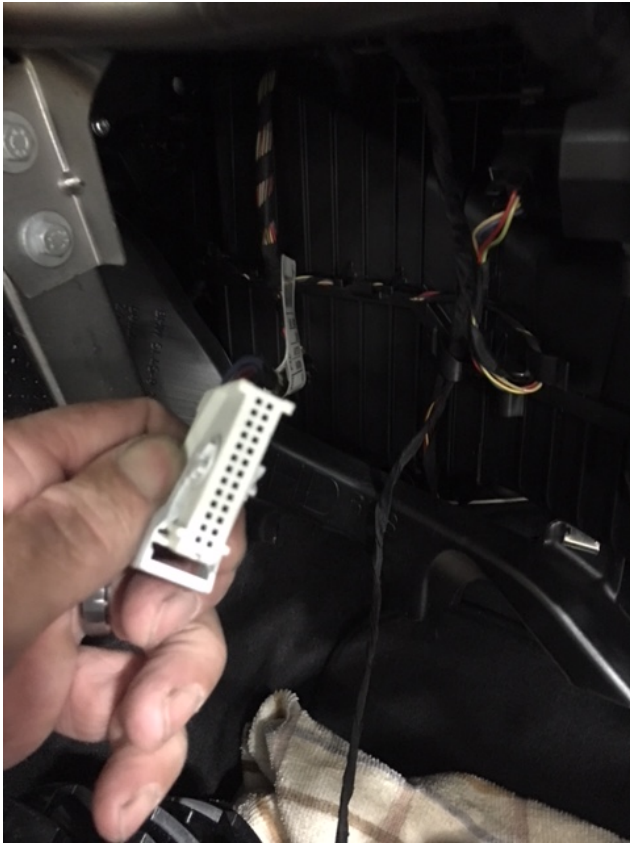
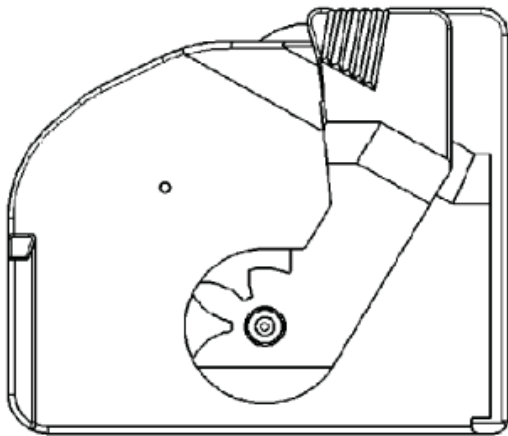
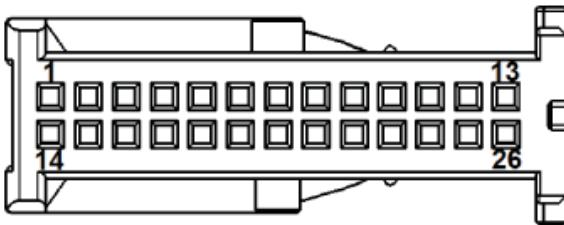
On this example vehicle (F30) the wire (pin 22) is violet colored.

Remove the outer plastic housing from the internal wire holder to identify the wire you will be modifying.

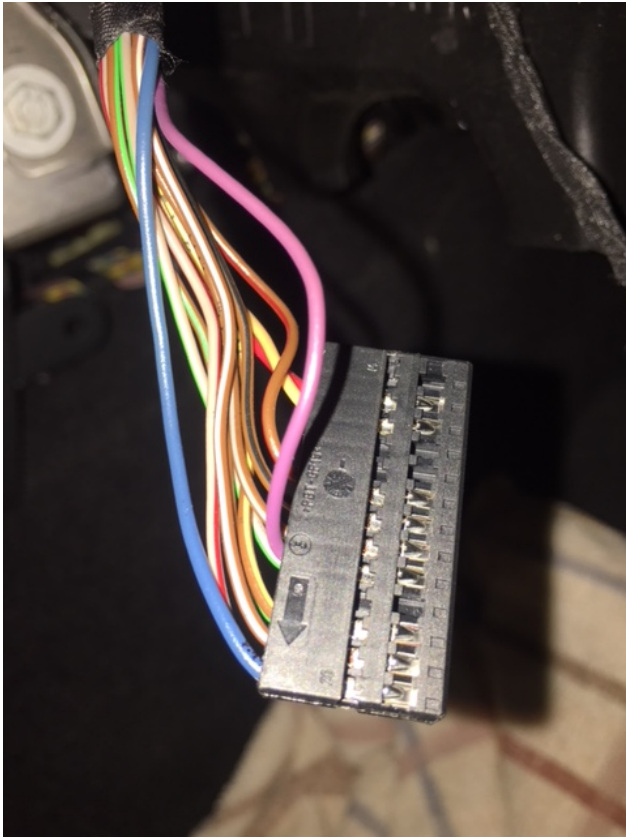
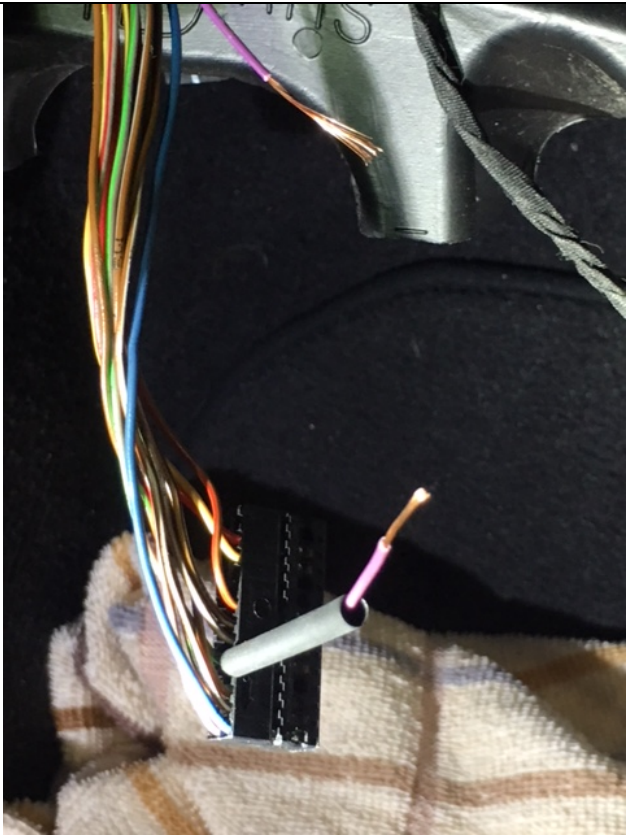
The evaporator temperature sensor signal wire goes to pin 22 at IHKA control panel connector x4711.

For this F30 the wiring can be found in schematic Temperature Control SP0000058999.

Reference wiring diagrams to identify evaporator Temperature sensor (B4) wire.
