**SIB 65 05 18**

2021-11-29

AIR BAG LAMP ILLUMINATED. FAULT CODE 9309A0This Service Information Bulletin (Revision 5) replaces SI B65 05 18 **dated February 2020**.**What's New** (Specific text highlighted):

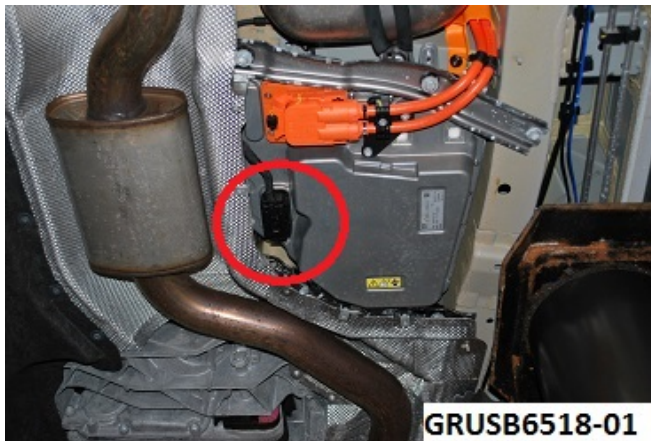
4. Perform a visual inspection of connector A190*1B on the bottom of the EME.

Notify technical support via a TSARA case if there is visual/water damage to these pins.
