December 18, 2021

Version 2

## Product Improvement Campaign: 3G TCU VoLTE OTA Update

Year	Model	Trim	VIN Range
2019–21	RDX	ALL	Check the iN VIN status for eligibility.

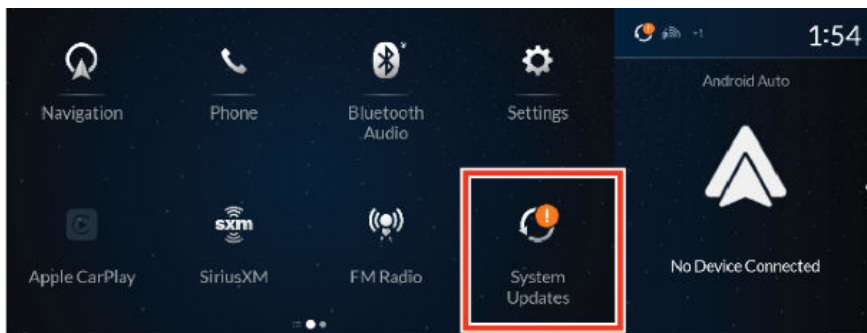
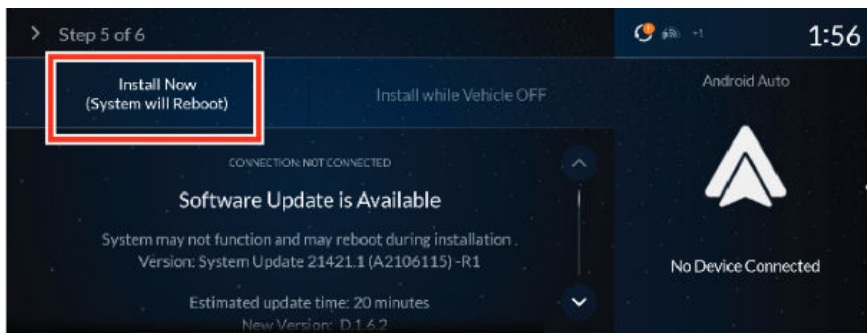
- This is an update to the TCU, which depends on a good cellular connection.
  - There is no need to connect to a WiFi network to proceed with the update.
1. To complete the update, press the Home button, select **System Updates** app, and when the download and preparation is complete, select **Install Now**.

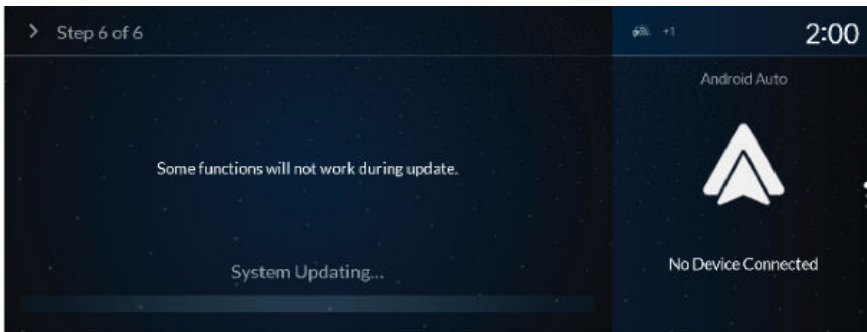
2. **The System Updating process will begin; this takes about 25 minutes total to complete. 5 minutes for the Front Control Box and 20 minutes for the TCU.**

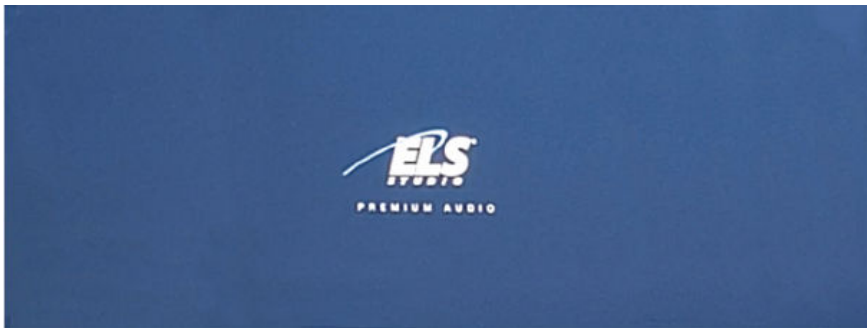
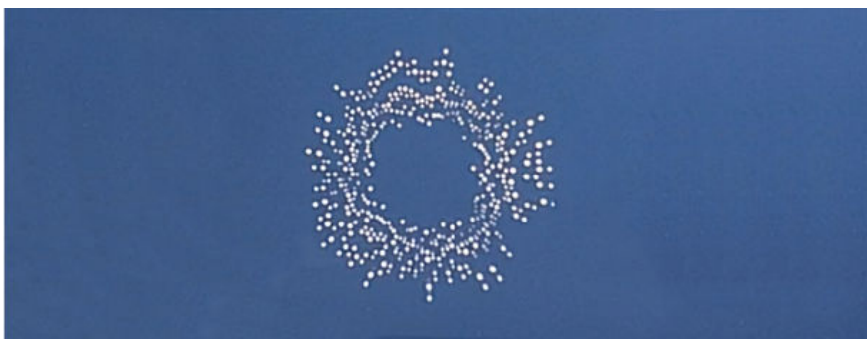
The system will restart.

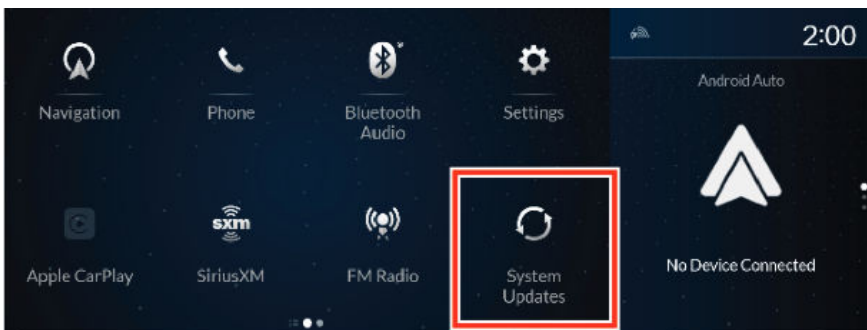
3. Wait for the Disclaimer screen to clear, then, on the HOME Screen select **System Updates**.

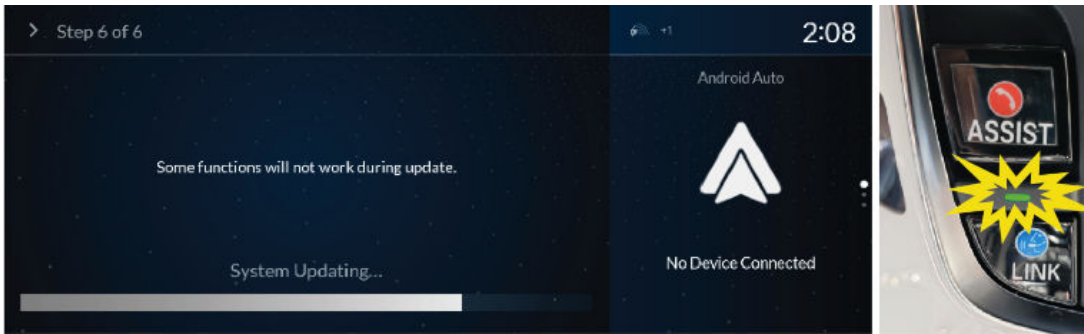
- 4. Step 6 of 6 will reappear; the TCU update will begin. This takes approximately **20 minutes** to complete.

- The Link LED will blink while the screen displays **System Updating**.

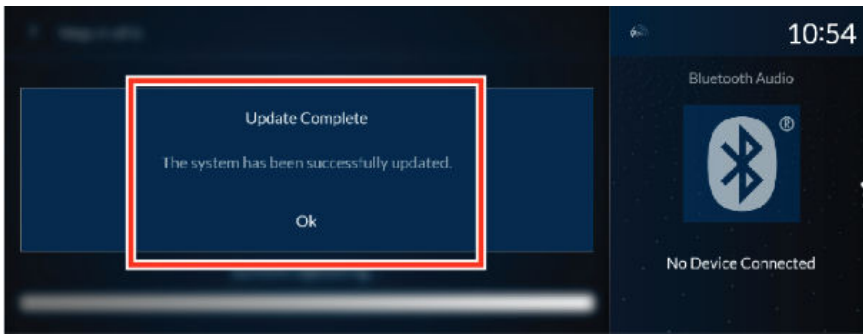
5. Once the update completes you will see Update Complete.

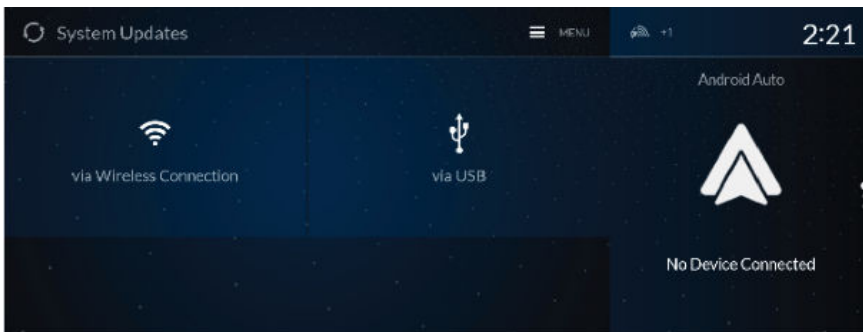
NOTE: If the System Updating bar completes and screen Step 6 of 6 clears without showing Update Complete go to SOFTWARE VERSION VERIFICATION - FRONT CONTROL BOX AND TELEMATICS CONTROL UNIT (TCU).

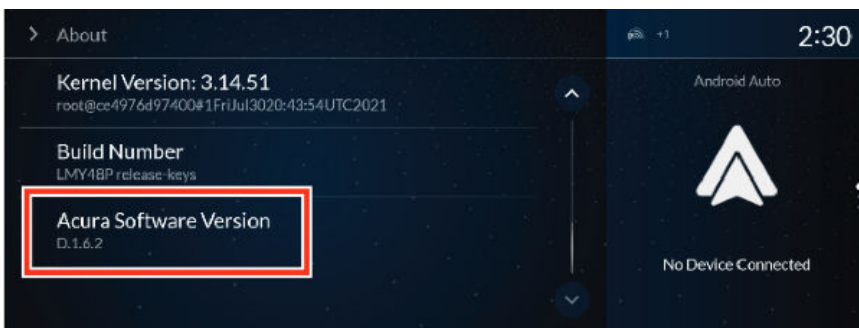
4. Scroll down and verify the Acura Software version is **D.1.6.2**.

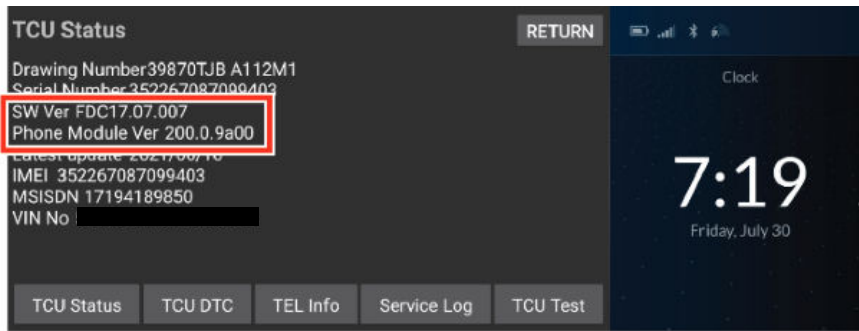
9. Confirm the TCU SW as follows:

TCU Software version **FDC17.07.007/ Phone Module Ver 200.0.9a00 or 200.0.9800.**

- If the software versions do not match after three update attempts, contact Tech Line for assistance. Tech Line will review the OTA campaign status for the VIN and will assist in trouble shooting possible TCU hardware issues.
- TCU replacement is not covered by this service bulletin.
