# Service Bulletin

Bulletin No.: 21-NA-149

**Subject: Engine Wire Harness Chafing / IPC Gauges Sweep / IPC Warning Message / SES/Check Engine/MIL / No Start / No Crank / Runs Rough / Stalls / Reduced Engine Power / Various DTCs**

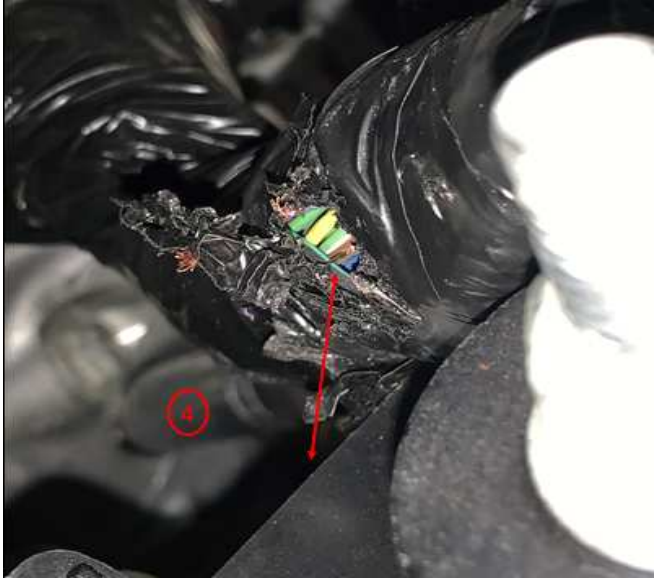
<p style="text-align: right;">5583331</p>

<p><b>Cause 4</b></p>	<p><b>This Cause pertains to vehicles equipped with engines 5.3L L82, 5.3L L84, 6.2L L87, 4.3L LV3, 2.7L L3B, or 3.0L LM2.</b></p>

The cause of the condition may be an engine wire harness clip was removed during production due to ergonomic issues (hand clearance and branch stiffness). This led to an uncontrolled branch that came into contact with a sharp edge (1) & (2) on the ECM/TCM bracket, driver side upper control arm, and/or shock tower and caused chaffing during engine vibration and roll.

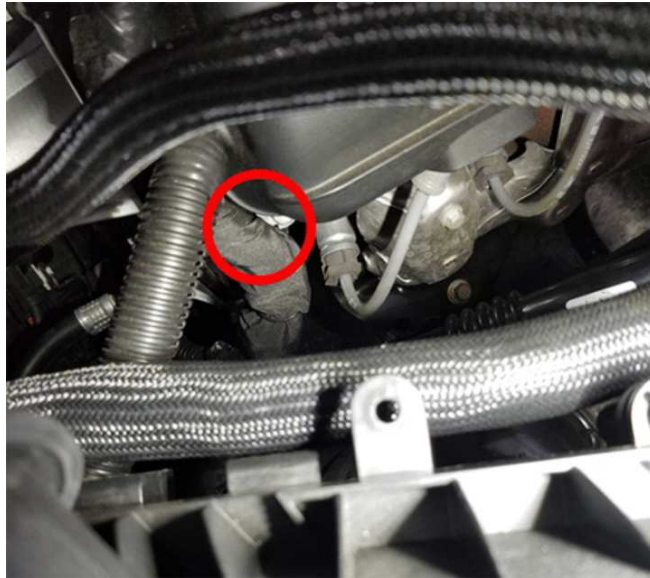
5412204

**This Correction pertains to vehicles equipped with engine 4.3L, LV3 only.**  
**Note:** The first graphic below is a before, and after (2), repair example of harness chaffing at the Oil Dipstick bracket.

To correct this concern, repair the damaged wiring following the SI wire-to-wire repair procedures. Once repaired, protect and reposition the engine wiring harness to prevent future harness damage.
