GROUP
Product Improvement

NUMBER
PI1803Y/Z (Rev 6, 12/23/2021)

PRODUCT IMPROVEMENT CAMPAIGN

ENGINE REPLACEMENT INSTRUCTIONS FOR DTC P1326 (PI1803Y/Z)

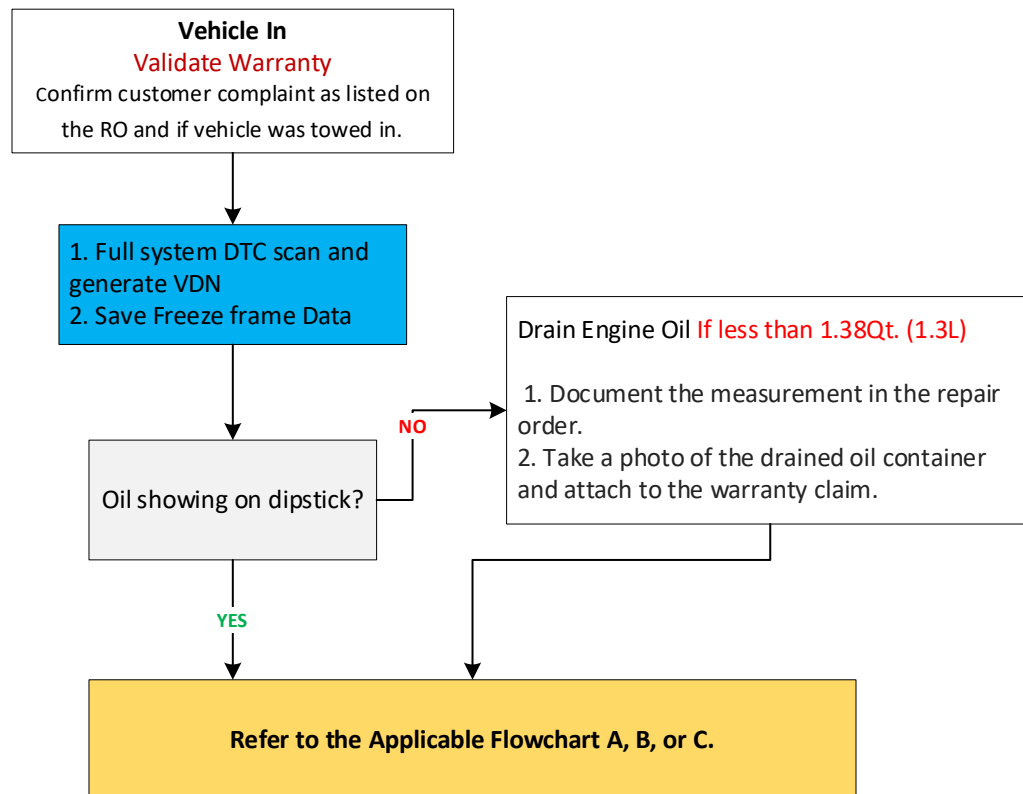
Main Flowchart:

Follow the applicable Main Flowchart below upon documenting customer complaint. Then follow the corresponding flowchart for one (1) of the three (3) following concerns:

- A. DTC P1326 Stored... (Page 3) - NO Engine Noise
- B. ENGINE NOISE... (Page 4)
- C. ENGINE, NO CRANK... (Page 5)

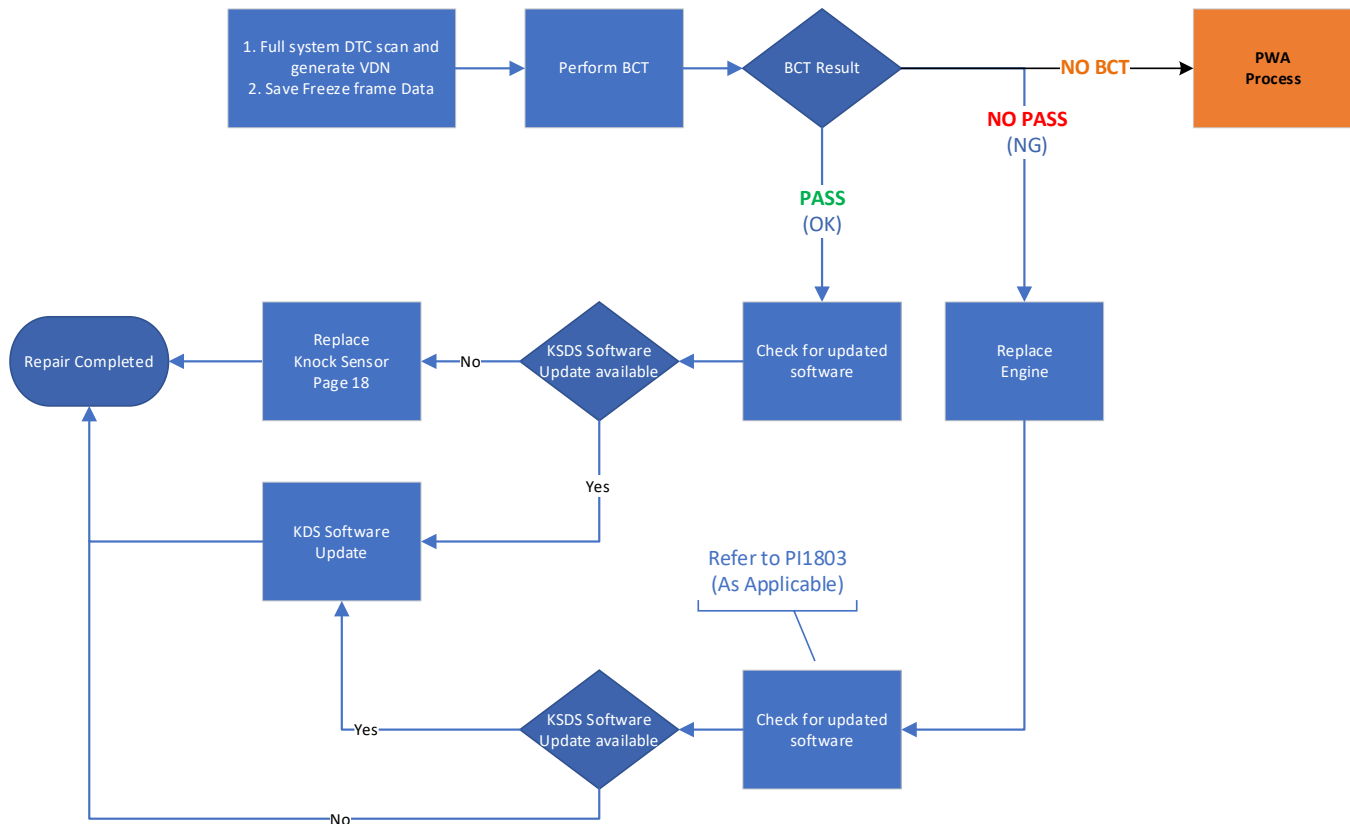
SUBJECT: ENGINE REPLACEMENT INSTRUCTIONS FOR DTC P1326 (PI1803Y/Z)**Flowcharts:****A. DTC P1326 Stored**

Create PI1803Y Claim - No PWA Required (Pass/No Pass result)

Create PI1803Z Claim - PWA Required (No BCT result)

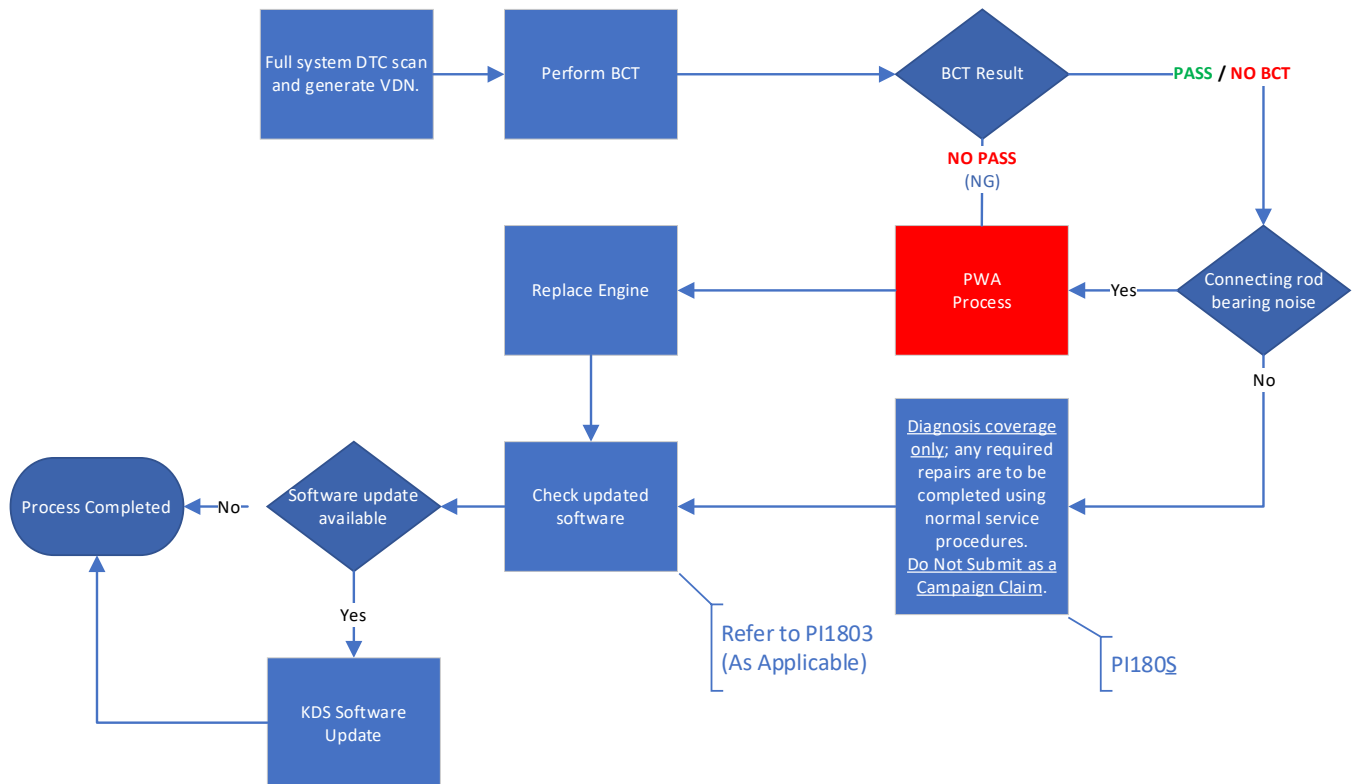
B. Engine Noise

Techline PWA Required; Diagnosis only Campaign Possible

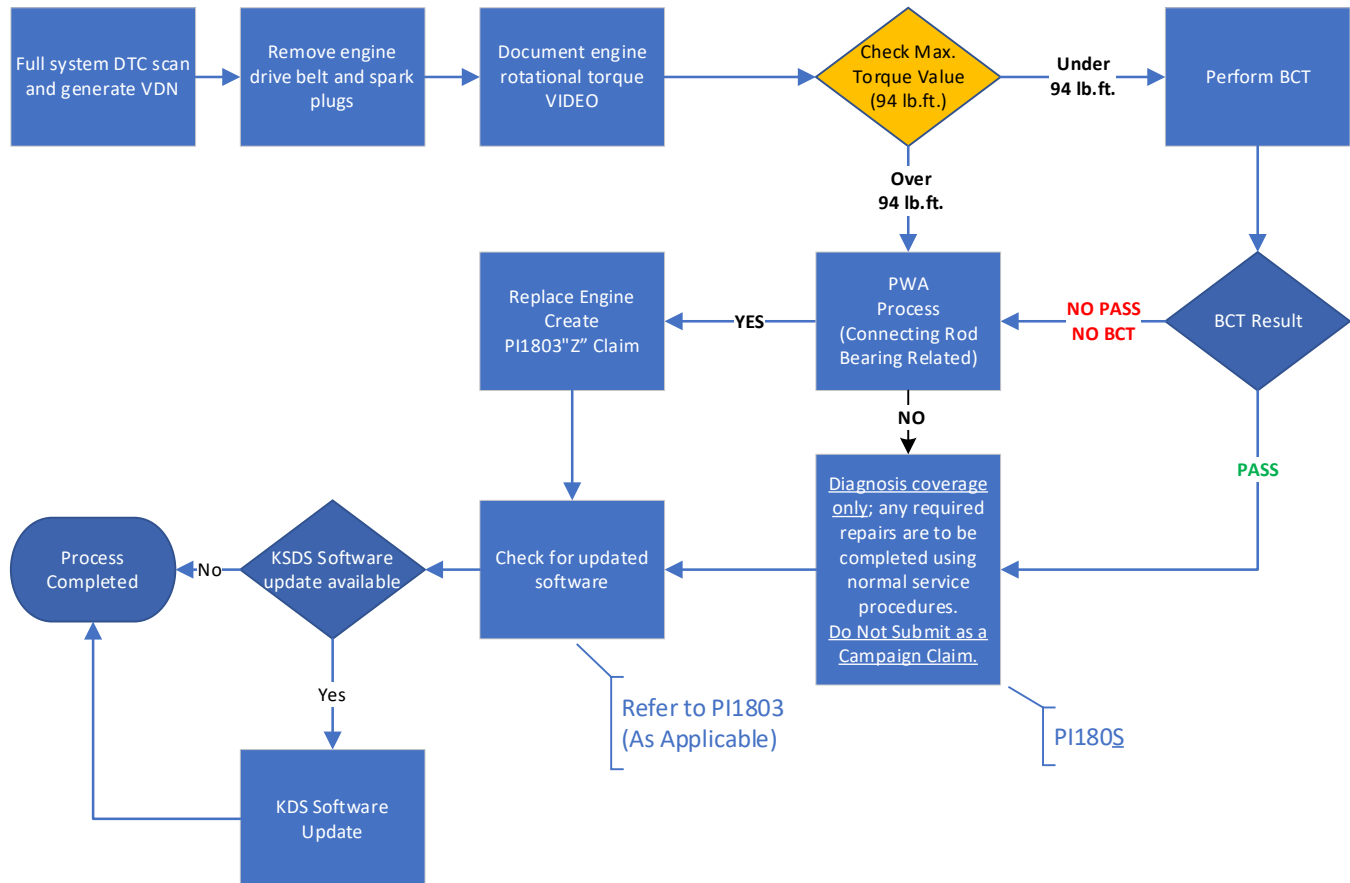
SUBJECT: ENGINE REPLACEMENT INSTRUCTIONS FOR DTC P1326 (PI1803Y/Z)**C. Engine No Crank**

Techline PWA Required; Diagnosis only Campaign Possible

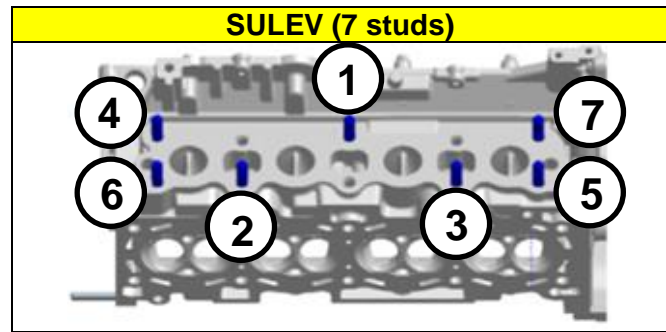
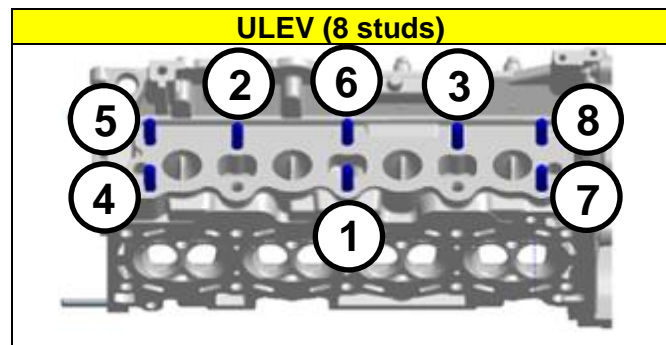
- All engines supplied under this Product Improvement Campaign have the exhaust manifold studs configured for SULEV engines.
- Using the pictures to the right, check the exhaust manifold stud location and quantity. Relocate as required for ULEV engines and obtain one (1) extra from the removed engine.
- Prior to installation, replace the exhaust manifold gasket and front muffler gasket.
- Torque nuts in the sequence shown.

Tightening torque of nuts:

**36.2 – 39.7 lb.ft (49.0 – 53.9 N.m,
5.0 – 5.5 kgf.m)**

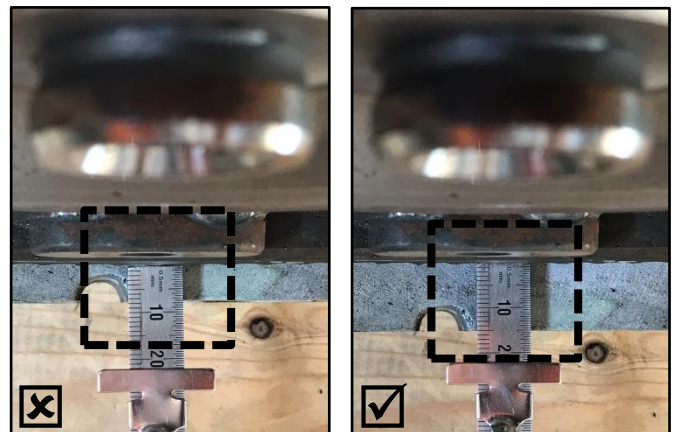
Not Fully Inserted

Fully Inserted

- If the torque converter has moved from the fully inserted position, carefully push inward while rotating the torque converter until it is recessed approximately 9/16 – 5/8" (14 – 16mm) (☑) into the transaxle case when reinstalling the automatic transaxle.
