# TECH TIPS GREATEST TIPS

## ERRATIC DIGITAL FUEL GAUGE OPERATION, 2012MY AND LATER IMPREZA, BRZ AND 2014MY FORESTER

## 01 Sending Immobilizer Components, Broken on Arrival

## 15 B2255 and B2256 misdiagnosis and Diagnostic changes

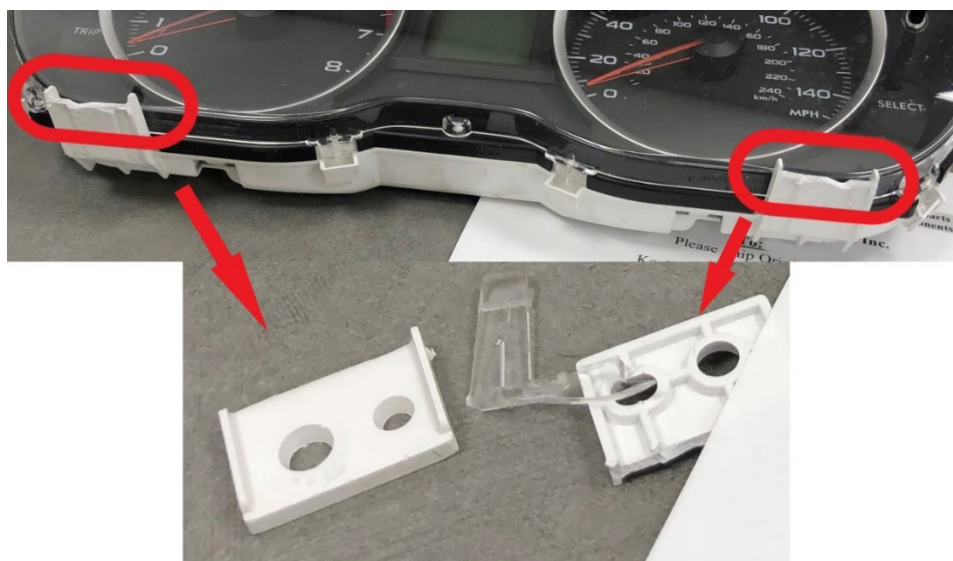
Techline has received several broken immobilizer components in recent months for lost key reprogramming. This has been attributed to poor choices of packing material (or lack thereof), and inadequate box size. The most common parts found broken on arrival to SOA are the combination lens and meter mounting tabs.

When sending components for clearing, take extra consideration and care when packing. Using the proper insulating material and box size could be the difference between a broken meter or not. Inflatable bags are not recommended they are not reliable and can easily deflate.
