<b>Subject:</b>  <b>CONNECTED VEHICLE SYMPTOM TROUBLESHOOTING</b>	<b>Service Alert No.: SA-013/21</b>
	<b>Last Issued : 12/22/2021</b>

2019-2022 Mazda3  
 2020-2022 CX-30  
 2021-2022 CX-5  
 2021-2022 CX-9  
 2022 MX-30

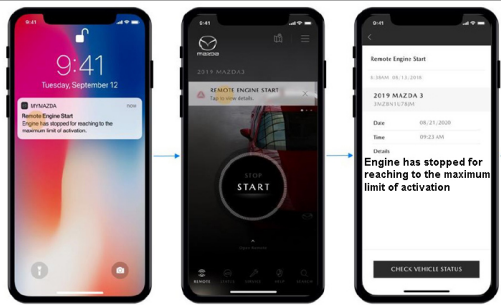
Connected Vehicle Troubleshooting			
	Symptom	Cause	Action
1	Remote function(s) inoperative. <ul style="list-style-type: none"> <li>• Engine Start / Stop</li> <li>• Door Lock / Unlock</li> <li>• Lights ON / OFF</li> </ul>	Go to the MyMazda App to view the reason for remote function failure.	Push Notification

<div style="display: flex; justify-content: space-around; margin-top: 10px;"> <div style="text-align: center;"> <b>OS Lock Screen</b> Tap the push                             </div> <div style="text-align: center;"> <b>Home</b> Tap the alert card                             </div> <div style="text-align: center;"> <b>Inbox Detail</b> Tap "check"                             </div> </div>

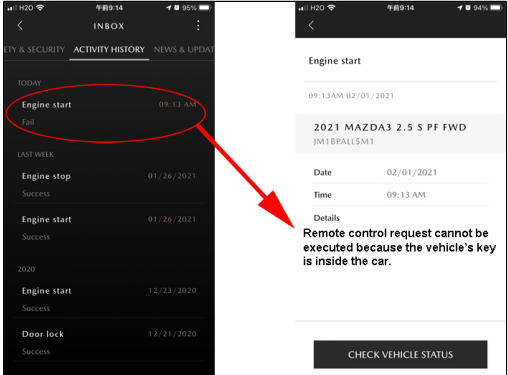
notification		vehicle status"
	Troubleshooting needed	Activity History	<p>Go to the MyMazda App INBOX -&gt; ACTIVITY HISTORY -&gt; to view reason for remote function failure.</p>

<ol style="list-style-type: none"> <li>1. Use MDARS to ID the vehicle and check for DTC's stored. Are DTC(s) stored? <ul style="list-style-type: none"> <li>• Yes - Go to MGSS and perform normal DTC diagnostics.</li> <li>• No - Go to next step.</li> </ul> </li> <li>2. If applicable, confirm SSPC7 or DRW41 is closed. Go to <a href="#">eMDCS Vehicle Inquiry</a>.</li> <li>3. Confirm TCU software version is at the following using <a href="#">TCU Software Version Check</a> <ul style="list-style-type: none"> <li>• CX-5 and CX-9 - 10020 or later</li> <li>• CX-30 and Mazda3 - 10004 or later</li> <li>• <b>MX-30: N/A</b></li> </ul> </li> <li>4. Disconnect battery for 30 seconds and then reconnect (KAM reset). <p><b>NOTE:</b> Test drive vehicle after battery disconnect to allow the GPS clock to synchronize before retrying Authorization Code.</p> </li> <li>5. Perform one of the following: <ul style="list-style-type: none"> <li>• <b>Customer:</b> Un-enroll Connected Services, then re-enroll into Connected Services as a new primary user.</li> <li>• <b>Dealer:</b> Perform customer take-over enrollment for test confirmation, then at customer pick-up, inform customer to re-enroll into Connected Services as a new primary user.</li> </ul> </li> <li>6. Contact Hotline for additional technical support if</li> </ol>

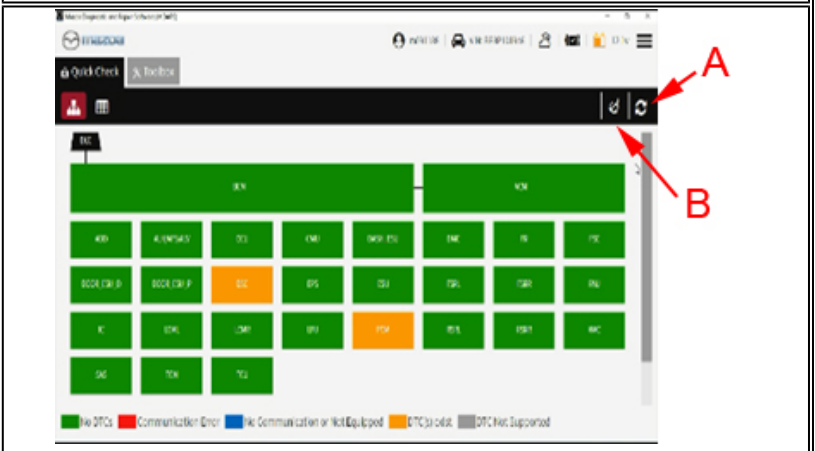
**CAUTION:** If the engine is not started, DTC P2610 is stored and cannot be erased.

5. Select Quick Check (A), then start the engine and select the DTC Clear icon (B).
