## Electronic Log Devices (ELD): Qualcomm, PeopleNet, OmniTracs, GPS, Location Tracker, Etc. - Installation Instructions And Information - US17+OBD16 Emissions And Newer

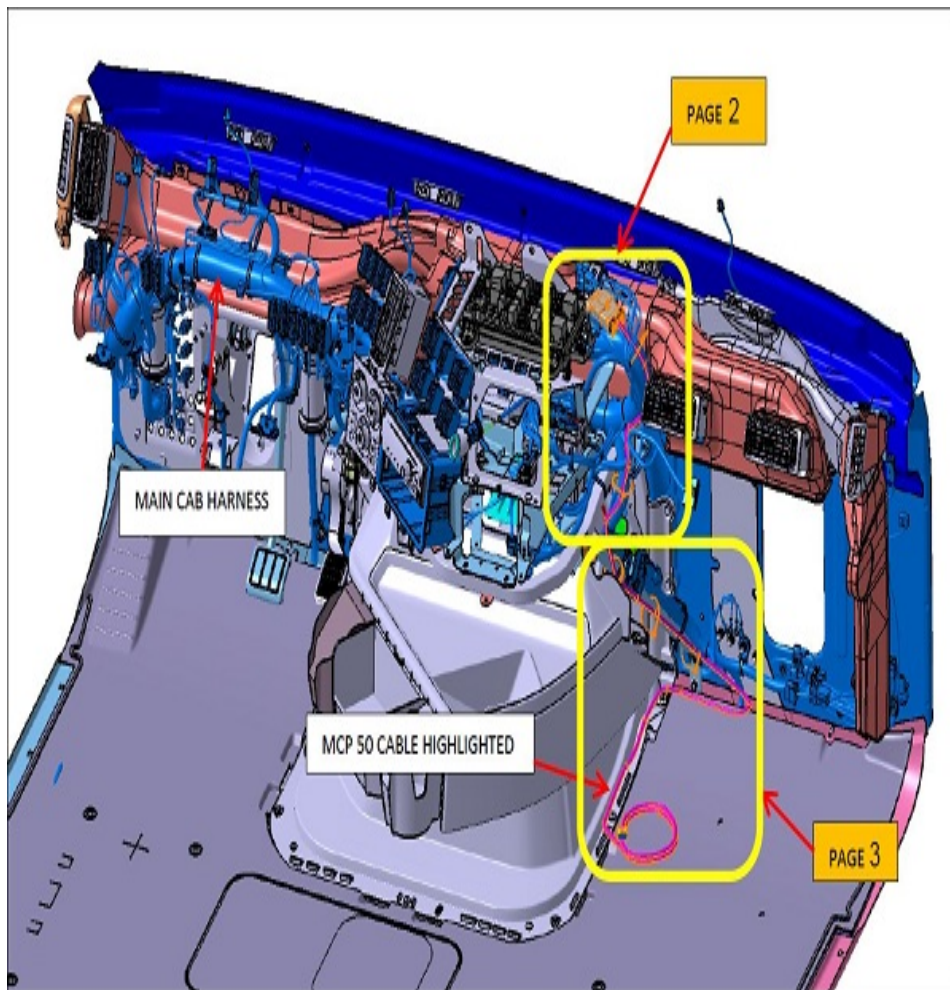
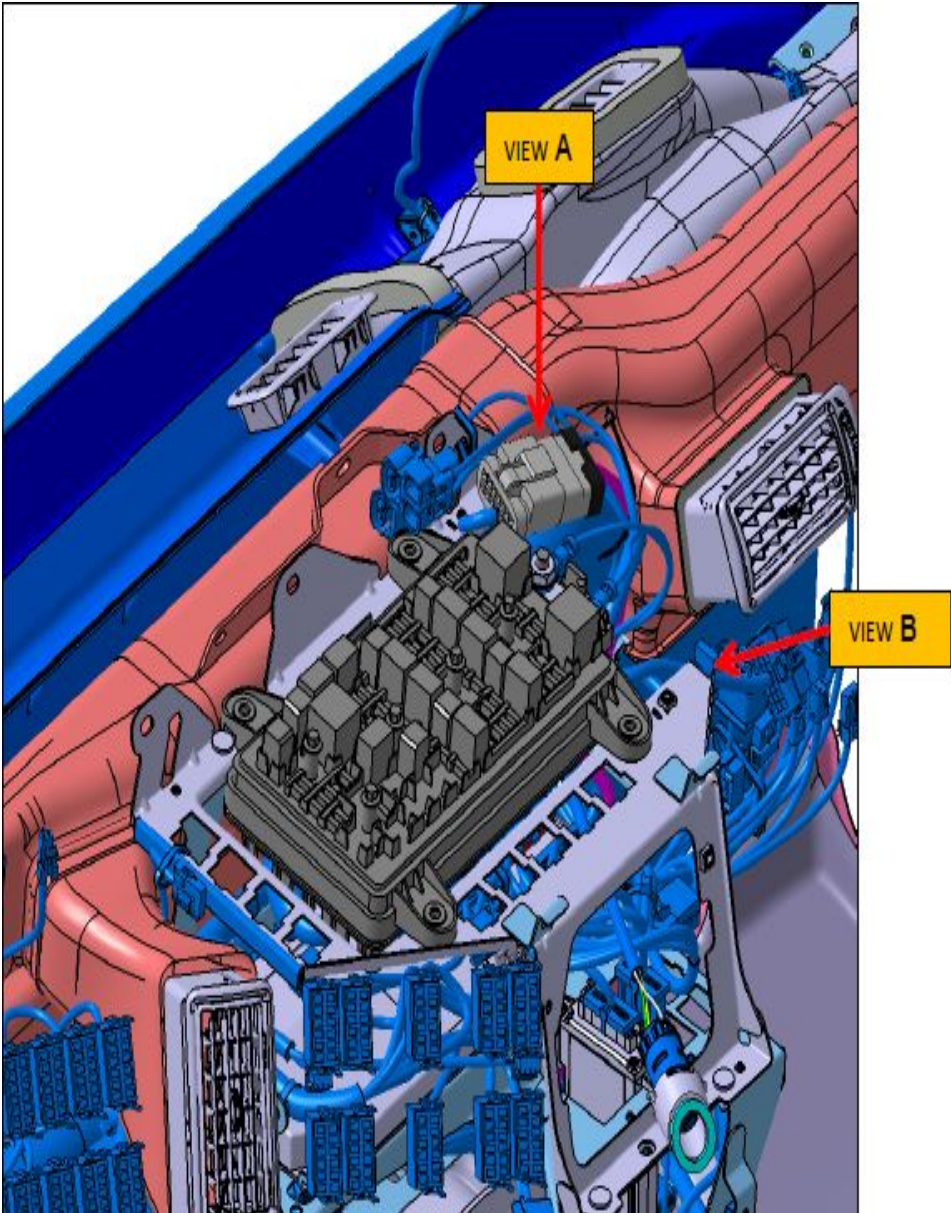
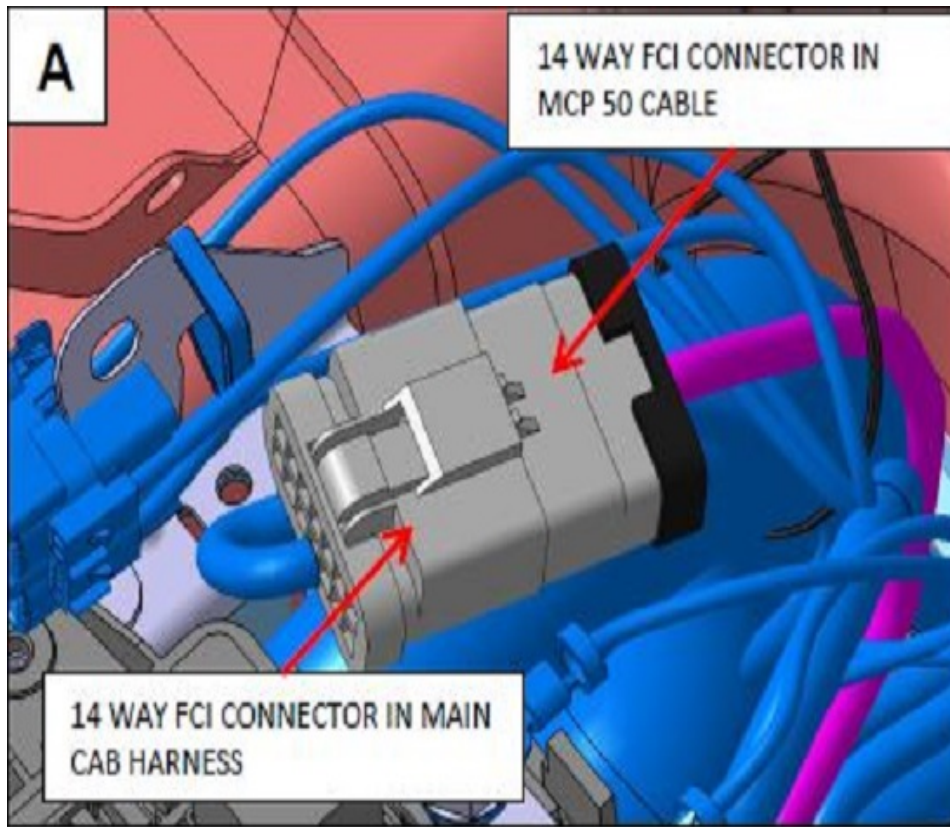
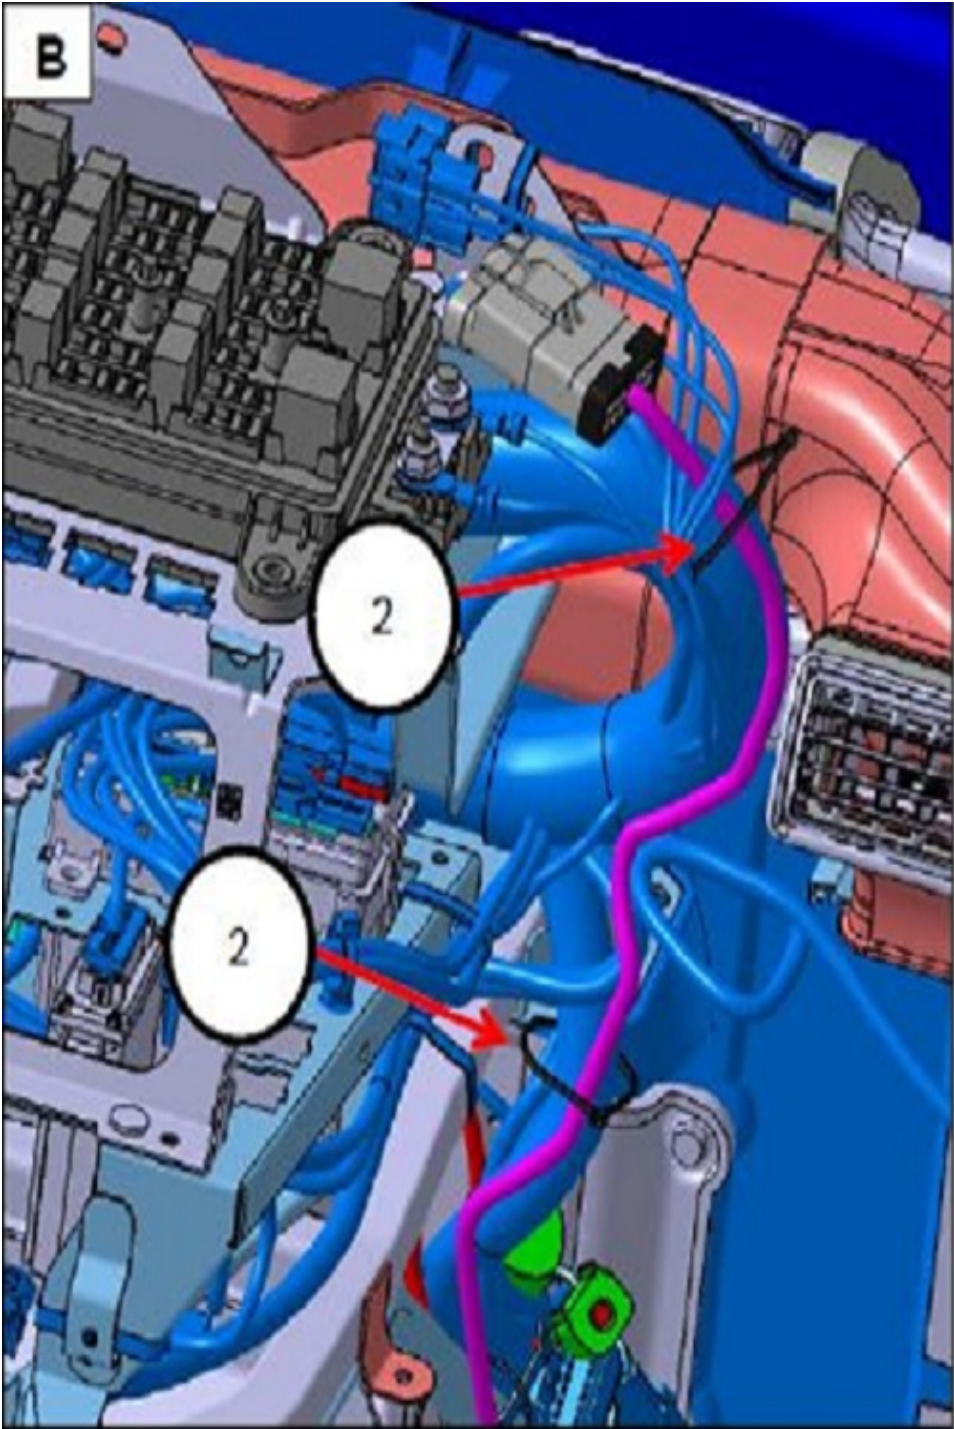
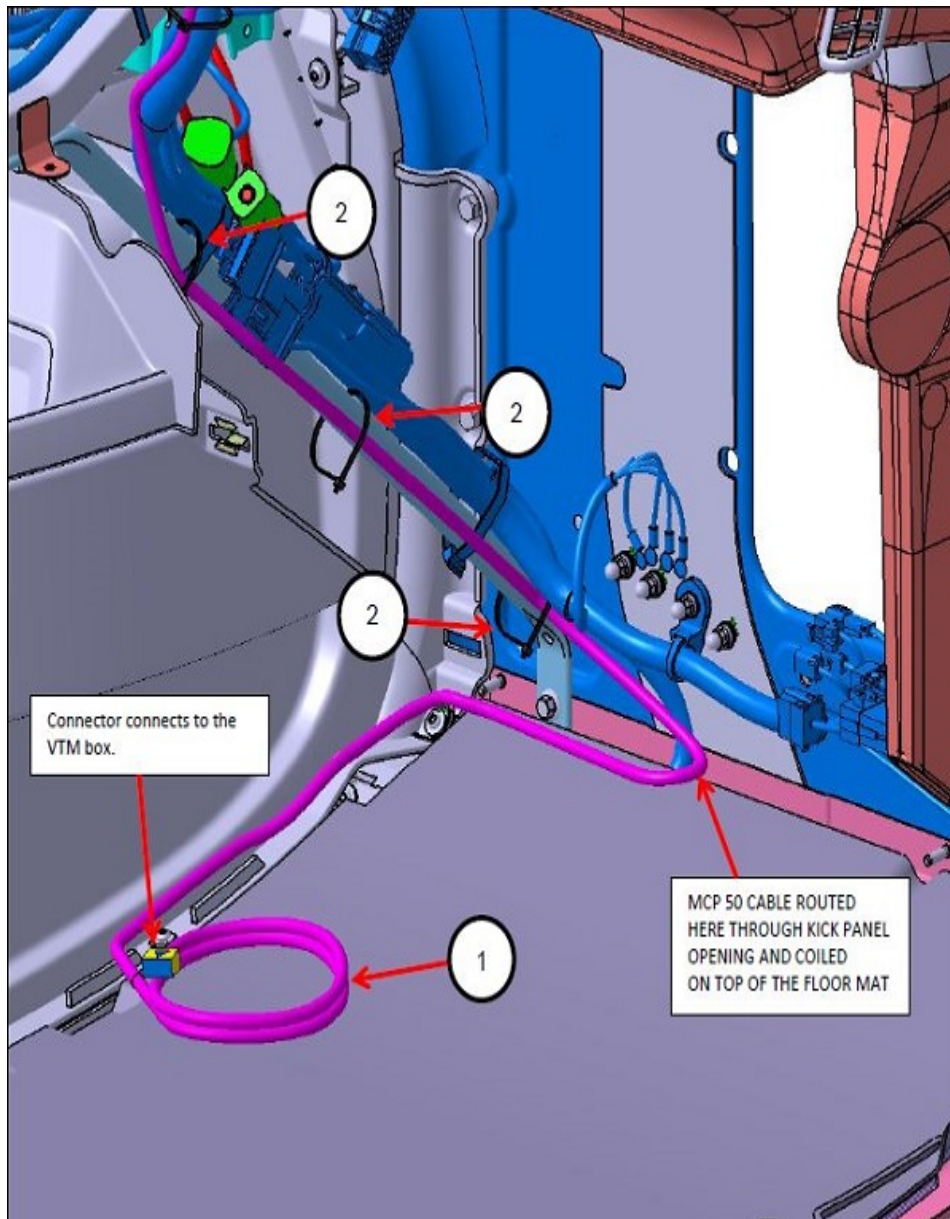
- 3rd party devices must not be connected to the main diagnostic connector under the steering wheel.
- 3rd party devices must be listen-only or passive mode.
- 3rd party devices must not use power with key off to avoid battery drain.
- The truck must maintain all factory install terminating resistors in the harness.
